Migrated Expansion Tower Problem Analysis, Repair and Parts

Version 4

First Edition (June 2000)

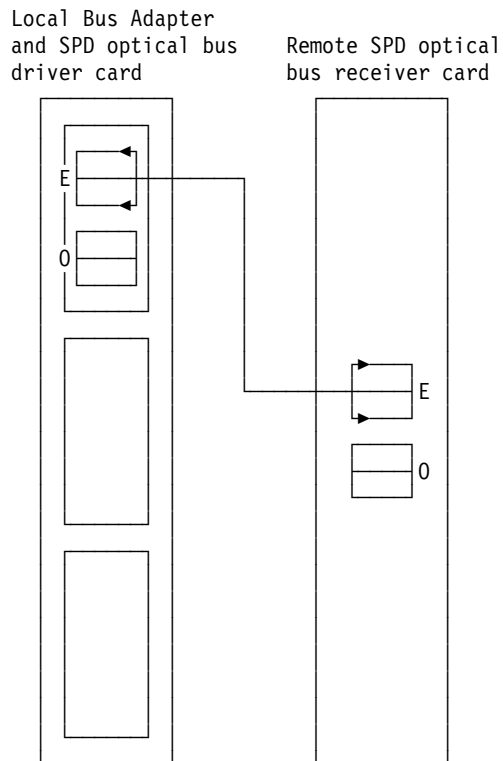
Figure 1. Example Single Bus

- Ensure that the cable in the bottom, odd-number position (shown in the following figures as **O**) of the local SPD optical bus driver card is connected to the bottom connector (**O**) of the remote SPD optical bus receiver card.
- Use the system configuration list and the following configuration examples to identify the correct configuration for your SPD migrated tower.

11. Perform the following to verify the configuration of the optical bus hardware:
- Ensure that both ends of all optical cables are tightly connected.
 - Use the system configuration list, and Figure 1 through Figure 5 on page 274 to identify the correct configuration for your SPD migrated tower. Verify that the optical bus cable connections are correct. Use the *AS/400e server 170, 250, 6xx, 7xx, and Sxx System Installation and Upgrade* if you need to verify the system configuration rules.
 - Ensure that an optical wrap plug is installed on the local local SPD optical bus driver card for all buses that are not used.
 - Use the cleaning kit if you suspect that the optical bus cables are dirty.
 - Ensure that there are no bends in the optical bus cables less than a 2.54 cm (1 in) radius and no coils in the cables less than a 3.05 cm (1.2 in) diameter.

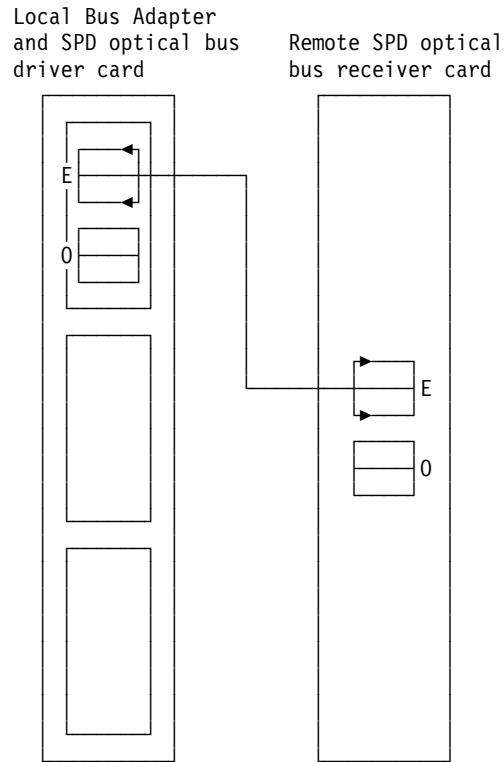
Figure 6. Example Single Bus

- Ensure that all optical connections are tight.
- Ensure that the cable in the top, even-number position (shown in the following figures as **E**) of the SPD optical bus driver card is connected to the top connector (**E**) of the remote SPD optical bus receiver card.
- Ensure that the cable in the bottom, odd-number position (shown in the following figures as **O**) of the SPD optical bus driver card is connected to the bottom connector **O** of the remote SPD optical bus receiver card.
- Use the system configuration list and the following configuration examples to identify the correct configuration for your system.

12. Perform the following to verify the configuration of the optical bus hardware:
- Ensure that both ends of all optical cables are tightly connected.
 - Use the system configuration list, and Figure 6 through Figure 10 on page 285 to identify the correct configuration for your system. Verify that the optical bus cable connections are correct. Use the *AS/400e server 170, 250, 6xx, 7xx, and Sxx System Installation and Upgrade* or *AS/400e server 270 and 8xx System Installation and Upgrade* if you need to verify the system configuration rules.

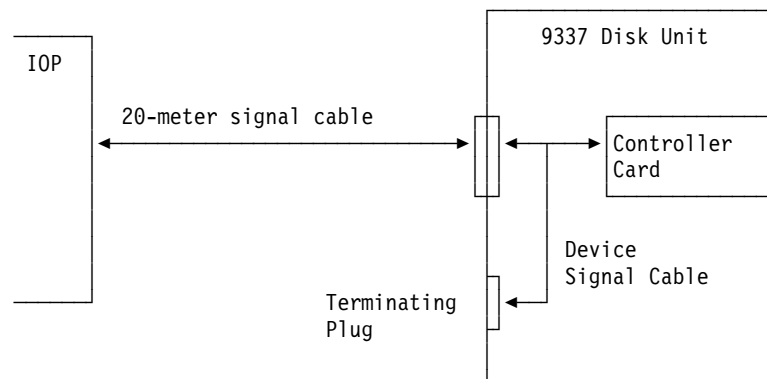
- 1) To disconnect the card, see the *9337 Disk Array Service Information*
- 2) It is easier to disconnect the card than to disconnect the cable.
- 3) See the following diagram to help understand this step.
- 4) If the signal cable is isolated as the failing item, this failing item now includes the signal cable inside the 9337.

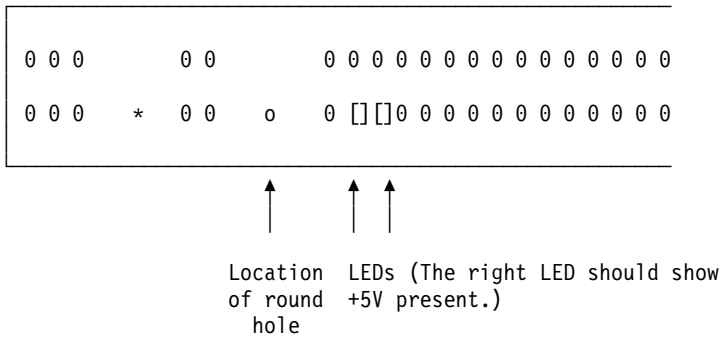
Figure 12. Round Hole Location On Back of Supply

- 1) Disconnect all output cables plugged into the supply (not the AC linecord).
- 2) Using a non-conductive tool, locate the only *round* hole on the back of the supply.

- 3) Insert the tool into this round hole only to push the button within the supply (see Figure 12). Hold the button in. (The right LED indicates +5V present.)
While holding the button in, does the second LED light and remain lit?
No Yes
↓ Replace the control panel card (see “SPNLCRD” on page 581).
This ends the procedure.
- 4) The power supply does not power on and remain powered on. Replace the power supply, part number 21H9364.
This ends the procedure.

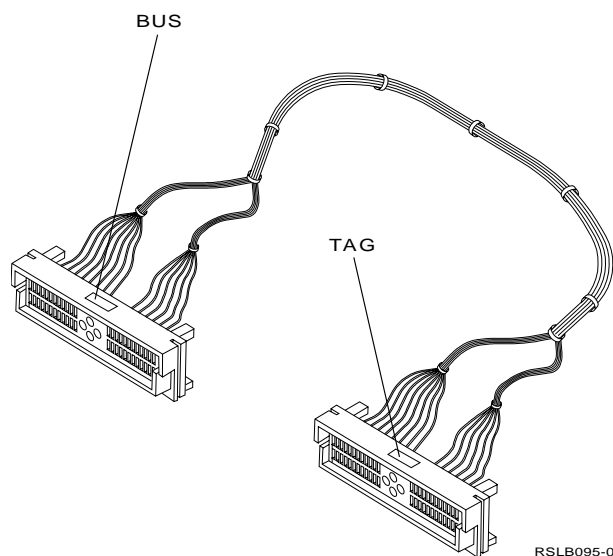
Figure 13. Channel Wrap Block 1, part 62X3403

1. To perform this procedure, the tape unit must be the alternate IPL device.
2. To perform this procedure, you need one or both of the following:
 - Channel wrap block 1 (part 62X3403)
 - Channel wrap block 2 (part 6473051)

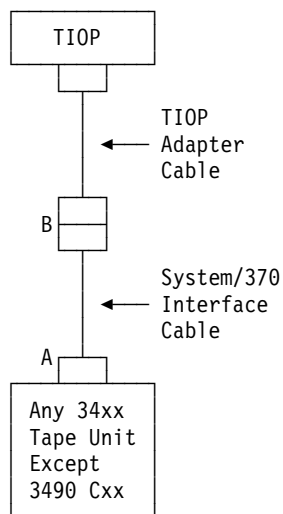
Figure 15. Tape Subsystem Cable Connections

2. The tape subsystem cables connect as shown in Figure 15.

- a. Disconnect channel wrap block 1 from the end of the System/370 interface cable.
- b. Disconnect the TIOP adapter cable from the System/370 interface cable (at **B** in Figure 15 on page 471).
- c. Connect channel wrap block 1 to the end of the TIOP adapter cable.

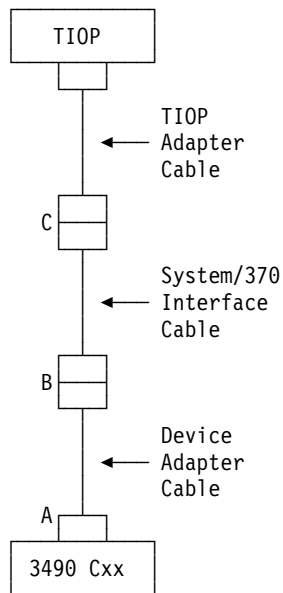
Figure 16. Tape Subsystem Cable Connections

28. The tape subsystem cables connect as shown in Figure 16.

- a. Disconnect channel wrap block 1 from the end of the System/370 interface cable.
- b. Disconnect the TIOP adapter cable from the System/370 interface cable (at **C** in Figure 16 on page 475).
- c. Connect channel wrap block 1 to the end of the TIOP adapter cable (Bus to Bus and Tag to Tag).

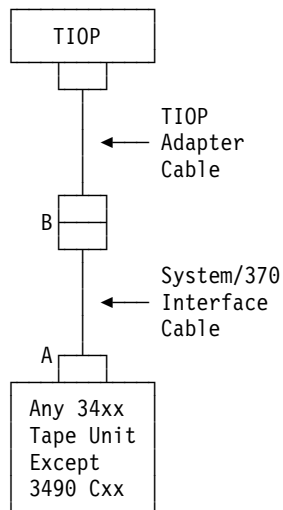
Figure 18. Tape Subsystem Cable Connections

2. The tape subsystem cables are connected as shown in Figure 18.

- a. Disconnect the System/370 interface cable from the I/O device control unit (at **A** in Figure 18).
 - b. Connect channel wrap block 1, part 62X3403, to the end of the System/370 interface cable (Bus to Bus and Tag to Tag). The channel wrap block 1 is stored with the system tools.
3. Perform the following:
 - a. Power off the system (see “Powering On and Powering Off the System or Expansion Tower” on page 868).
 - b. Select IPL type D in manual mode (see *AS/400 Service Functions*).
 - c. Power on the system.

- a. Disconnect channel wrap block 1 from the end of the System/370 interface cable.
- b. Disconnect the TIOP adapter cable from the System/370 interface cable (at **B** in Figure 18 on page 483).
- c. Connect channel wrap block 1 to the end of the TIOP adapter cable.

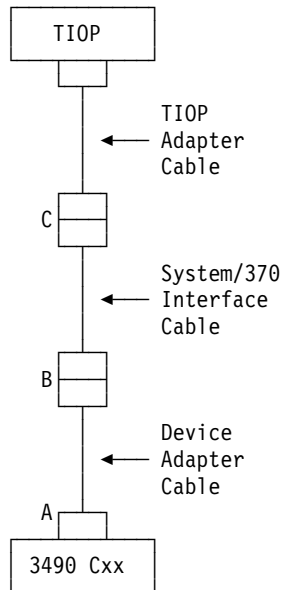
Figure 19. Tape Subsystem Cable Connections

28. The tape subsystem cables are connected as shown in Figure 19 on page 487.

- a. Disconnect the device adapter cable from the I/O device control unit (at A in Figure 19).
 - b. Connect channel wrap block 2, part 6473051, to the device end of the device adapter cable. The channel wrap block is stored with the system tools.
29. Perform the following:
- a. Power off the system (see "Powering On and Powering Off the System or Expansion Tower" on page 868).
 - b. Select IPL type D in manual mode (see *AS/400 Service Functions*).
 - c. Power on the system.

- a. Disconnect channel wrap block 2 from the end of the device adapter cable.
- b. Disconnect the System/370 interface cable from the device adapter cable (at **B** in Figure 19 on page 487).
- c. Connect channel wrap block 1 (part 62X3403) to the end of the System/370 interface cable (Bus to Bus and Tag to Tag).

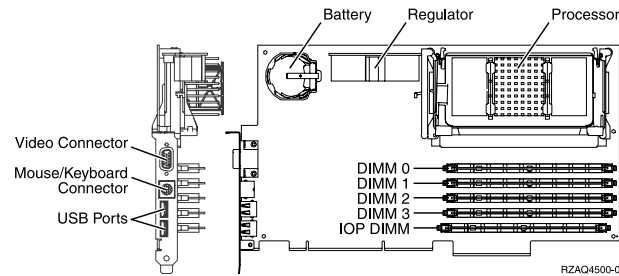
Figure 21. Locations of DIMM 0, DIMM 1, DIMM 2 and DIMM 3 on 2890 Integrated Netfinity Server (INS) card.

The memory module may be the failing item.

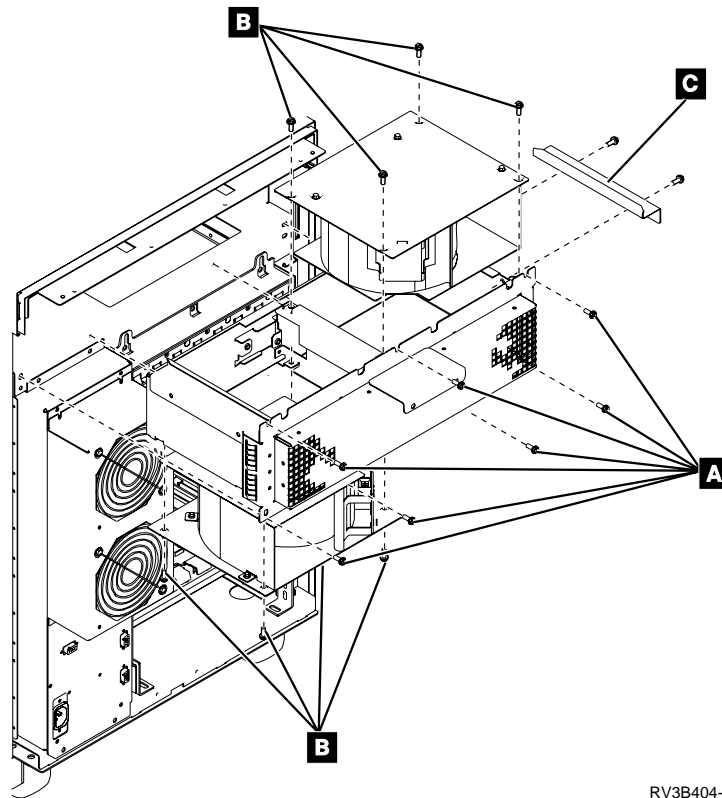
FC 507x and FC 508x

1. Power off the system (see “Powering On and Powering Off the System or Expansion Tower” on page 868).
2. Disconnect the power cord.
3. Remove the rear cover (see “Covers” on page 638).
4. Remove the screws **A**.
5. Pull the AMD assembly from the frame.
6. Remove the screws **B** that hold the AMD you are exchanging to the AMD assembly. You may need to remove the blower support bracket **C**.
7. Install the parts of the AMD assembly by reversing the removal procedure. After exchanging an item, go to “Verifying the Repair” on page 866.
This ends the procedure.

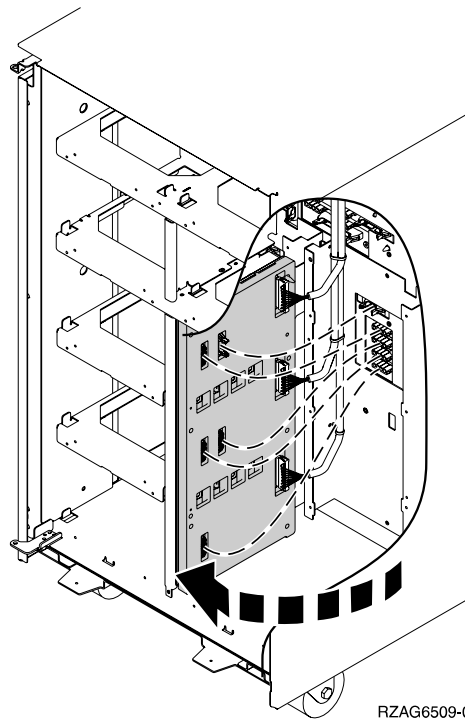
Attention: The disk units are sensitive to electrostatic discharge (see “Appendix C. Working with Electrostatic Discharge-Sensitive Parts” on page 899).
 - c. Remove the screws that hold the disk unit cage assembly in to the frame.
 - d. Remove the two retaining screws that are located inside of the disk unit cage assembly (the top right and bottom left corners).
 - e. Remove the disk unit cage assemblies.
 - f. Remove the screws that hold the DASD shelf to the frame.
 - g. Remove the DASD shelf from the frame.
5. Remove the retaining screw that is holding the DASD board assembly to the frame.
6. Pull the DASD board assembly out until it slides off the guide pins, then rotate the DASD board assembly 90° to remove the cables that are located on the

7. Remove the cables from the rear of the DASD board assembly and note their locations.

Note: Both ends of the ribbon cables are marked “LH” or “RH” indicating that one end of the cable is plugged in to either the left-hand (DB1) or right-hand (DB2) DASD board assembly. The other end of the cable is plugged in to either the left-most (LH) or right-most (RH) DASD controller card (The cables will crisscross in the center of the tower).

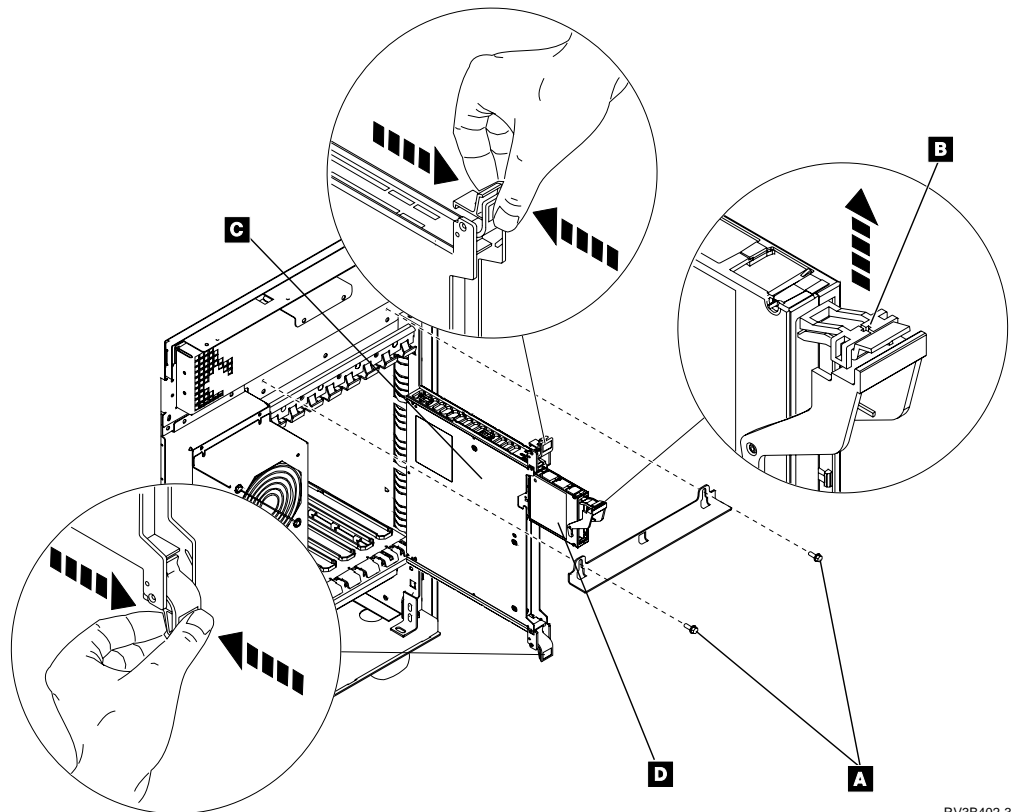
1. Power off the system (see “Powering On and Powering Off the System or Expansion Tower” on page 868).
2. Disconnect the power cords.
3. Remove the front or rear cover (see “Covers” on page 638).
4. Loosen the screws **A** on the card retaining bar.
5. Label and disconnect any cables attached to the card you are going to remove.
6. If you are working with card type 2620, 2628, or 65x2, read the following:

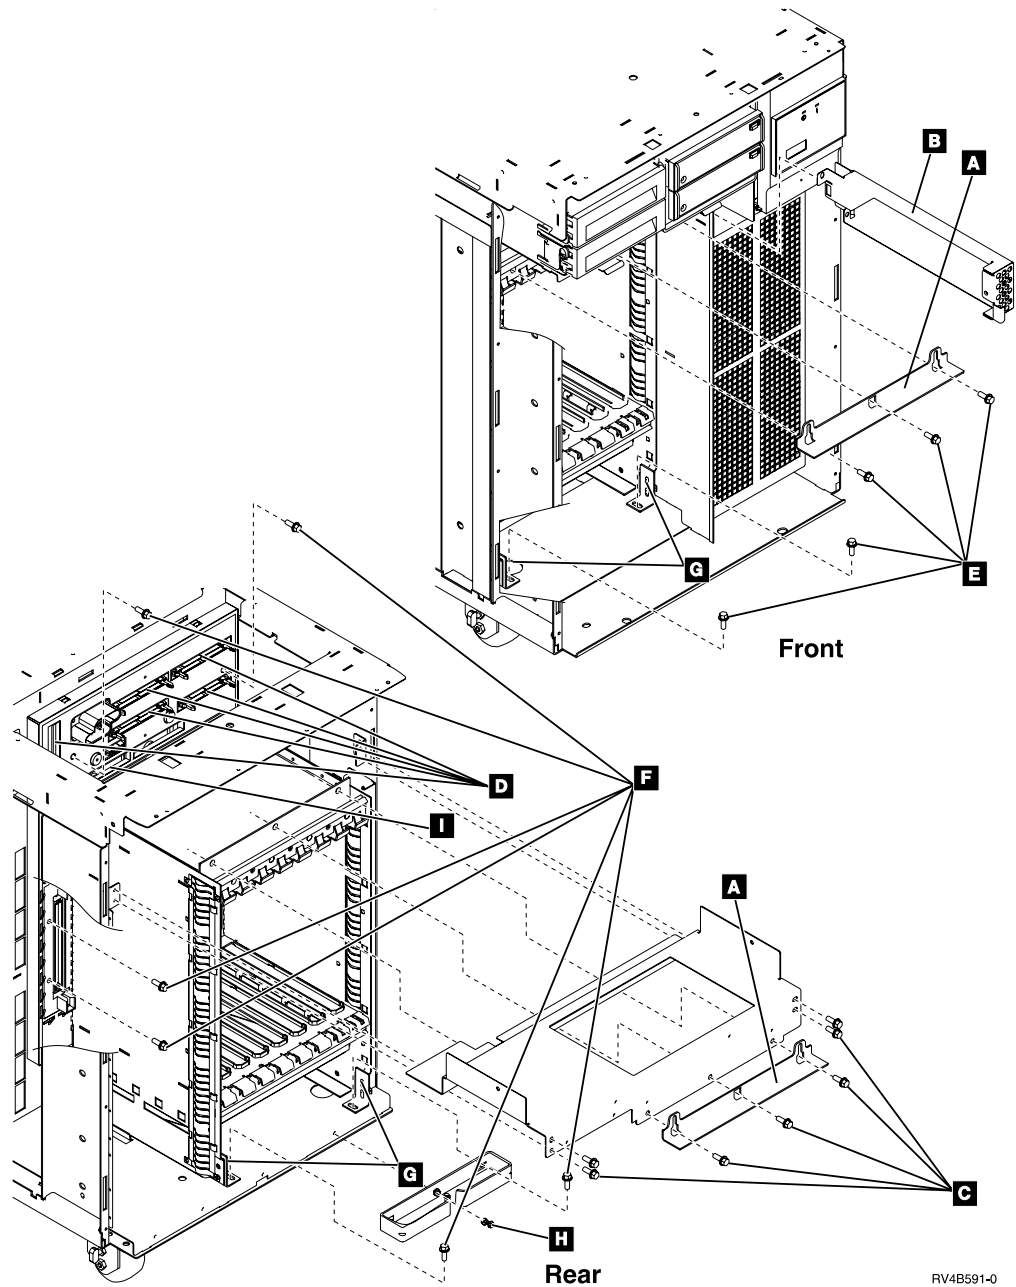
FC 507x/508x Card Enclosure

1. Power off the system (see “Powering On and Powering Off the System or Expansion Tower” on page 868).
2. Disconnect the power cord.
3. Remove the front and rear covers (see “Covers” on page 638).
4. Because safety labels may be applied to the card retaining bars **A**, it is important to install the card retaining bars in the same location from which they were removed.
Label or write down the location of the card retaining bars.
5. Remove the card retaining bars.

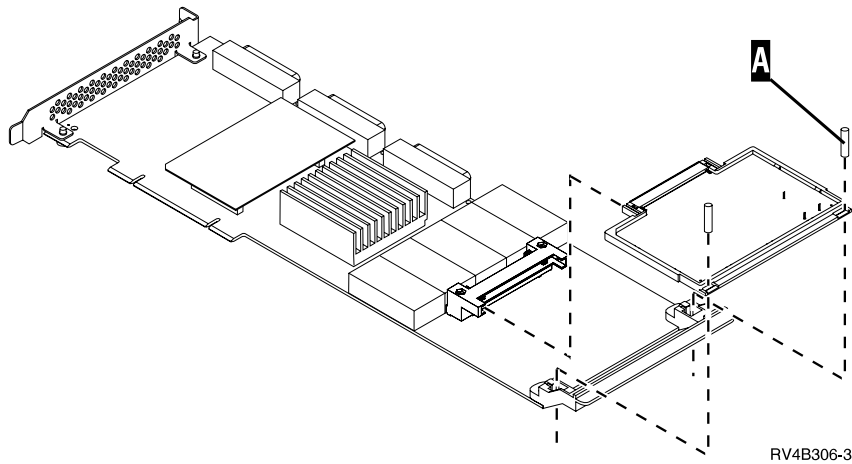
Figure 24. Cache card removal

1. Power off the system. (see “Powering On and Powering Off the System or Expansion Tower” on page 868)
2. Disconnect the power cord from the system or expansion unit.
3. Remove the covers. (See “Covers” on page 638 or if you are working in a FC 5065 or FC 5066 expansion tower see “FC 5065 and FC 5066” on page 639.)
4. Remove the EMC access plate.

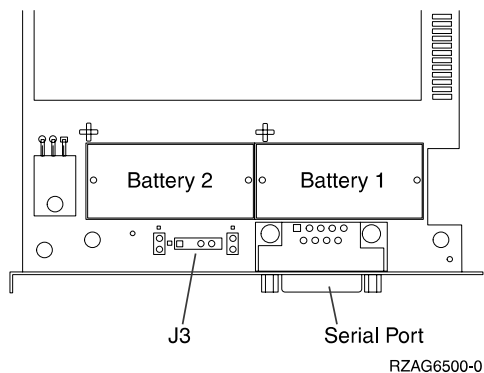
Figure 25. Battery Locations on the 4758 PCI Cryptographic Coprocessor

1. Remove the 4758 PCI Cryptographic Coprocessor card from the system.
2. Find the location of the 4 lithium batteries. They are located in adjacent holders, with the Battery 2 holder above the J3 connector. Refer to the illustration below.

Note: The 4758-023 card contains 4 batteries, even though only 2 batteries are shown in the figure above. Battery 3 is next to Battery 1, and Battery 4 is next to Battery 2.

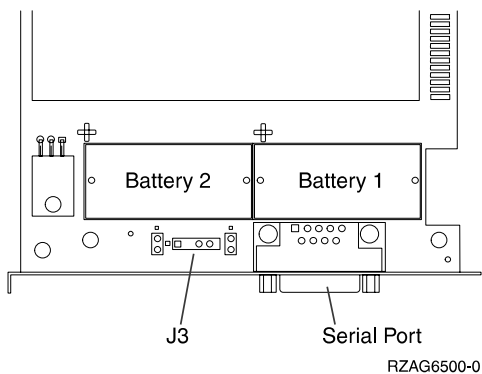
Figure 26. Battery Locations on the 4758 PCI Cryptographic Coprocessor

1. Remove the 4758 PCI Cryptographic Coprocessor card from the system.
2. Find the location of the four lithium batteries. They are located in adjacent holders, with the Battery 2 above the J3 connector. Refer to the illustration below.

Note: The 4758-023 card contains 4 batteries, even though only 2 batteries are shown in the figure above. Battery 3 is next to Battery 1, and Battery 4 is next to Battery 2.

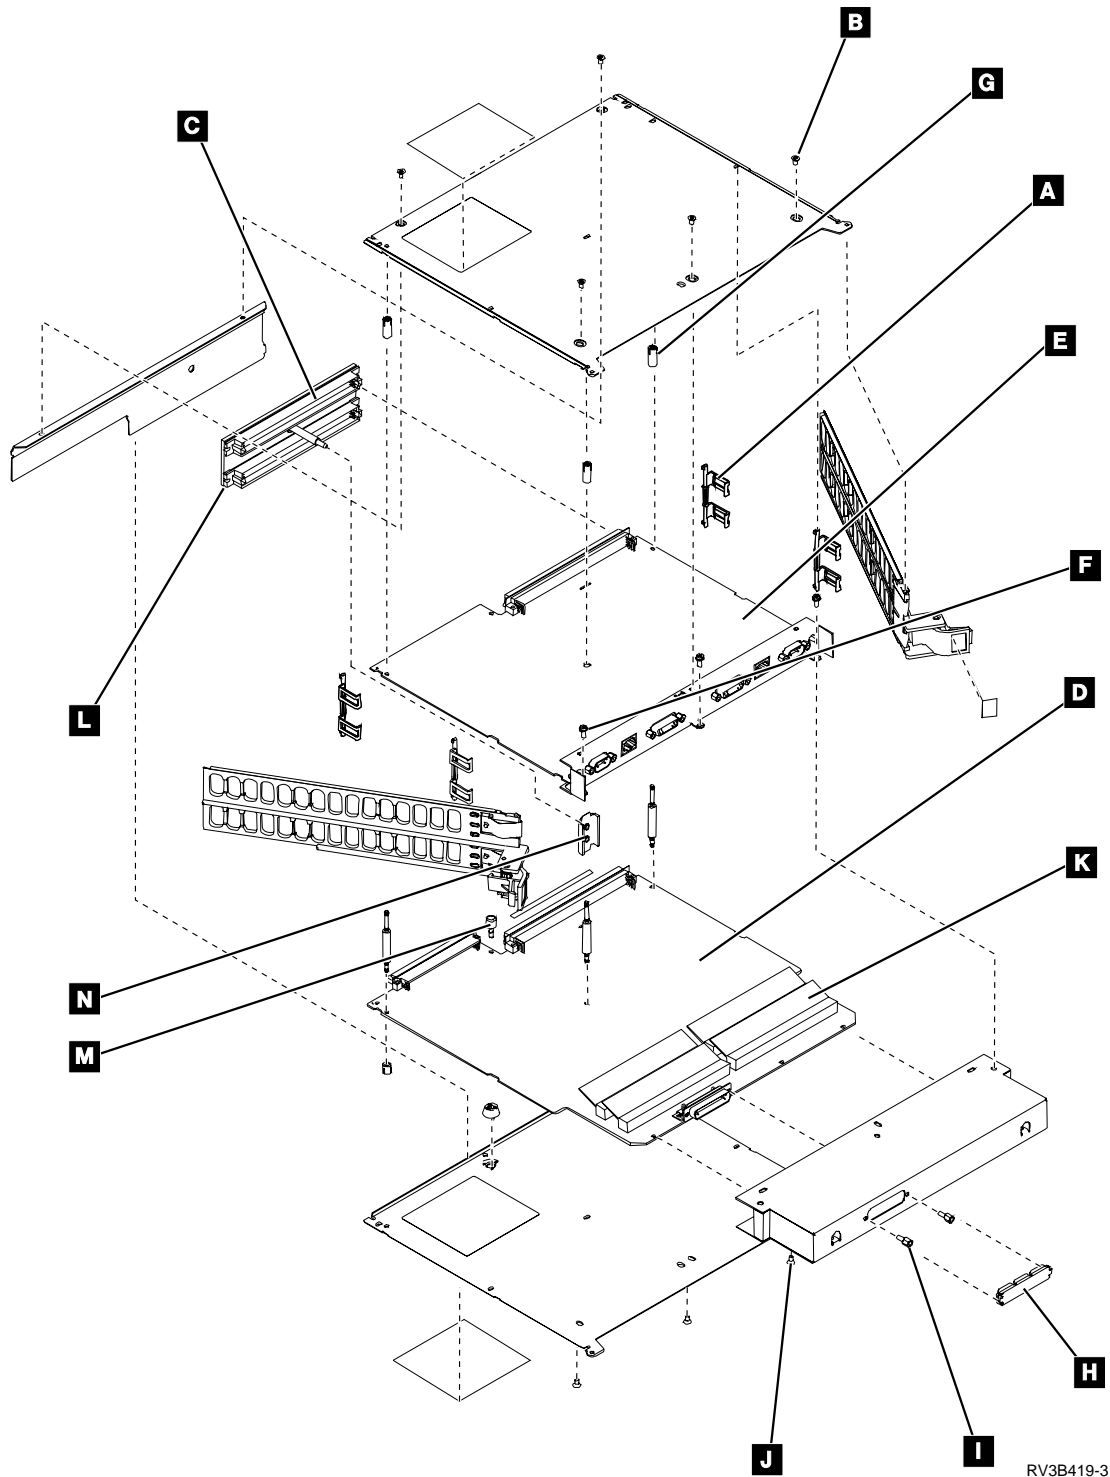
Type 6506 File Server IOP (FC 507x/508x)

1. Remove the file server IOP card from the system (see “Cards” on page 615).
2. Place the card assembly on a flat surface with the latches next to the work surface.
3. Release the four clips A from the rail assemblies. It may be necessary to use a screwdriver to release the clips.
4. Rotate the top and bottom rail assemblies away from the card as shown. Remove the rails by lifting the cover at the hinge points.

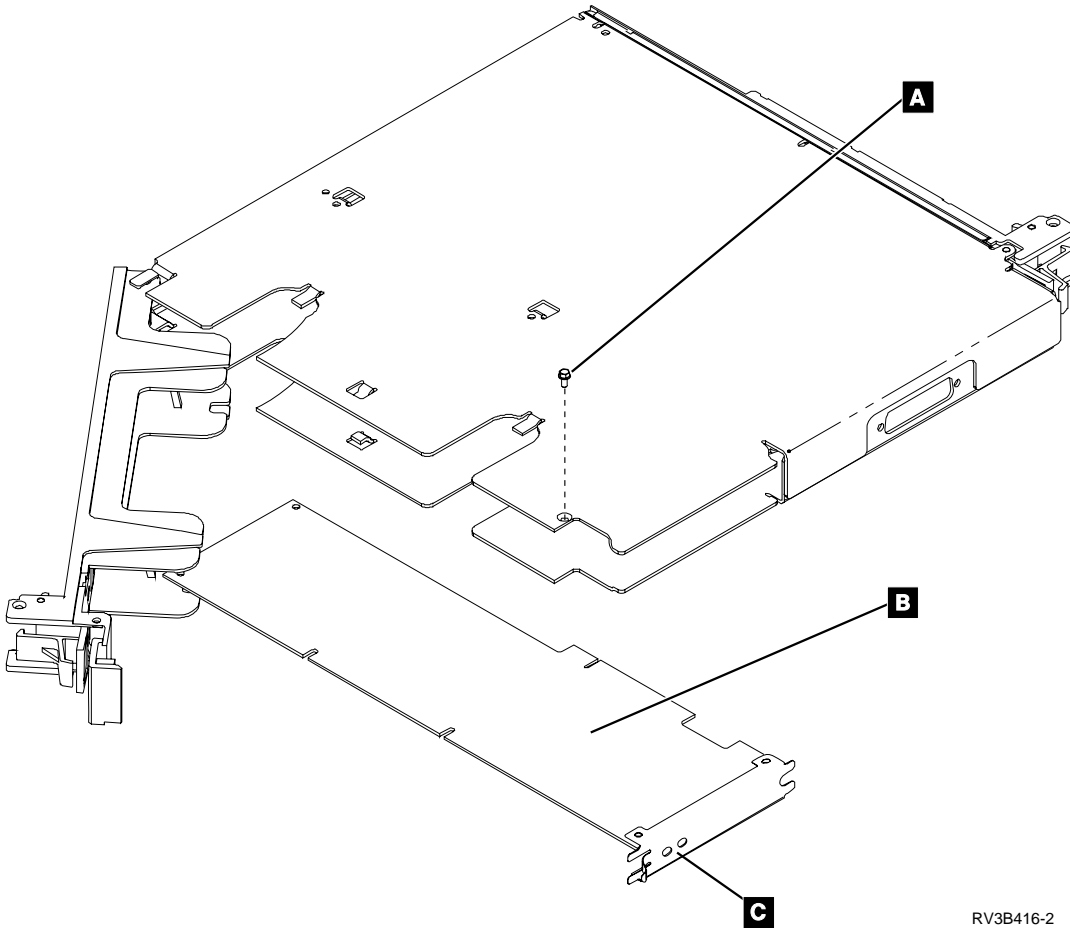
1. Remove the cables C.
 2. Remove the micro channel adapter assembly from the system (see “Cards” on page 615).
 3. Remove the screw A.
 4. Rotate the bottom rail away from the assembly as shown.
 5. Remove the micro channel adapter B.
 6. Install the micro channel adapter assembly by reversing the removal procedure. After exchanging an item, go to Verifying the Repair.
- This ends the procedure.**

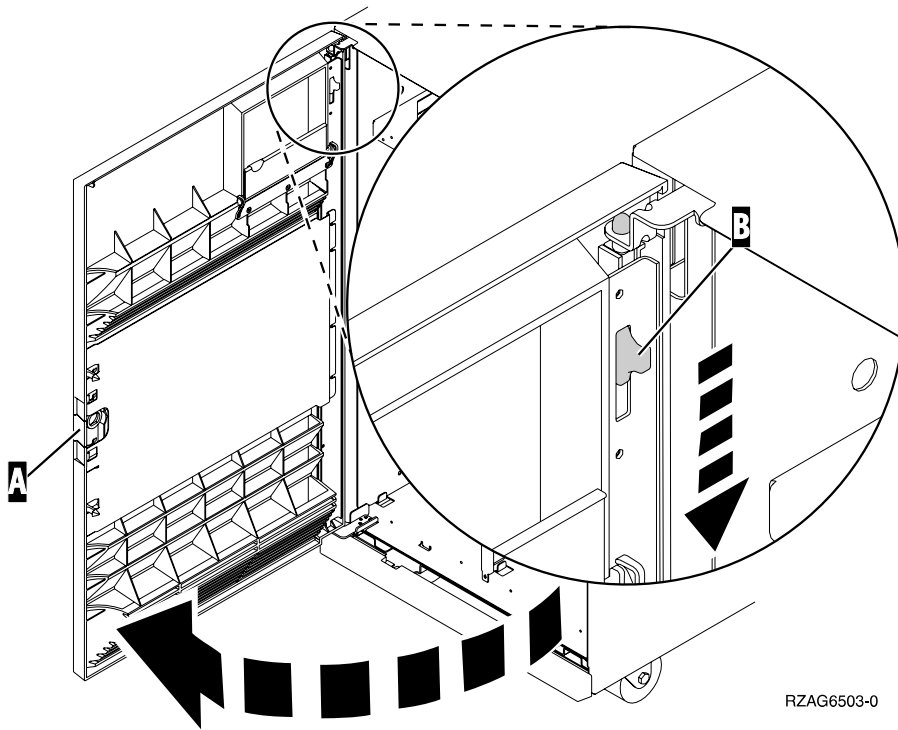
Figure 27. Front Cover - Removal

5. **To remove the cover:**
 - a. After opening the cover, press down on the lever "**B**" that is located inside along the top, left side of the cover.
 - b. Tilt the top of the cover away from the tower and lift the cover off. See Figure 27 on page 640 and Figure 28 on page 640.

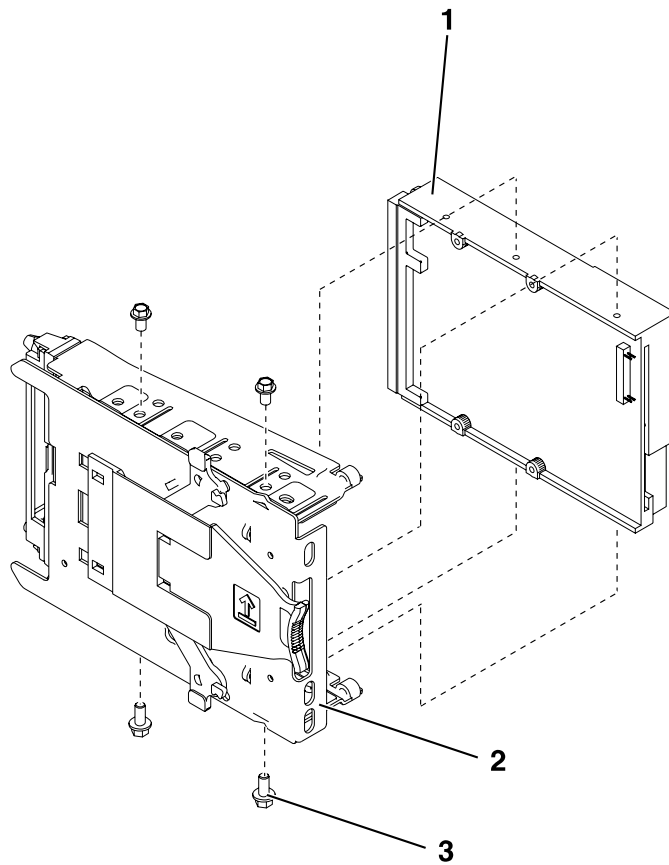
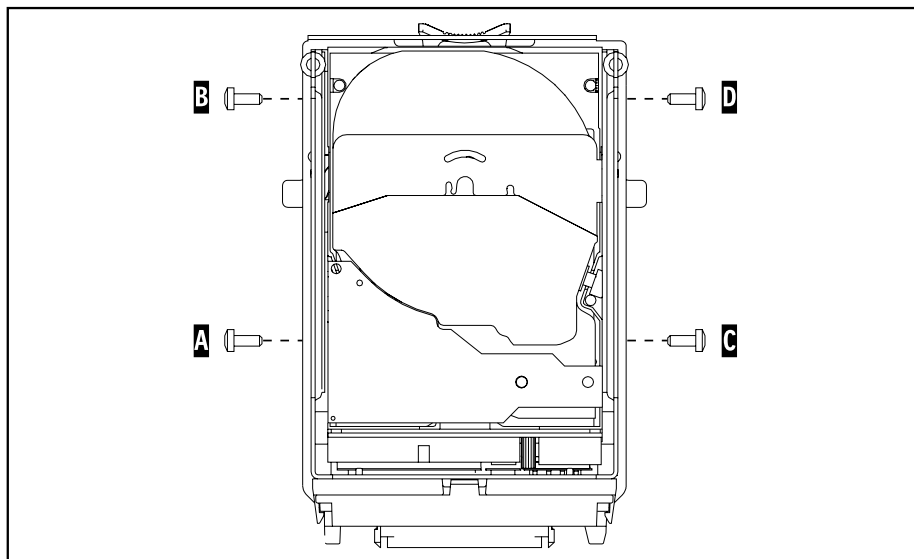
FC 5033, FC 5034, FC 5035:

1. If necessary, remove the disk unit from the system or expansion unit.
2. Loosen and remove screws **A** and **B** first. Then loosen and remove screws **C** and **D**.

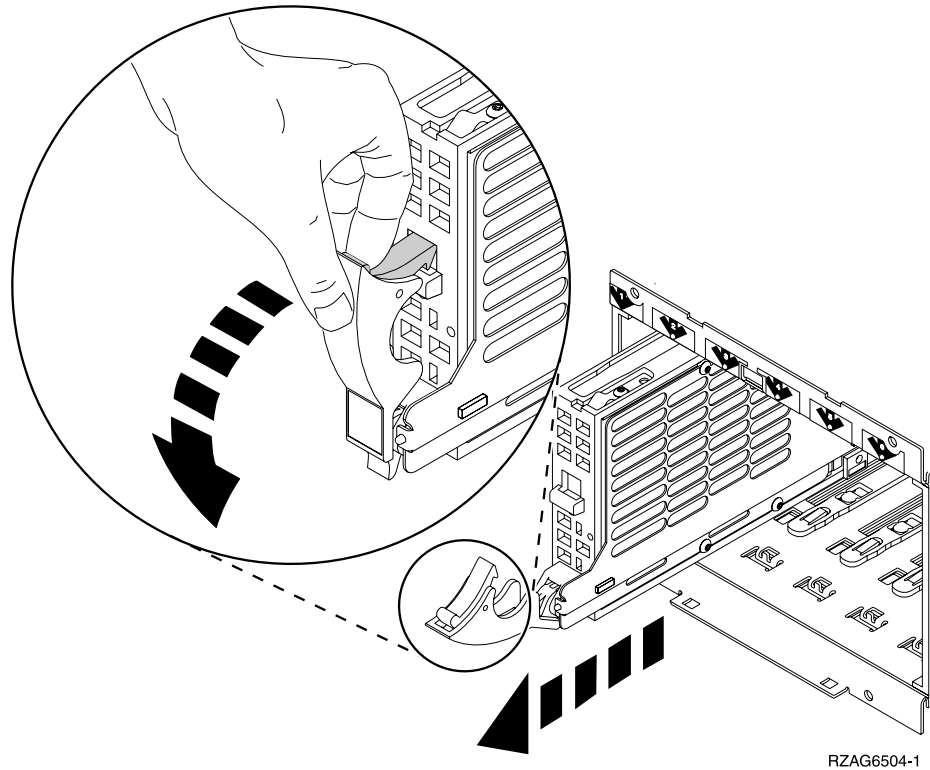
1. **To remove a disk unit using concurrent maintenance perform the following:**
 - a. Select System Service Tools (SST). If you cannot get to SST, select DST.
Do not perform a system IPL to get to DST.
 - b. Select the *Start a Service Tool* option.
 - c. Select the *Hardware Service Manager* option.
 - d. Select *Device Concurrent Maintenance* and enter the required information in the information fields.
 - e. Press the Enter key on the console. After the delay time, the light above the device location will begin flashing. You now have 9 seconds to pinch the two surfaces of the latching mechanism together and rotate the handle of the disk unit towards you. Pull the disk unit partially out of the tower.

Note: The light above the device location will go off and remain off as soon as the device is no longer making contact with the backplane.

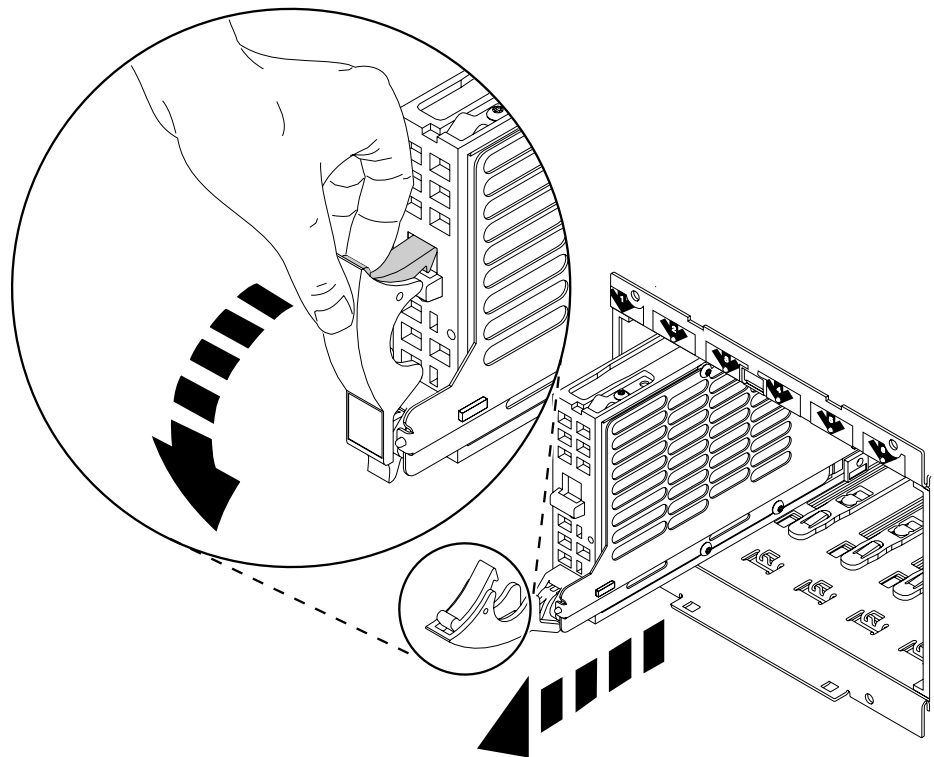
1. To remove a disk unit using dedicated maintenance perform the following:
 - a. Power off the system (see "Powering On and Powering Off the System or Expansion Tower" on page 868).
 - b. Disconnect the power cord.
 - c. To remove the disk unit, pinch the two surfaces of the latching mechanism together and pull the handle towards you to release the disk unit from the slot.
 - d. Remove the unit from the tower.

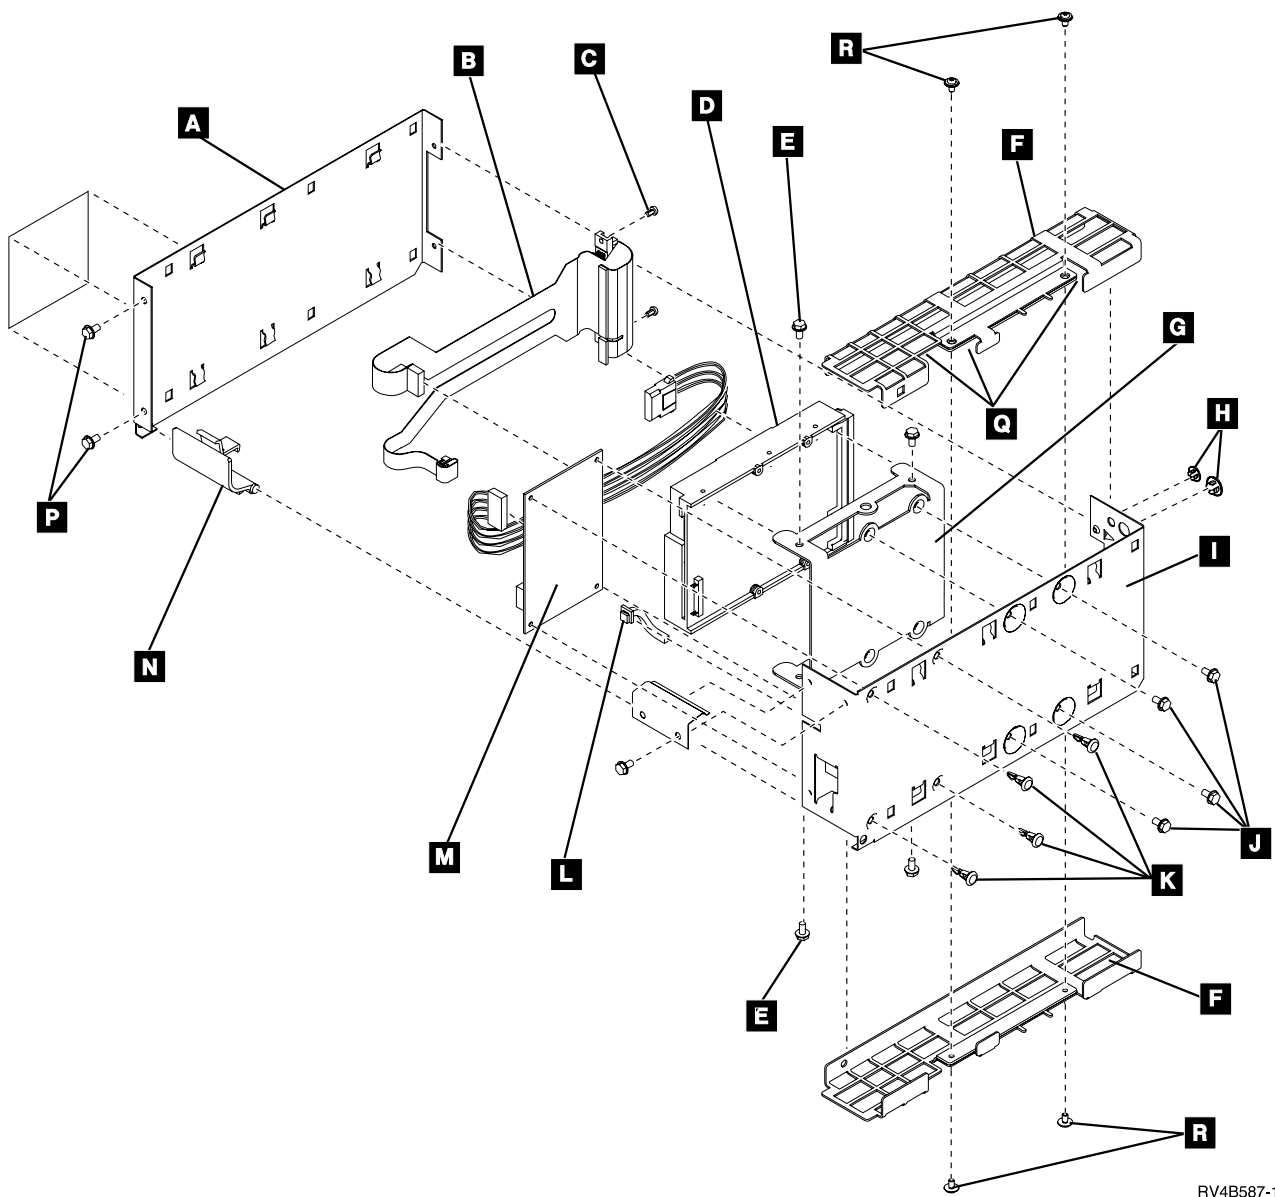
Figure 29. Disk unit holder assembly

- a. Disconnect the power and address cables from the power card.
- b. Disconnect the power and signal cables from the disk unit.
- c. While supporting the disk unit, remove the 4 screws that secure the disk unit to the holder.
- d. Lift the disk unit from the case.
- e. Some disk units have a bracket installed on them. Refer to Figure 29 on page 658. Remove screws **H** and remove bracket **G**.
- f. To exchange the disk unit logic card, use the instructions included with the new disk unit logic card FRU.

Note: The disk unit and flex cable may not be exactly the same type as shown in Figure 29 on page 658.

- Assemble the disk unit into the tray by reversing the steps above.
- **Important:** Tighten and torque the screws in the following sequence (see Figure 29 on page 658).
 - **A**
 - **B**
 - **C**
 - **D**
- **Do not over tighten!**

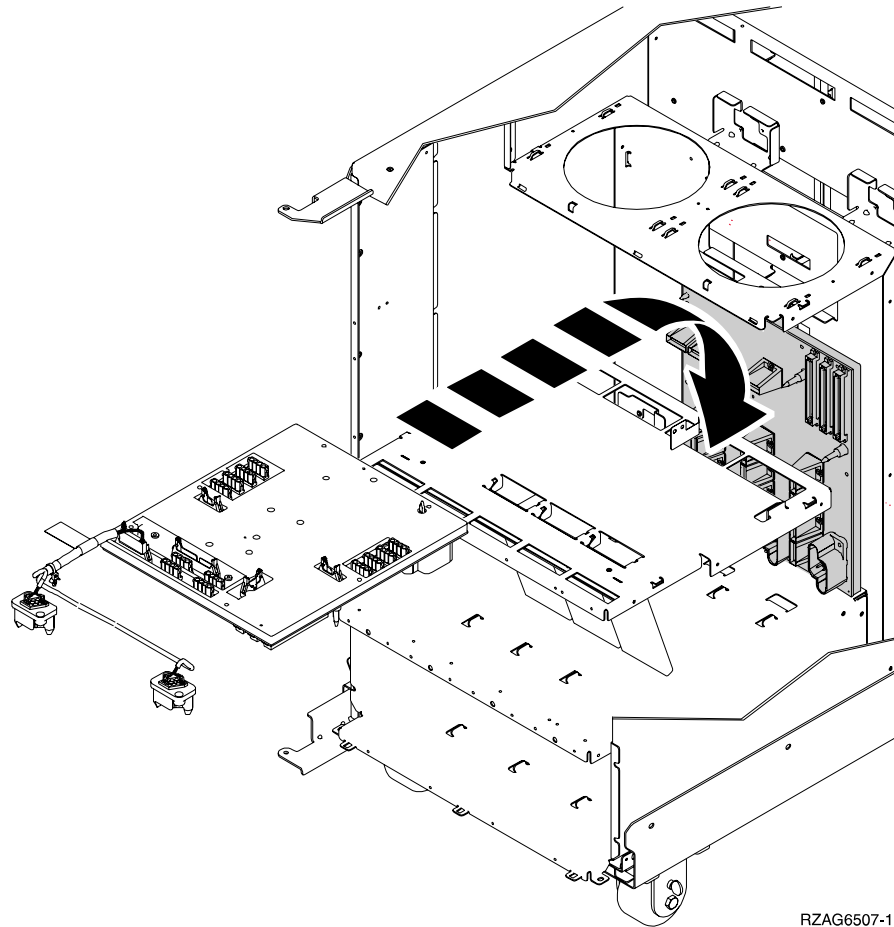
7. From the rear of the tower, remove the mounting screws that hold the power distribution backplane to the frame.

8. Pull the power distribution backplane slightly towards you and lift it up to remove it from the frame.

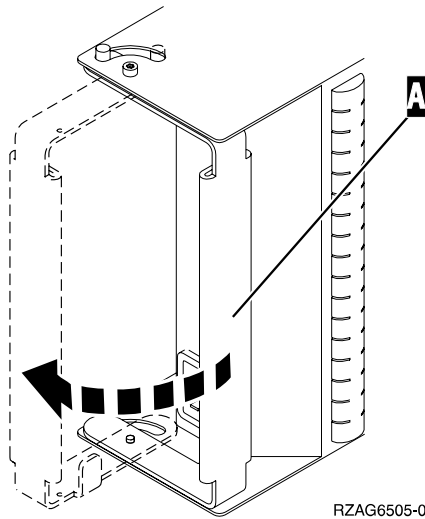
Note: Do not slam the power supply in when installing it into the system. Insert it until the power supply engages the frame, then rotate the

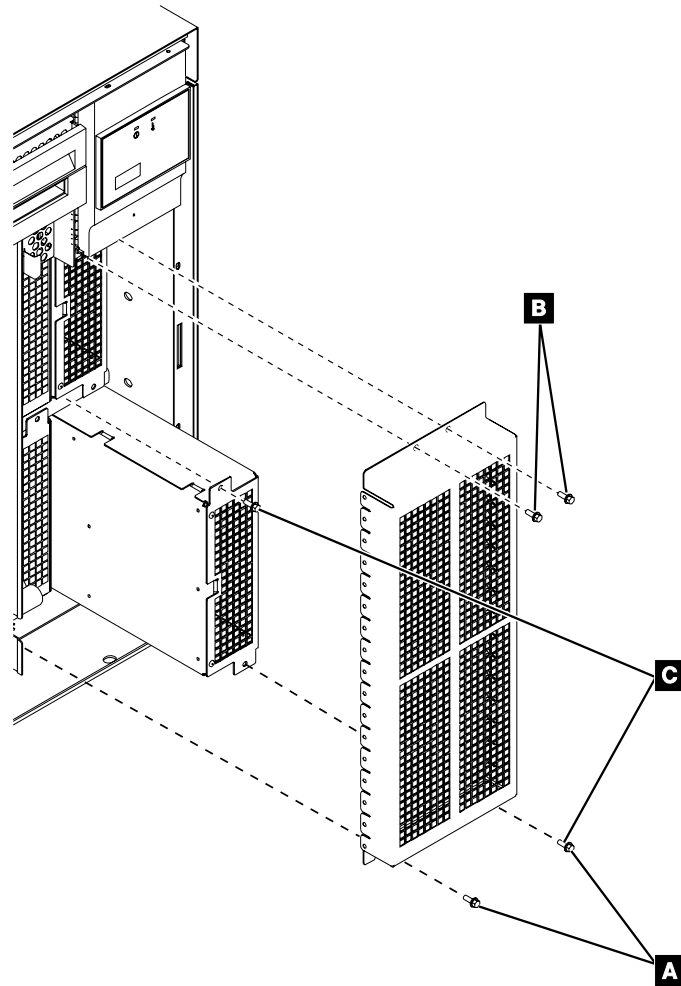
1. Power off the system (see "Powering On and Powering Off the System or Expansion Tower" on page 868).
2. Disconnect the power cord.
3. Remove the front cover (see "Covers" on page 638).
4. Loosen the screws **A**.
5. Remove the screws **B**.
6. Pull out and lift to remove the screen.
7. **DANGER**

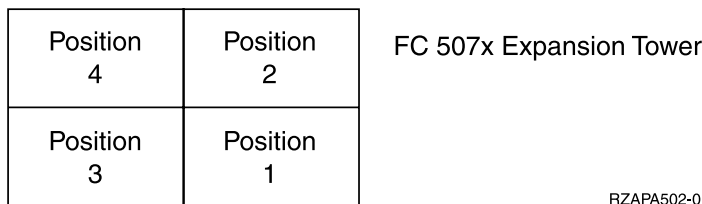
Figure 35. Internal removable media locations

2. Before exchanging a removable media unit, you must verify that the unit is not in use.
3. Use the figure to determine the location of the internal removable media unit. Record this location for later use.

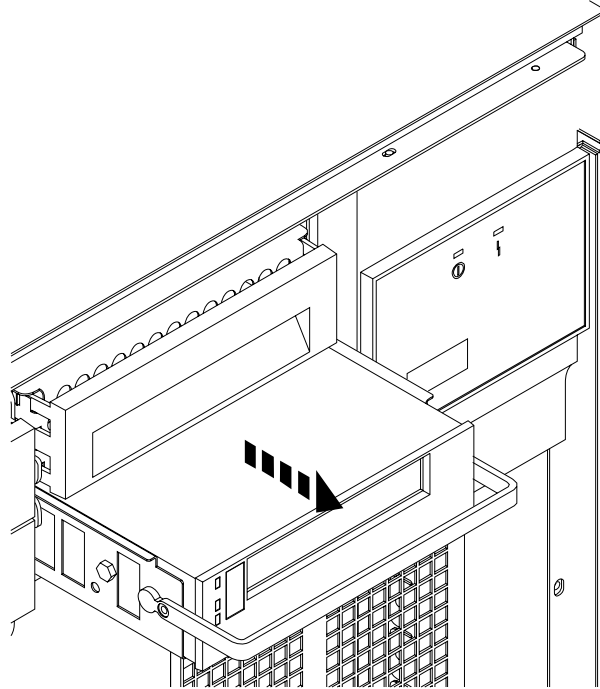
2. Power off the system unit or the expansion tower where the removable media is located. (See "Powering On and Powering Off the System or Expansion Tower" on page 868.)
3. Disconnect the power cord.
4. Remove the front cover (see "Covers" on page 638).
5. Remove the unit by pulling the handle down or up and then out.
6. Install the removable media unit by reversing the removal procedure.
After exchanging an item, go to "Verifying the Repair" on page 866.
This ends the procedure.

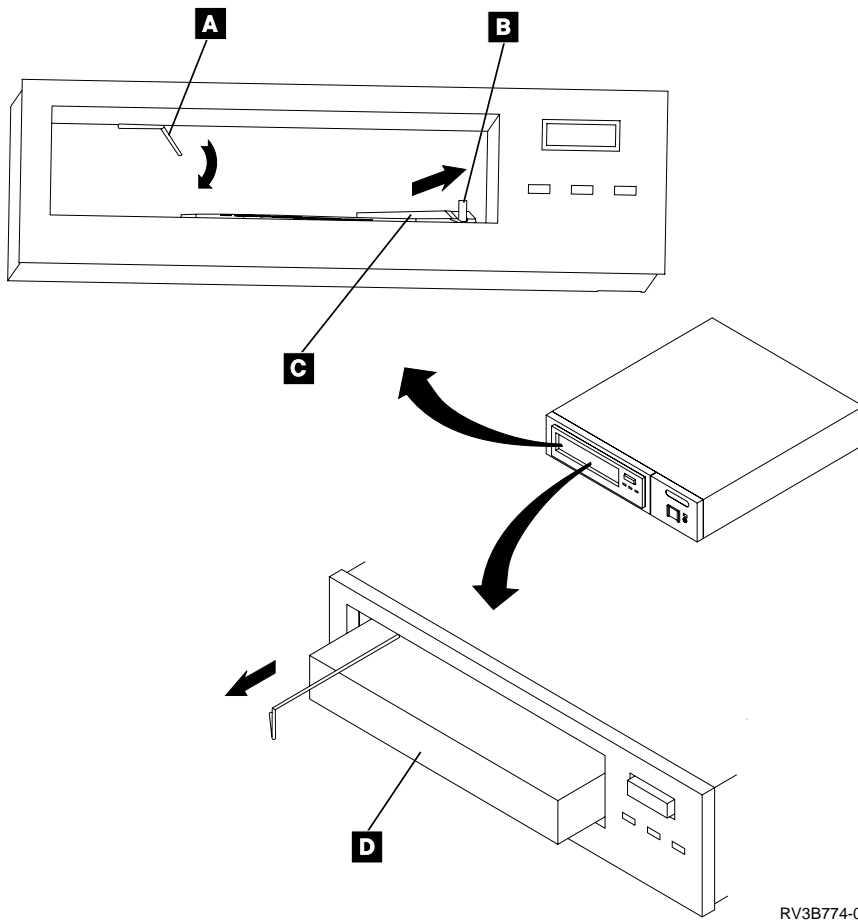
1. Power off the tape unit.
2. Open the tape unit door.
3. Locate the hook shaped metal rod **A** inside the tape unit in the upper left corner.
4. Insert a pointed object (like a pen or screwdriver) into the tape unit and push the metal rod downward.
5. Pull the metal rod forward until the cartridge ejects.
The cartridge **D** is pushed out the tape unit door and can be removed.

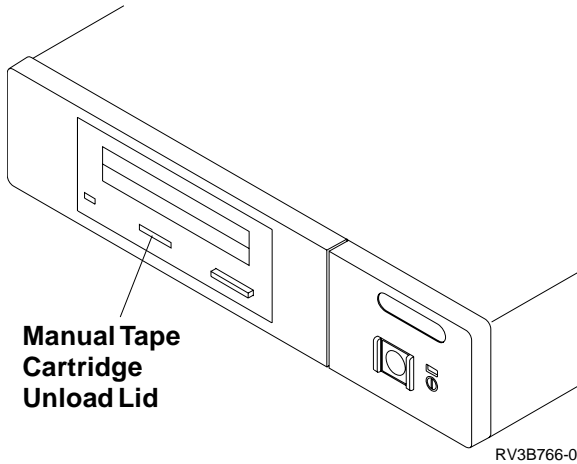
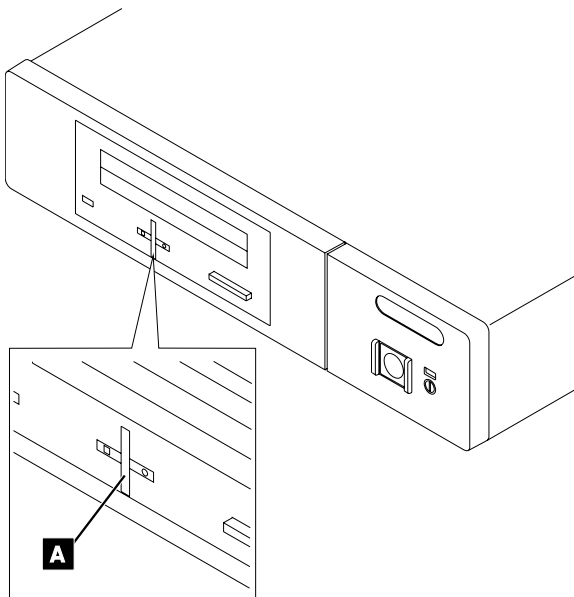
1. Power off the tape unit.
2. Carefully lift and turn the manual tape cartridge unload lid **A**.

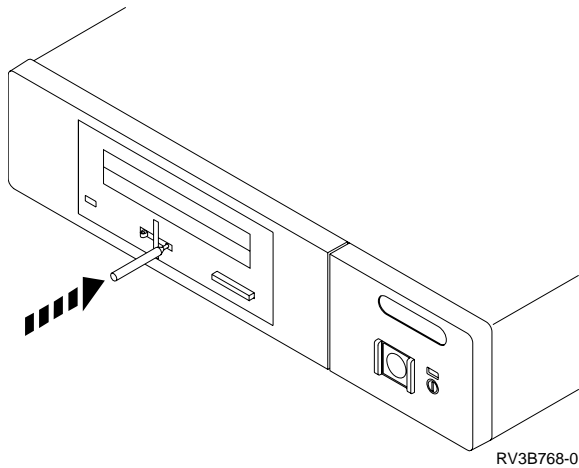
3. Insert a solid metal rod (like a bristol wrench) into the manual tape cartridge unload hole and push in until it stops and the arm appears.

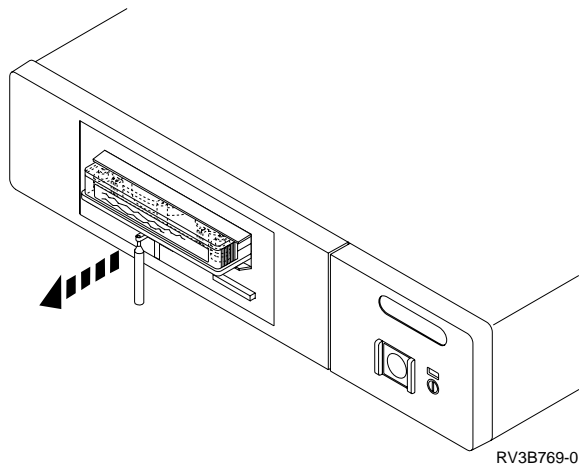
4. Pull the arm out until it stops. Insert the solid metal rod into the hole of the arm and pull out until the tape cartridge comes out.
