Migrated Expansion Tower Problem Analysis, Repair and Parts

Version 4

First Edition (June 2000)

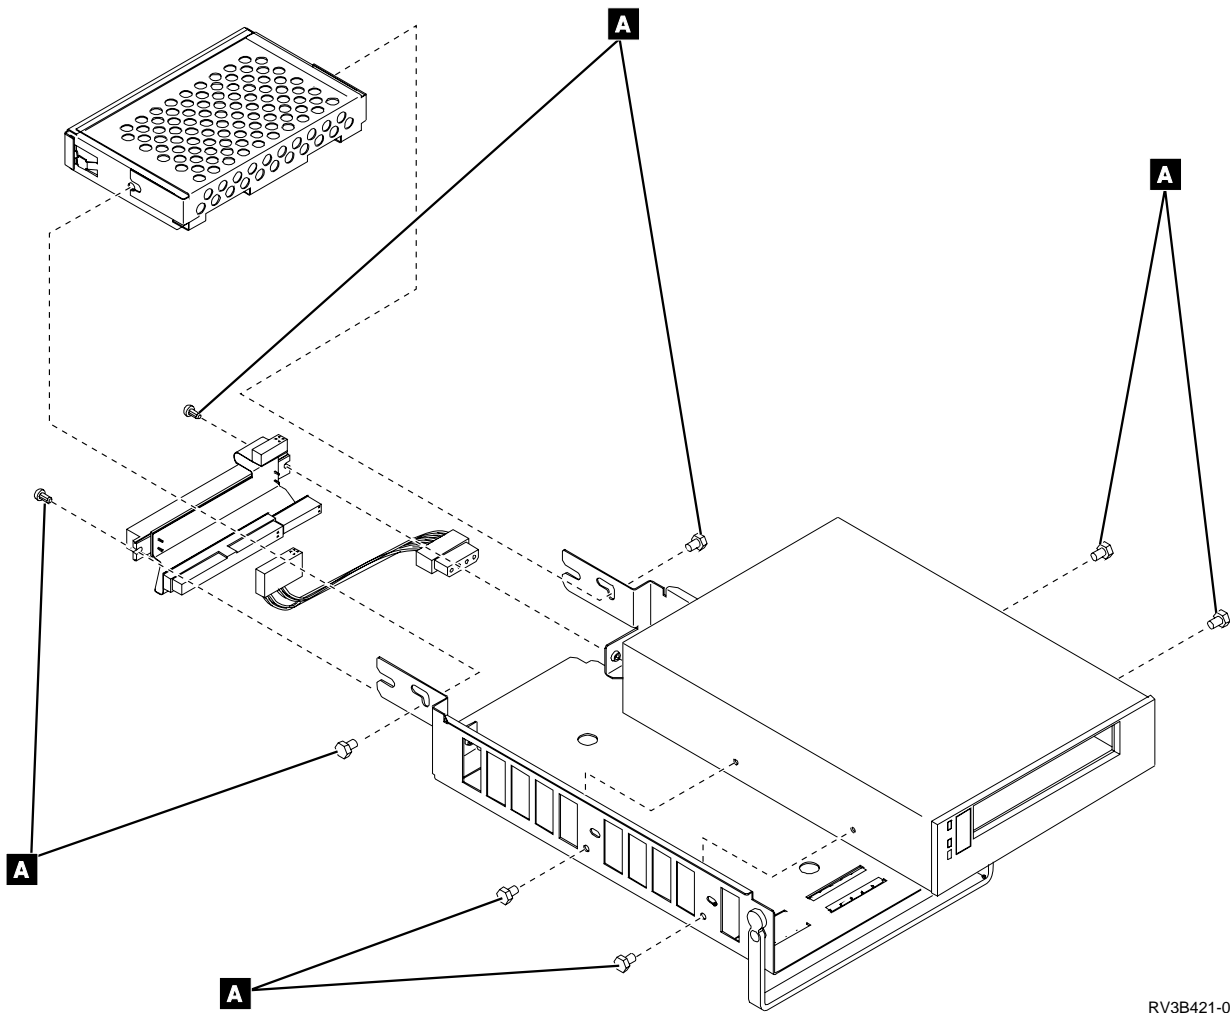
3. Remove the screws **A** to remove the tape drive from the tape tray.

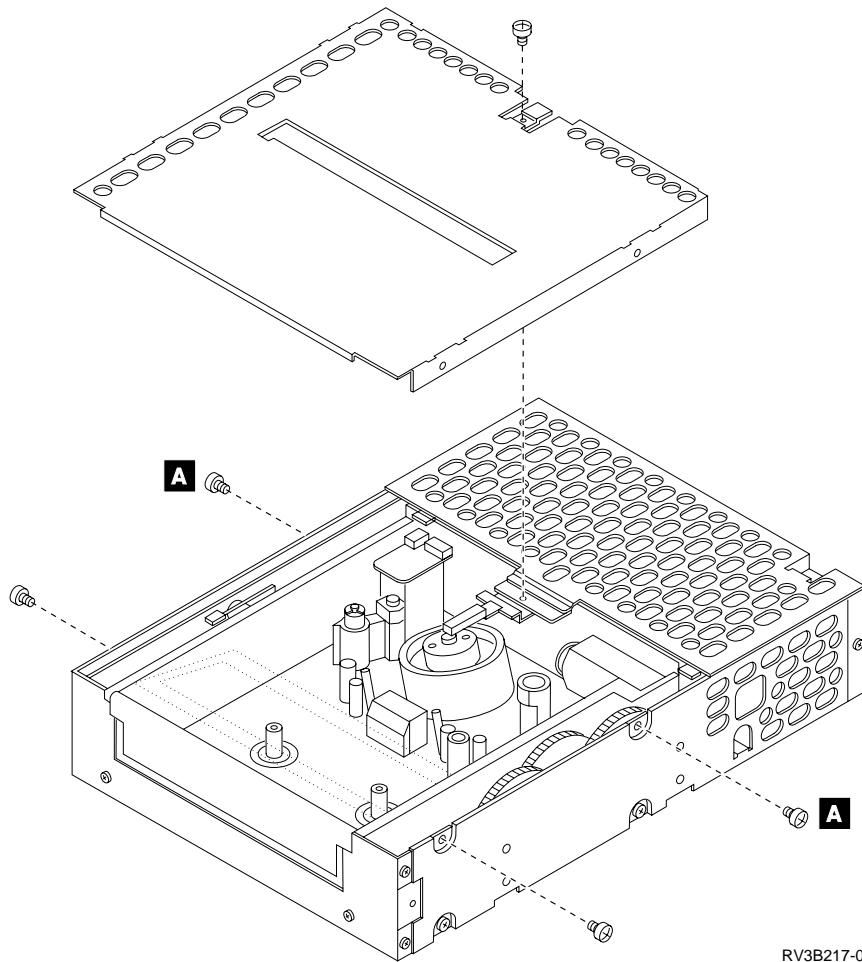
4. Remove the screws from the top cover of the drive assembly. Screws **A** may not be present.

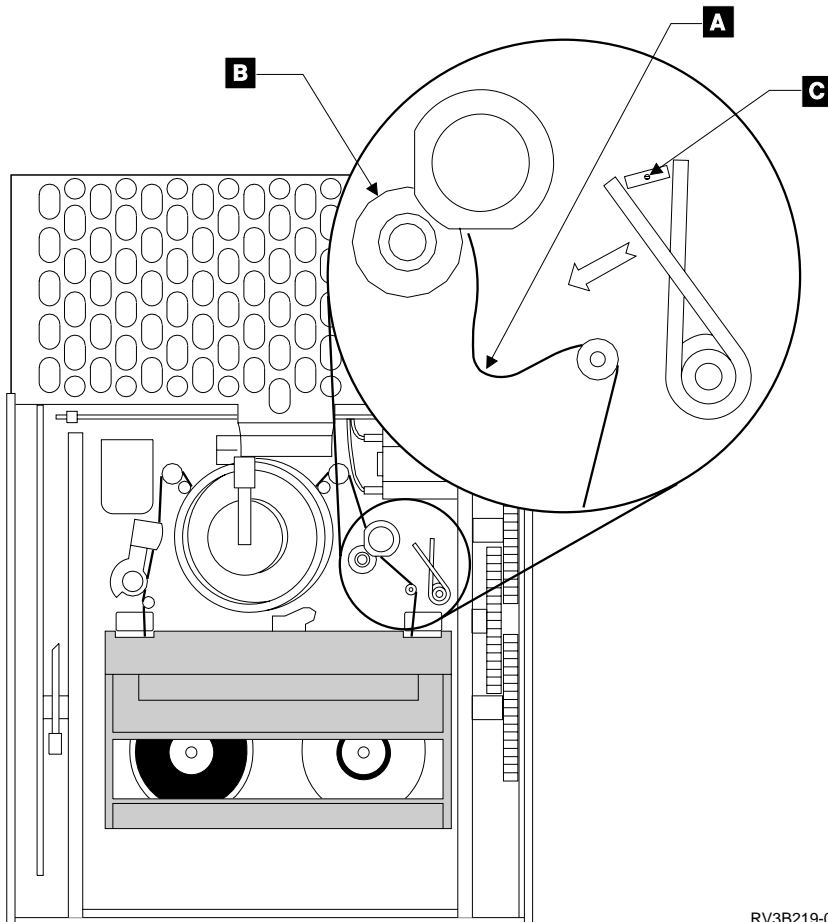
8. Perform the following:
 - a. Loosen the tape as shown **A**. Make sure not to damage or crease the tape. If the pinch roller **B** is engaged, push the pinch roller spring bracket as shown **C**. This releases the pinch roller and provides a gap from which the tape can be removed.

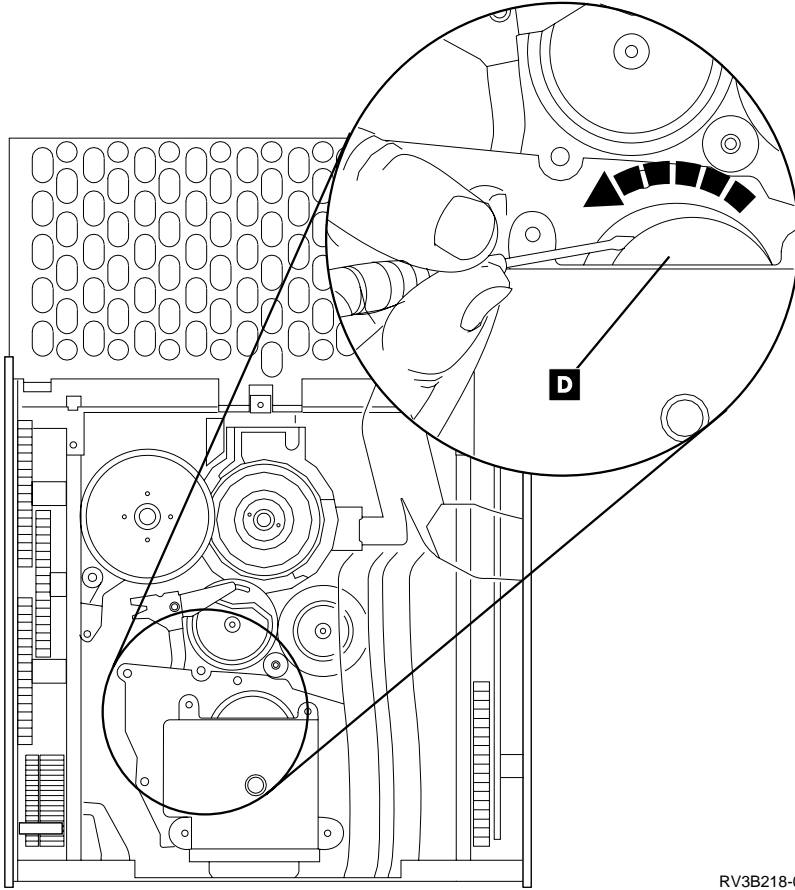
- b. Turn the drive assembly over. Remove the five screws from the bottom cover of the drive assembly. These screws are similar to the screws on the top cover.
- c. Wind the tape into the tape cartridge by following these steps:
 - 1) Using a small screwdriver, push and hold the reel motor gear **D** to the right as far as possible.
 - 2) Rotate the reel motor gear counter-clockwise while also maintaining pressure by holding the gear to the right.
 - 3) Continue to rotate the gear until all of the tape is wound into the tape cartridge and the tape is tight across the opening.

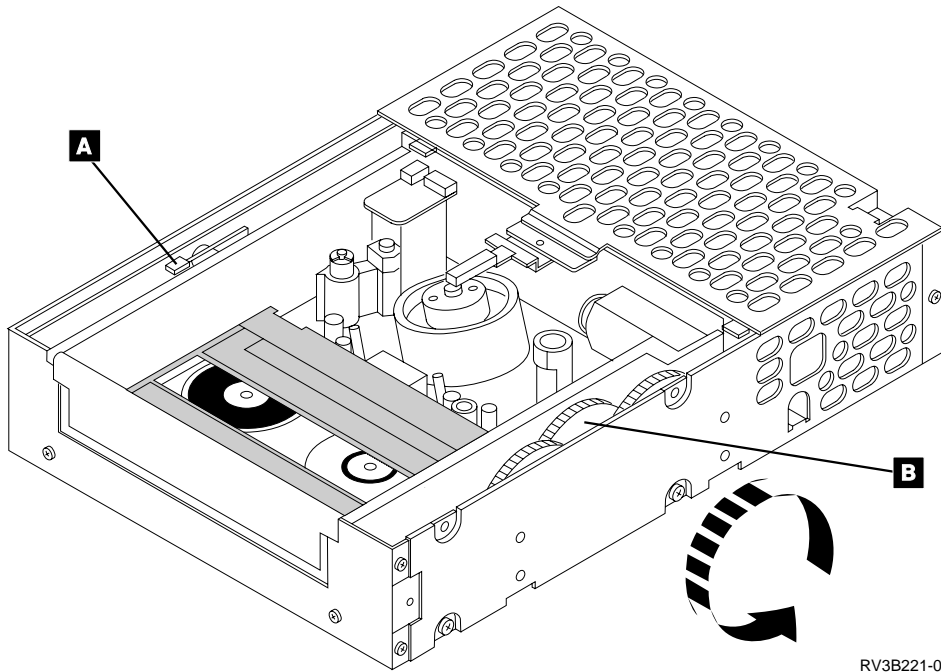
9. Find the lock release tab **A** and the cassette loading gear **B**.
10. Using your index finger, gently press down the lock release tab until it clicks.
11. Using the thumb of your other hand, roll the cassette loading gear toward the front of the drive assembly until the tape cartridge is ejected.

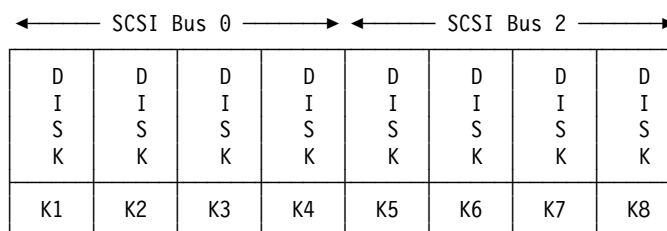
Figure 43. Front View

FC 5051 – Storage Expansion Unit

Note: Disk units 6109 (FC 1109, FC 6109), 6602 (FC 1602) and 6603 (FC 1603) can not be installed in disk unit positions K8 through K16 of the storage expansion unit.

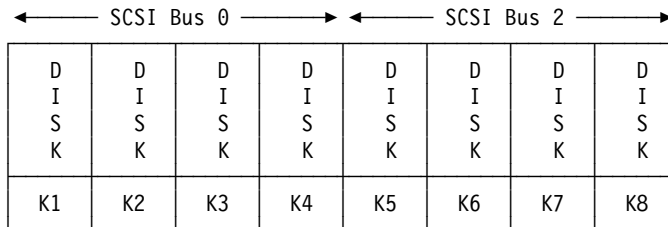
Figure 44. Front View

FC 5052 and FC 5058 – Storage Expansion Unit

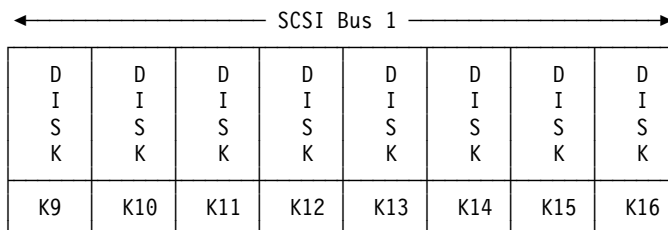
Figure 45. Rear View

Note: Disk units 6109 (FC 1109, FC 6109), 6602 (FC 1602) and 6603 (FC 1603) can not be installed in disk unit positions K8 through K16 of the storage expansion unit.

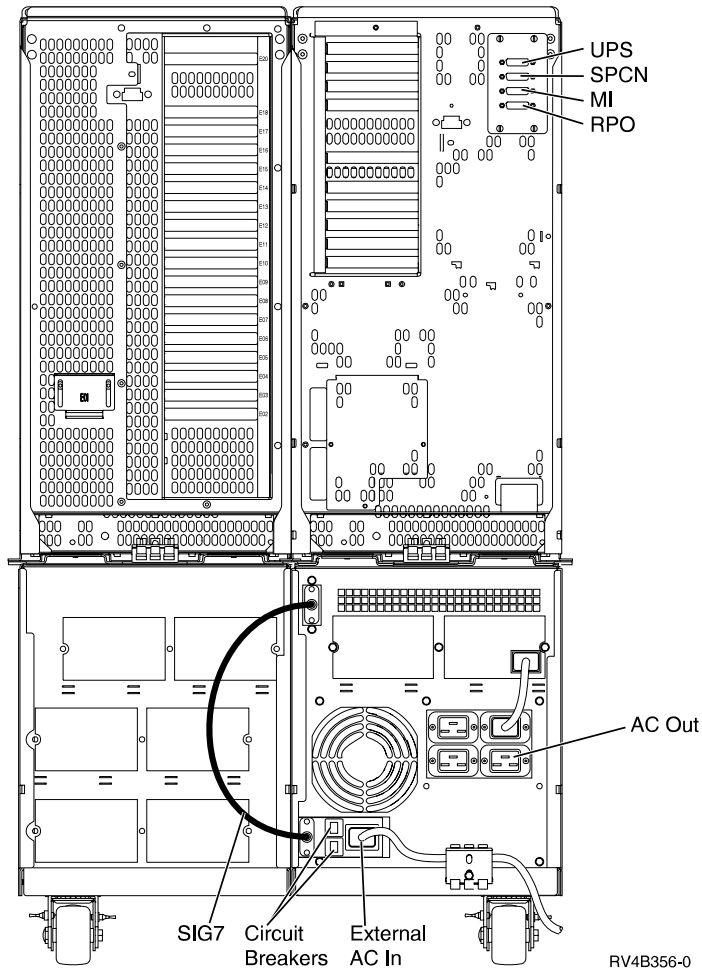
The illustration below shows where the external cable connectors (RPO, MI, SPCN and UPS) are located.

Figure 55. External Cable Connections (note: The FC 5033 Migrated Tower Base Unit does not have RPO and SPCN connectors)

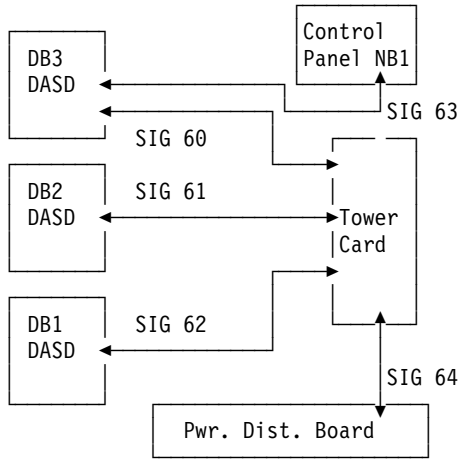
The following diagram shows the signal cables for a FC 5065 or 5066 expansion tower.

Figure 59. FC 5065 or 5066 Signal cables

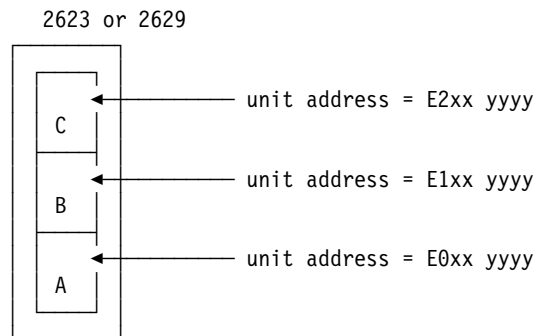
Figure 64. 2623/2629 Plugging

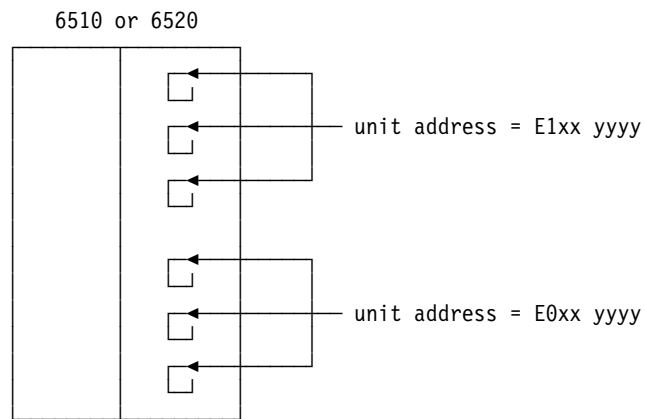
Figure 65. 6510/6520 Plugging

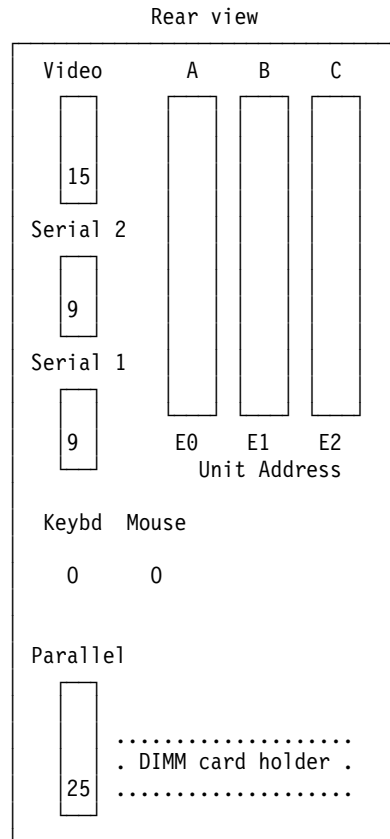
6617:

6617 requires 3 SPD card slots.

Slots A, B, C are PCI card slots

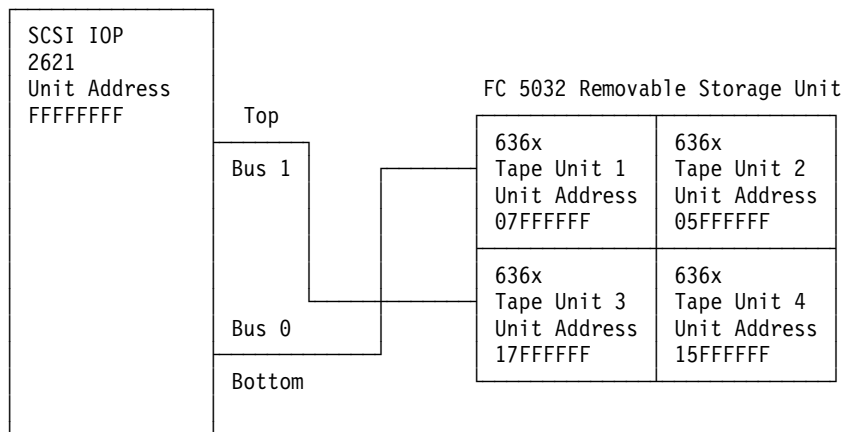
SCSI I/O Processor Unit Address Assignments:

The SCSI I/O processor maps the unit addresses as follows:

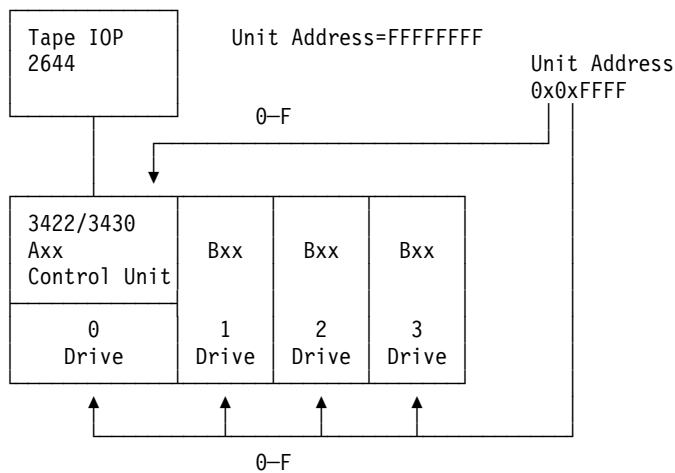
3422/3430 Tape Drives:

Tape I/O Processor (Type 2644) Addressing Scheme: The tape I/O processor (type 2644) provides support for the 3422, 3430, 3480, and 3490 Tape Units. The second character of the unit address is the control unit number and the fourth character is the drive address.

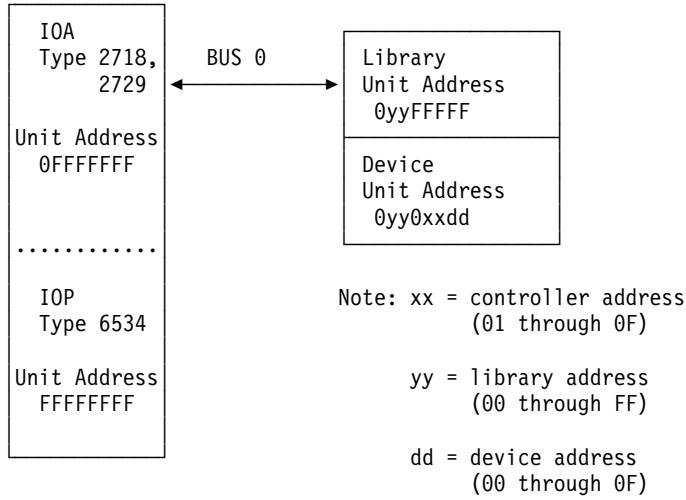
Figure 70. 2718 IOA, 2729 IOA, and 6534 IOP to tape or optical library

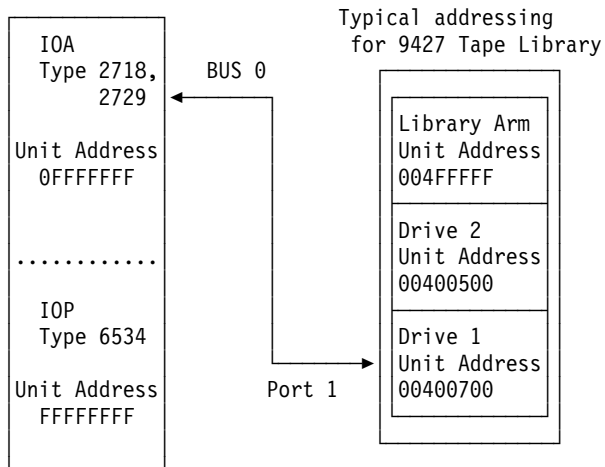
Figure 71. Typical addressing

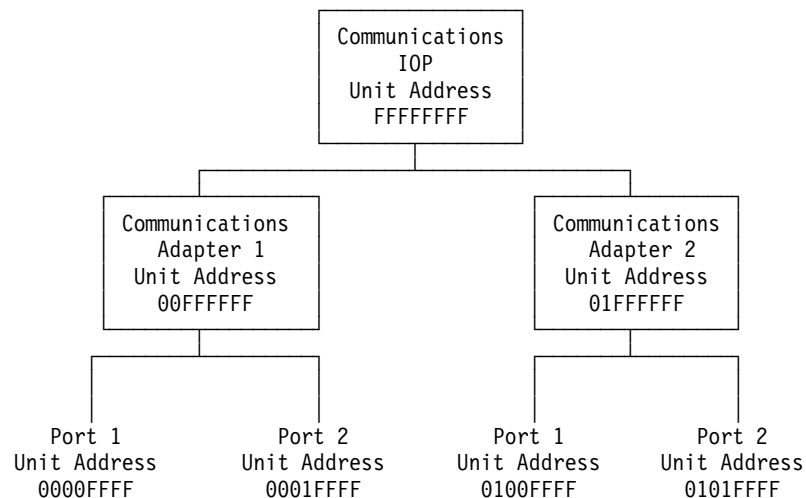
Communications I/O Processor Unit Addressing Scheme: This example, for an SRC that is displayed on the control panel, shows a communications I/O processor with two I/O adapters and two ports.

When the system indicates the I/O processor, the 4 bytes of unit address (UA) for the I/O processor contain hex FFFFFFFF (the unit address points back to the I/O processor). For an I/O adapter, the first byte of the unit address is the I/O adapter number-1, the second through fourth, hex FFFFFF. For a port, the first byte is the I/O adapter number-1, the second byte is the port number-1 and the third and fourth, hex FFFF. For example, in the following hardware configuration, the communications I/O processor maps the unit addresses as follows:

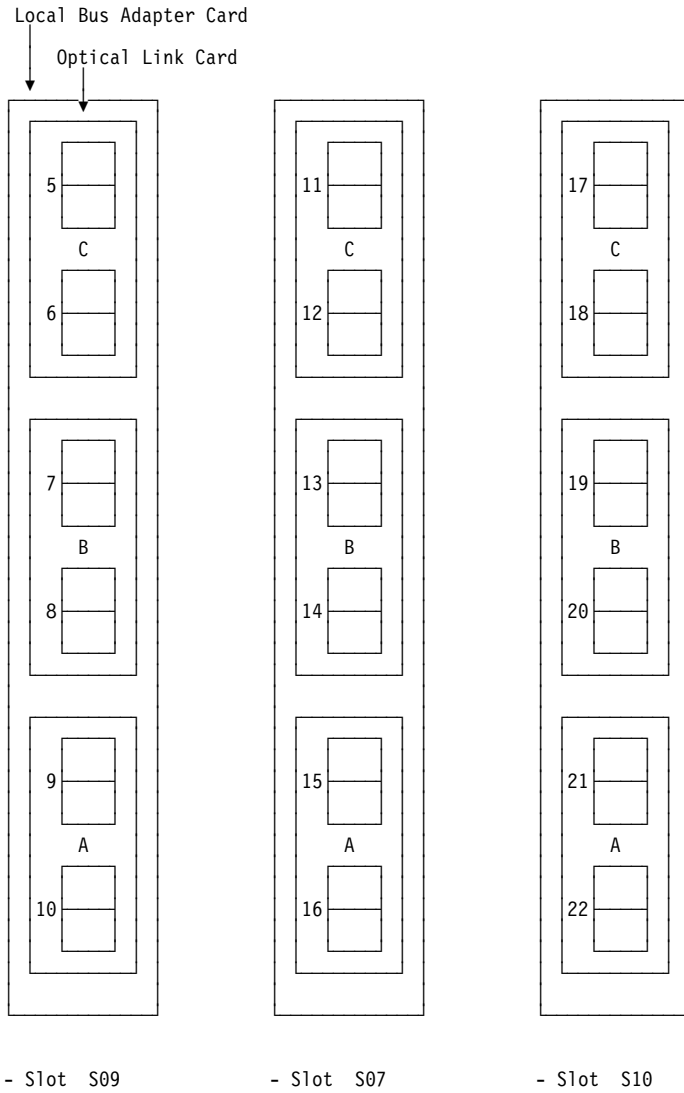
Figure 78. SPD Optical Bus Driver Card

FC 5077 Optical Bus Cable Layout and Local SPD Optical Bus Driver Card Positions

Refer to Figure 78 on page 747 to view bus pairings on the local SPD optical bus driver card.

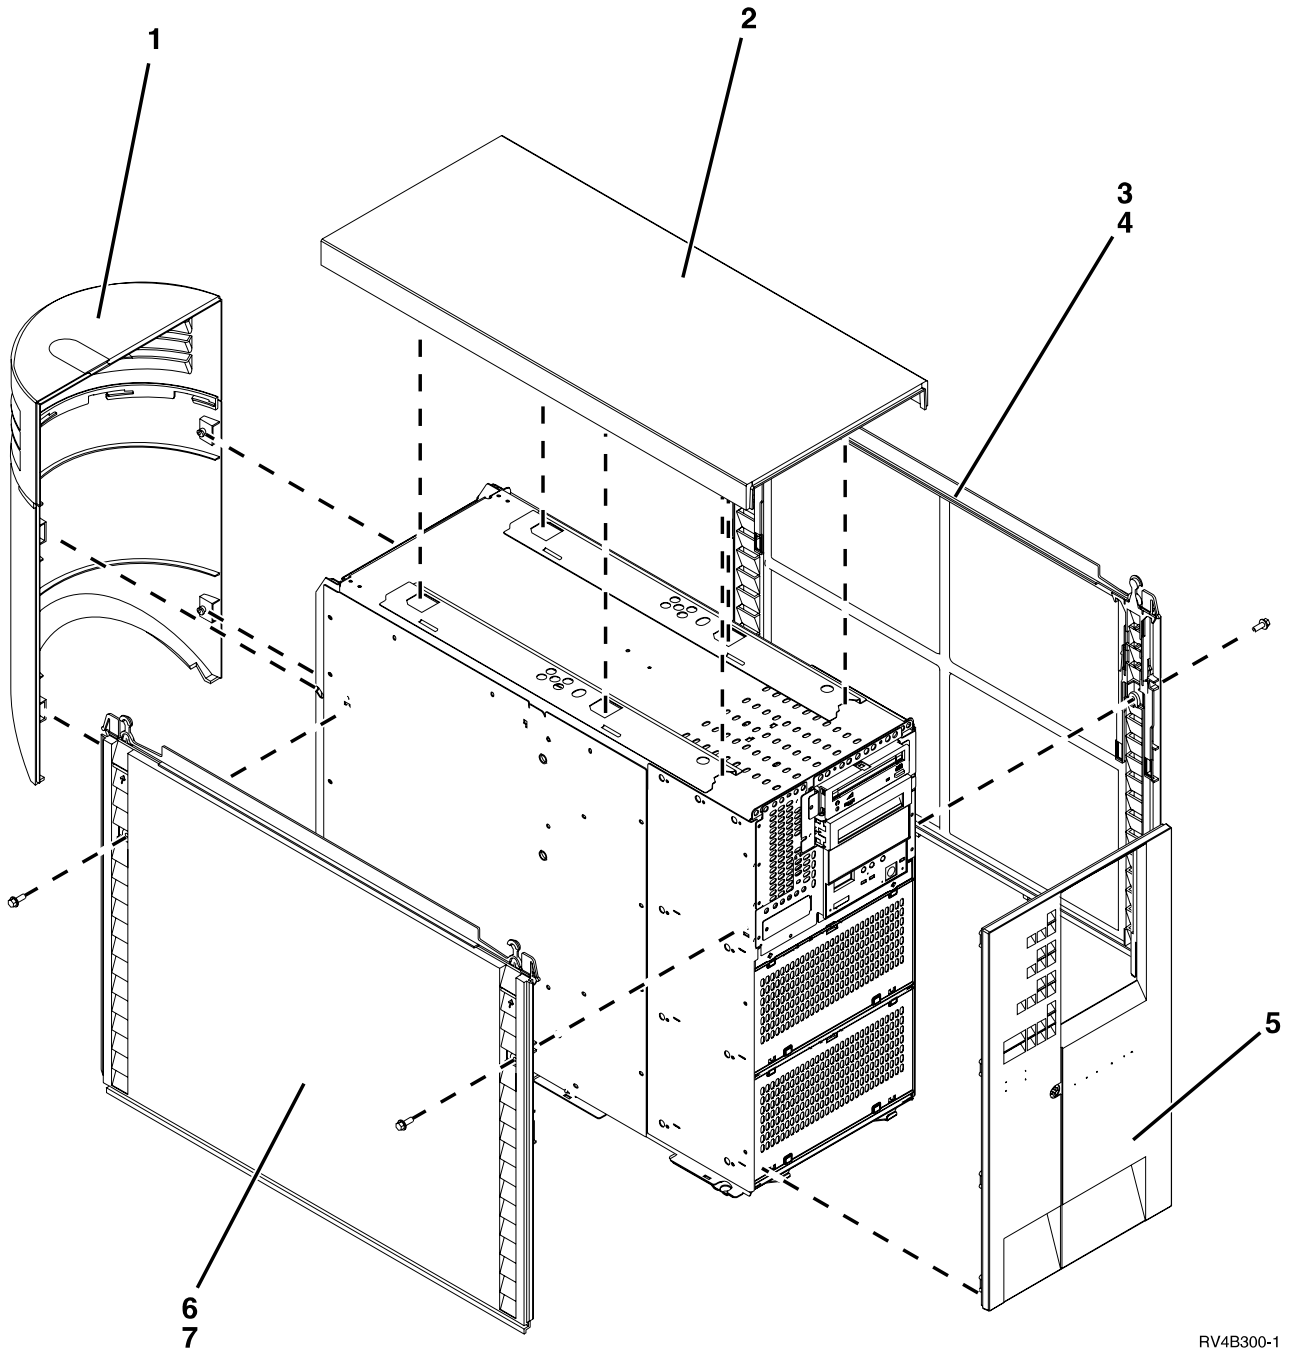
RV4B300-1

Assembly 1: Cover Assemblies for FC 5033 expansion tower

Asm- Index	Part Number	Units	Description
1-1	44H8040	1	Cover Asm, Rear (if migrated from model 600)
-1	44H8578	1	Cover Asm, Rear (if migrated from model S10)
-2	44H7742	1	Cover, Top
-3	44H7743	1	Cover, Side
-4	1621811	2	Screw
-5	44H7775	1	Cover Asm, Front (if migrated from model 600)
-5	90H6584	1	Cover Asm, Front (if migrated from model S10)
-6	44H7743	1	Cover, Side
-7	1621811	2	Screw

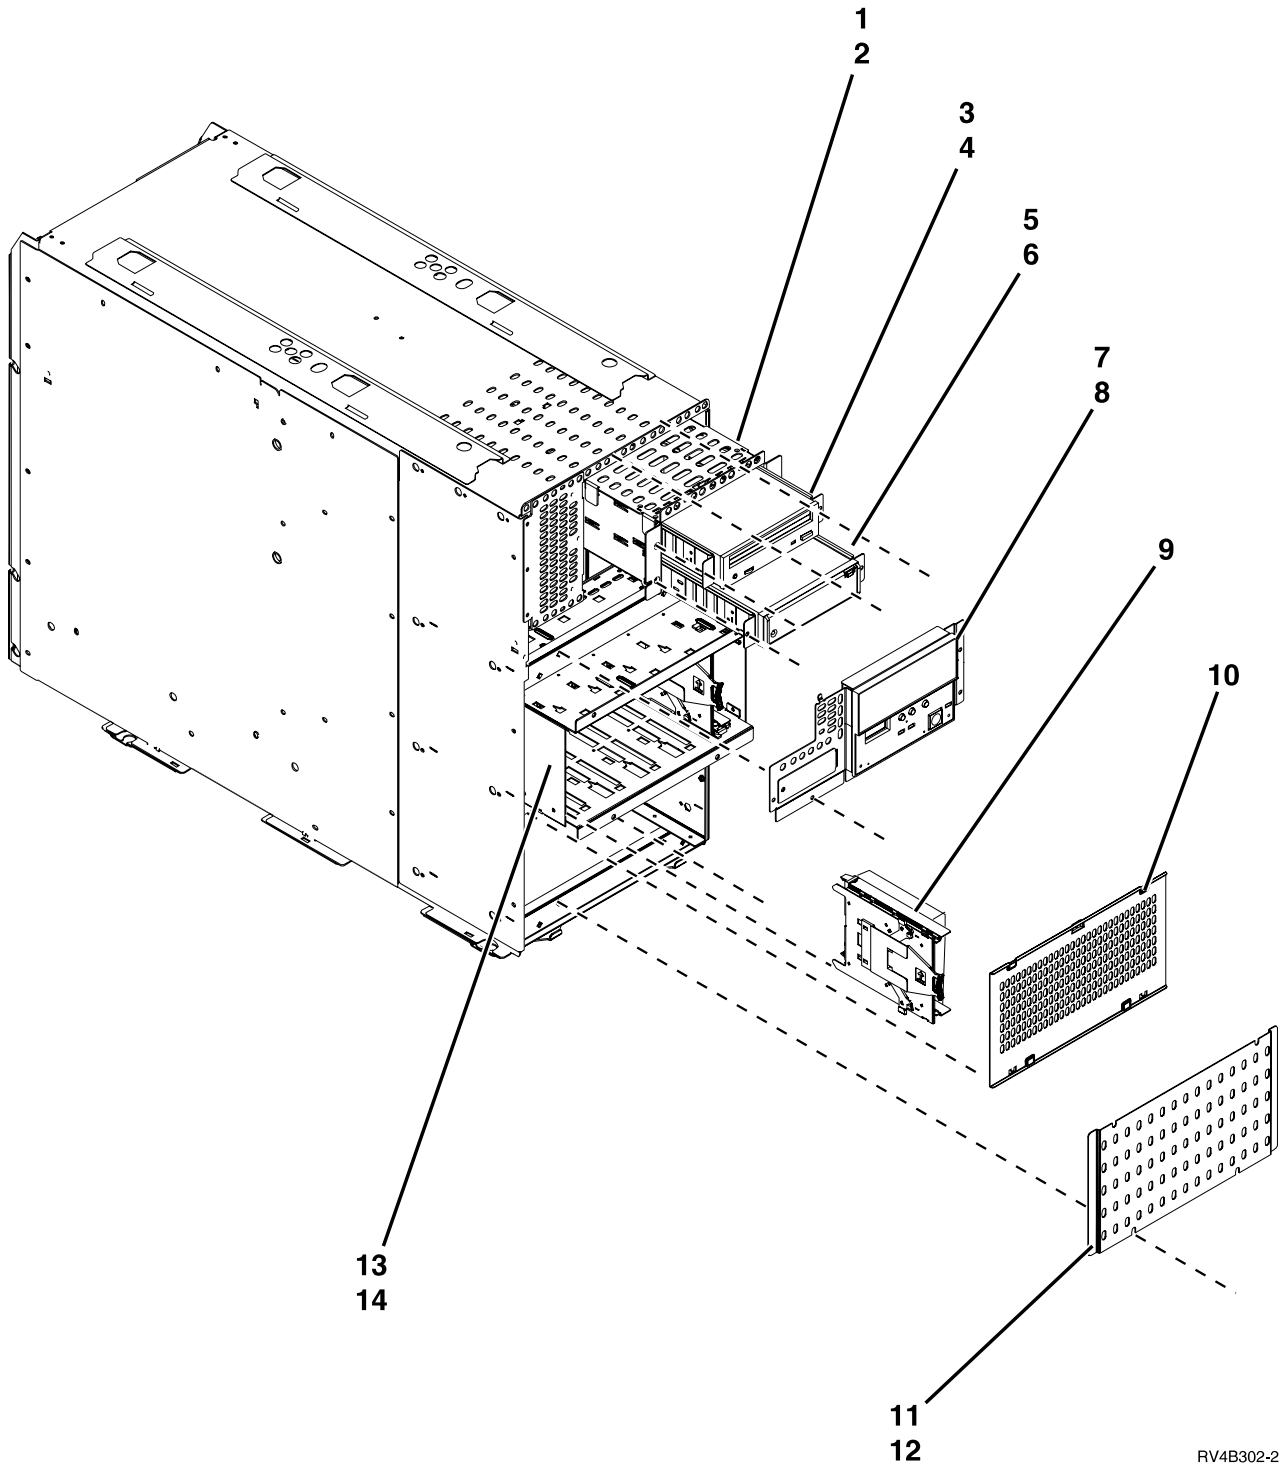
RV4B302-2

Assembly 2: Final Assemblies for FC 5033 expansion tower

Asm- Index	Part Number	Units	Description
2-1	44H8295	1	Removable Media Frame Asm
-2	1621812	4	Screw
-3		1	Optical Storage Device See "Type, Model, and Part Number List" on page 750.
-4	44H8681	2	Screw
-	NONUM	1	Bracket Asm for Optical Device/Tape
-5	86G7623	1	Removable Media Filler Asm
-5		1	Removable Media See "Type, Model, and Part Number List" on page 750.
-6	44H8681	2	Screw
-	NONUM	1	Bracket Asm for Optical Device/Tape
-6	87G4617	2	Screw for Optical Device/Tape bracket asm.
-7	NONUM	1	Control Panel Asm
-8	1621812	5	Screw
-9		AR	Disk Unit/Holder Asm See "Disk Unit Type, Model, and Part Number List" on page 756.
-9	44H4636	AR	Connector Cover (when media is not installed)
-10	44H7997	1	Disk Unit EMC access plate
-11	44H7924	1	Disk Unit Blank Cover
-12	1621812	4	Screw
-13	91H3905	1	Disk Unit Frame Asm, Base
-13	91H3906	1	Disk Unit Frame Asm, Feature
-14	1621812	4	Screw

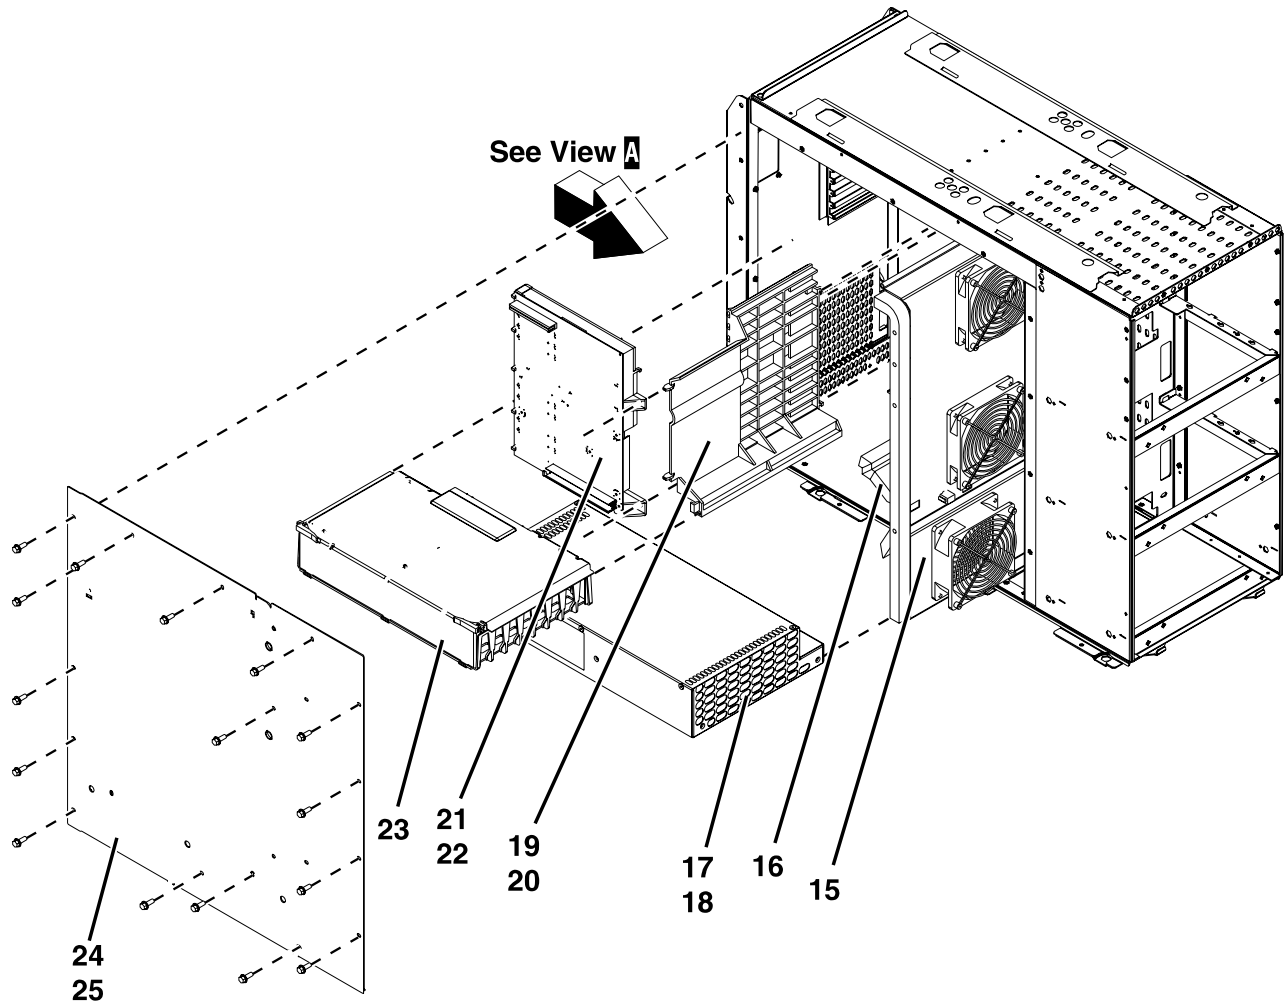
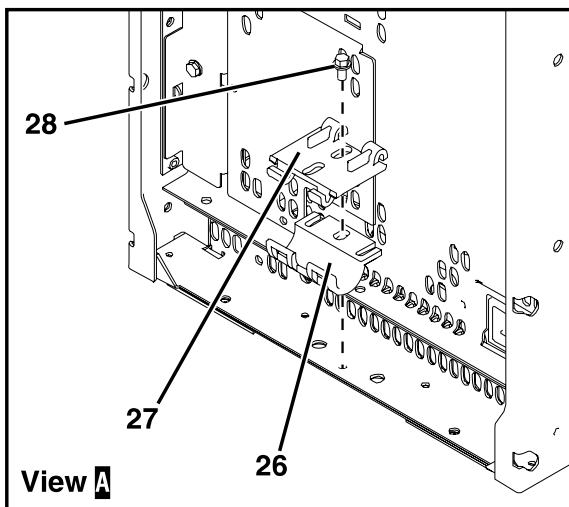
RV4B301-4

Asm- Index	Part Number	Units	Description
2-15	44H7756	1	AMDP Asm
-16	44H8000	1	Air Baffle
-17	21H9364	1	Power Supply, 480W
-18	1621812	4	Screw
-19	44H7934	1	Card Guide
-20	1621812	3	Screw
-21	45H1226	1	not applicable
-22	1621812	4	not applicable
-23	44H8167	1	• Main Storage Filler Card
-24	44H4568	1	Side EMC Access Plate
-25	44H8681	15	Screw
-26	44H8640	1	Power Cord Clamp - Lower
-27	44H8641	1	Power Cord Clamp - Upper
-28	1621811	1	Screw

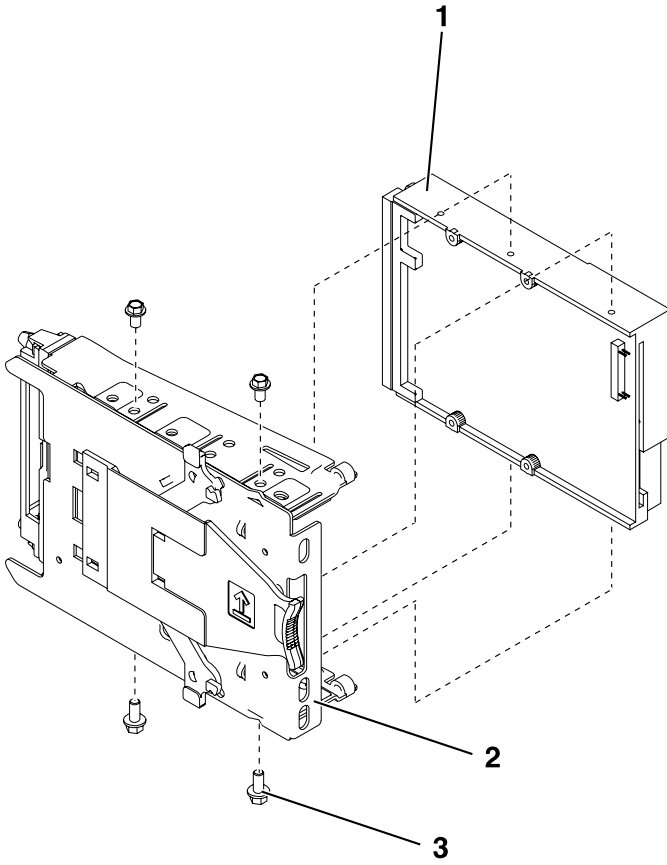
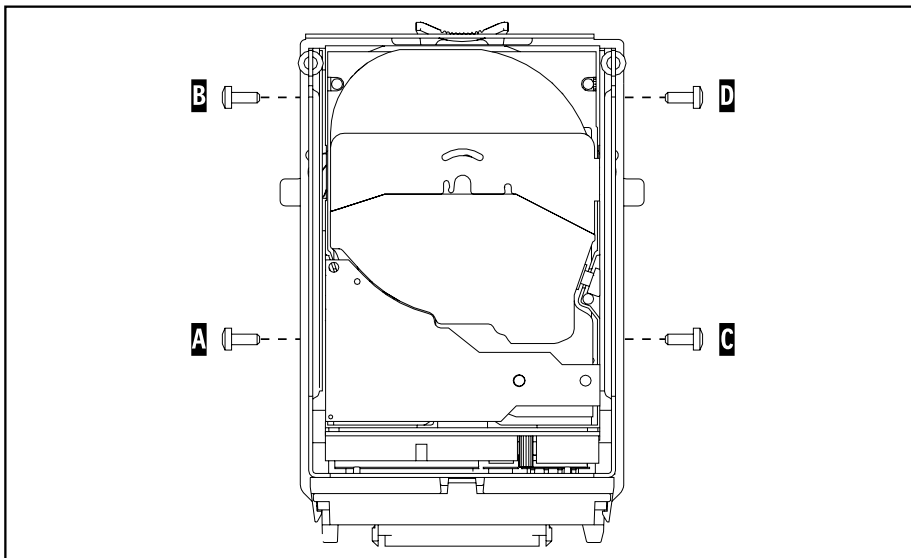
RV4B304-3

Assembly 3: Disk Unit/Holder Assembly

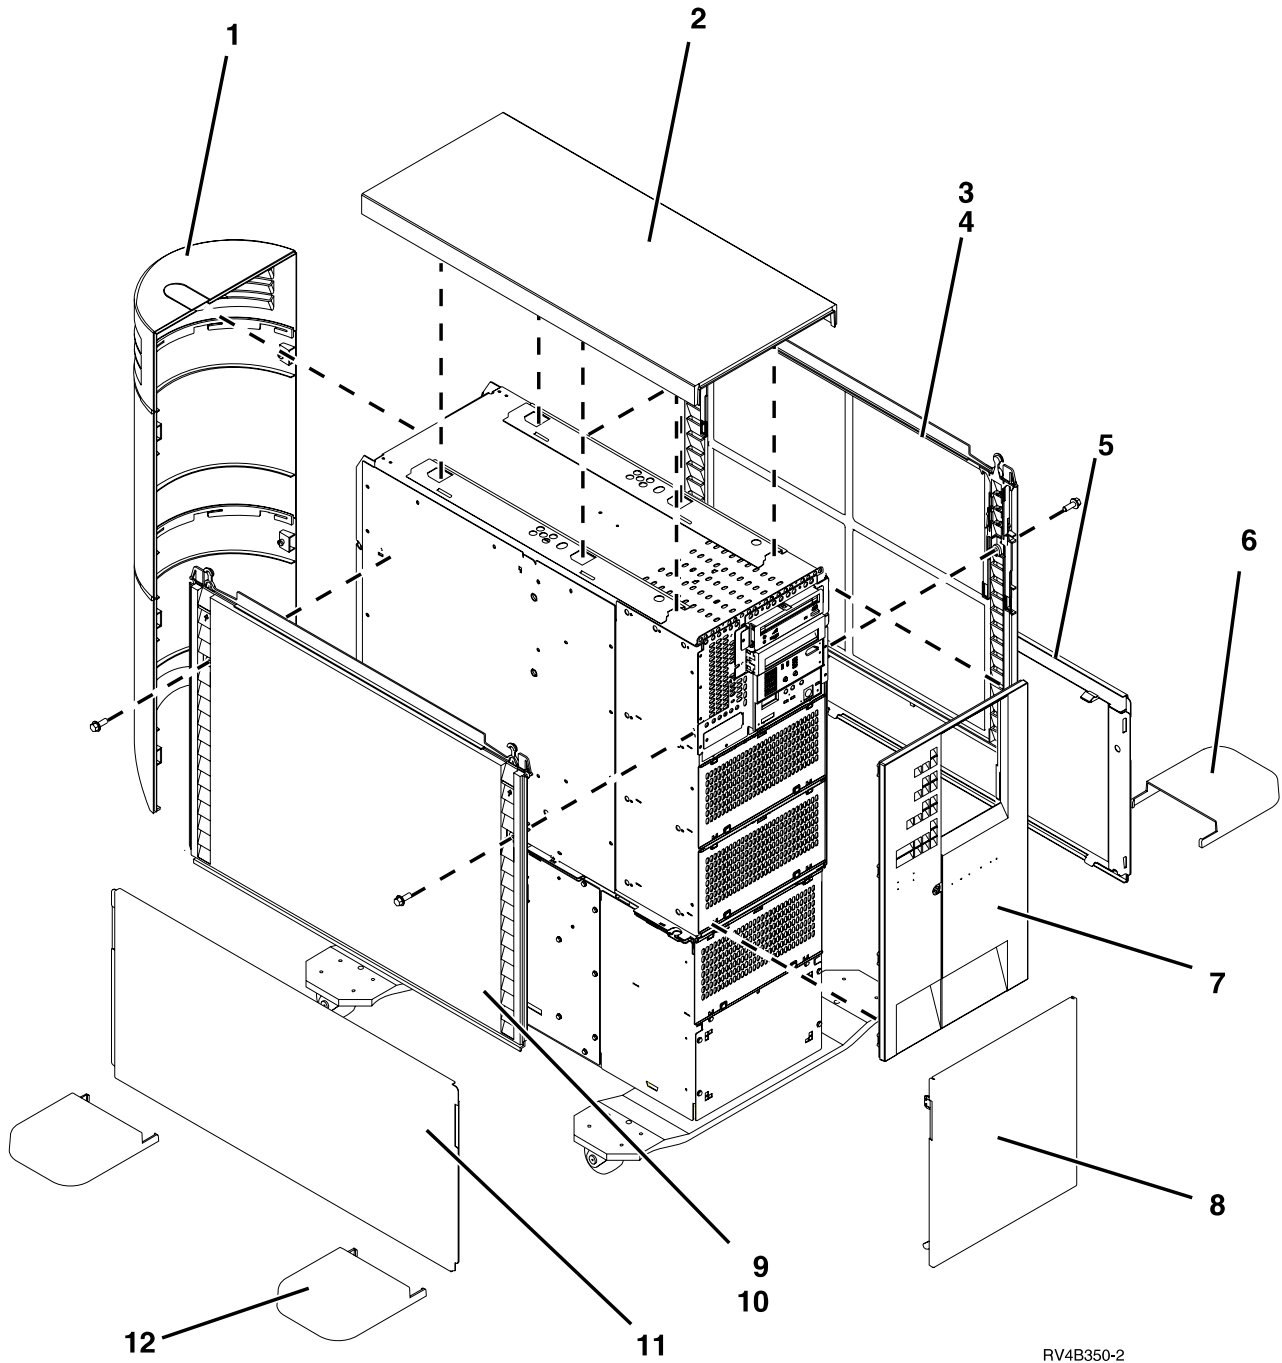
Assembly 4: Cover Assemblies for FC 5034 and FC 5035 migrated towers

Asm- Index	Part Number	Units	Description
4-1	44H8582	1	Cover Asm, Rear
-2	44H7742	1	Cover, Top
-3	44H7743	1	Cover, Side Upper
-4	1621811	2	Screw
-5	44H7895	1	Cover, Side Lower
-6	44H7892	2	Cover, Foot
-7	90H6584	1	Cover Asm, Front (if migrated from model 620 or S20)
-7	97H7769	1	Cover Asm, Front (if migrated from model 720)
-8	44H7880	1	Cover Asm, Front Lower
-9	44H7743	1	Cover, Side
-10	1621811	2	Screw
-11	44H7895	1	Cover, Side Lower
-12	44H7892	2	Cover, Foot

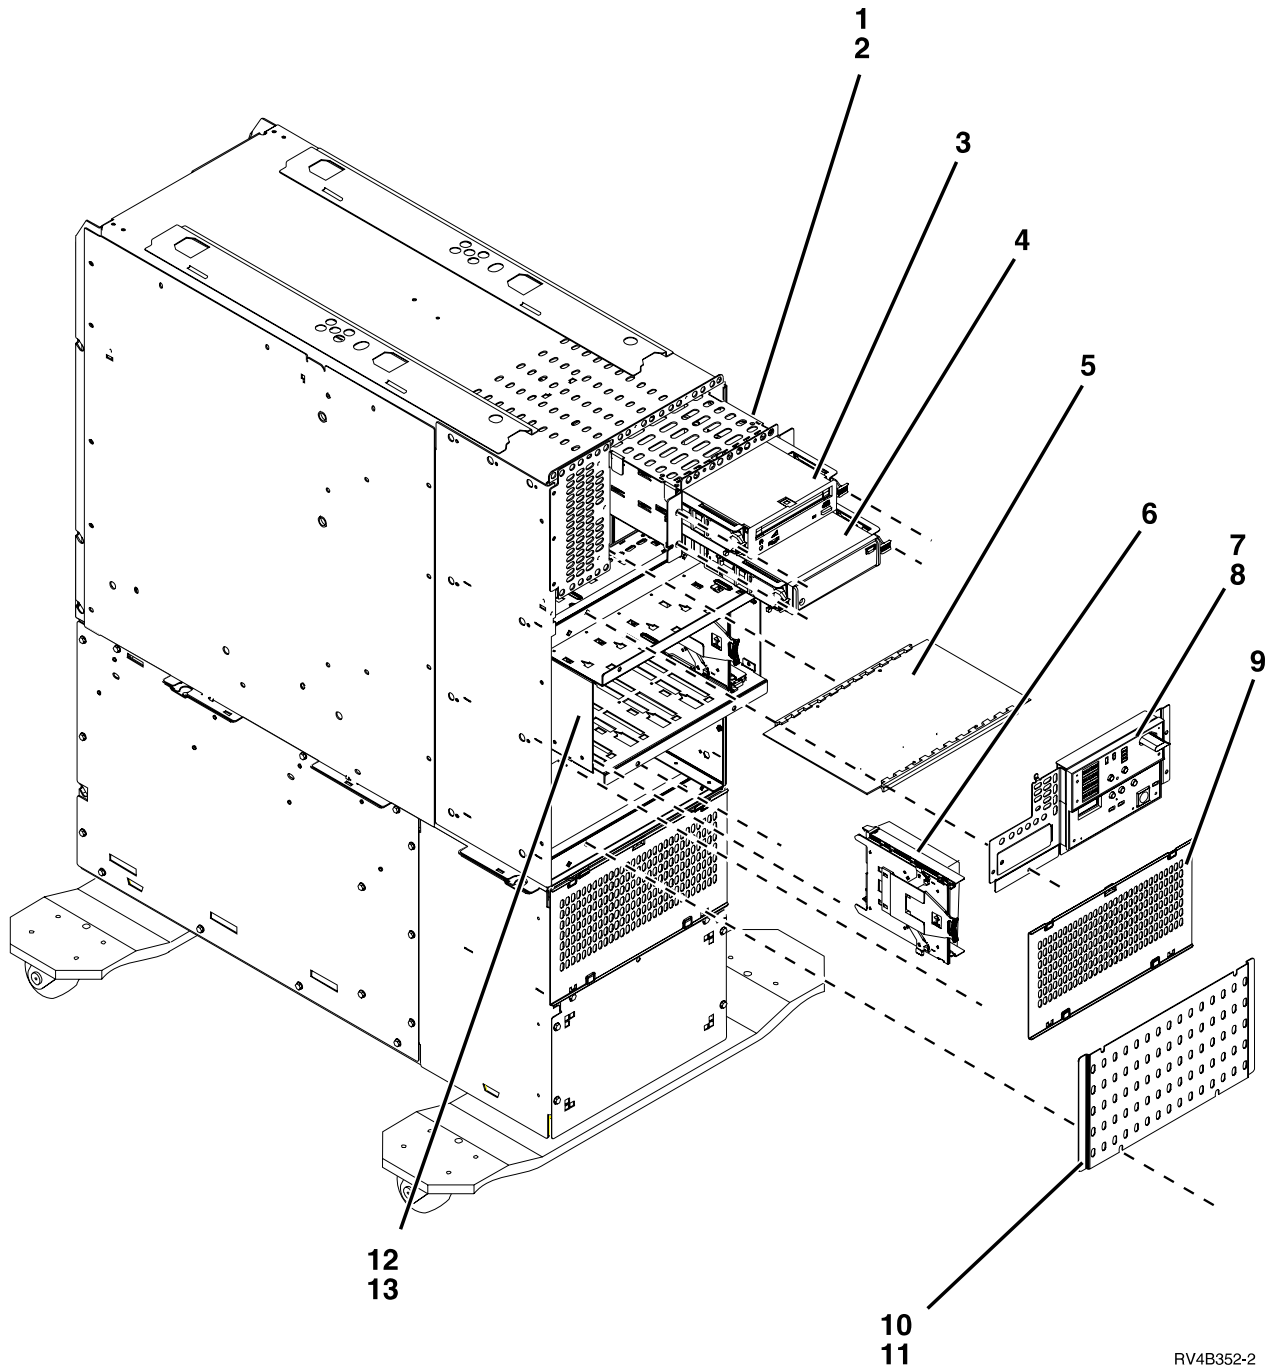
RV4B352-2

Assembly 5: Final Assemblies for FC 5034 and FC 5035 migrated towers

Asm- Index	Part Number	Units	Description
5-1	44H8421	1	Removable Media Frame Asm
-2	1621811	5	Screw
-3		1	Optical Device/Holder Asm See "Type, Model, and Part Number List" on page 750
-4	44H8406	1	Removable Media Filler Asm
-4		1	Removable Media/Holder Asm See "Type, Model, and Part Number List" on page 750
-4	44H4636	AR	Connector Cover (when media is not installed)
-5	44H8141	1	Card, SPCN panel (control panel with keystick)
-5	44H8313	1	Card, SPCN panel (control panel without keystick)
-6		AR	Disk Unit/Holder Asm See "Disk Unit Type, Model, and Part Number List" on page 756.
-6	44H4636	AR	Connector Cover (when media is not installed)
-7	NONUM	1	Control Panel Asm
-8	1621811	4	Screw
-9	44H7997	1	Disk Unit EMC access plate
-10	44H7924	1	Disk Unit Blank Cover
-11	1621811	4	Screw
-12	91H3905	1	Disk Unit Frame Asm, Base
-12	91H3906	1	Disk Unit Frame Asm, Feature
-13	1621811	4	Screw

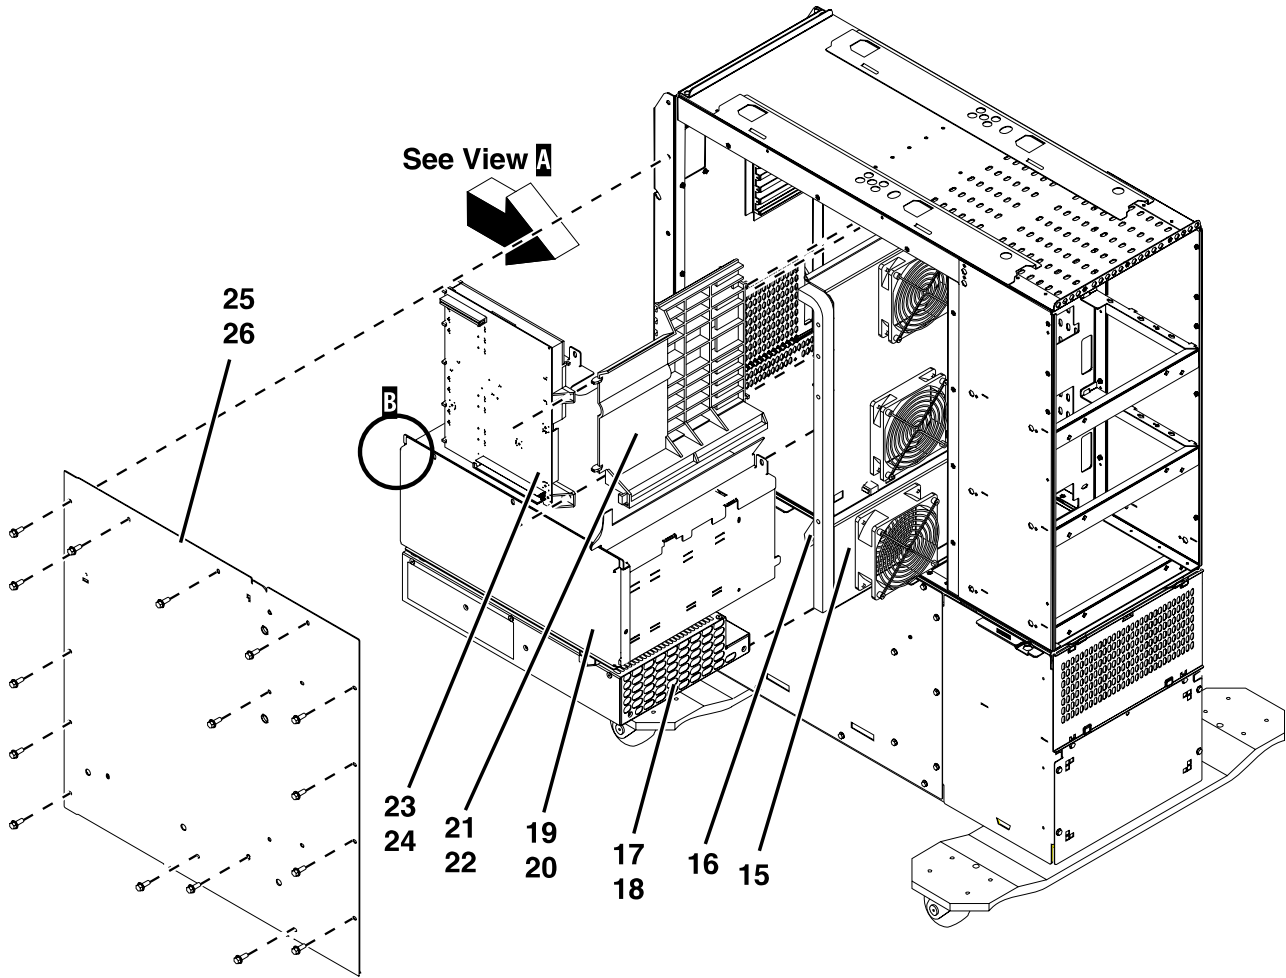
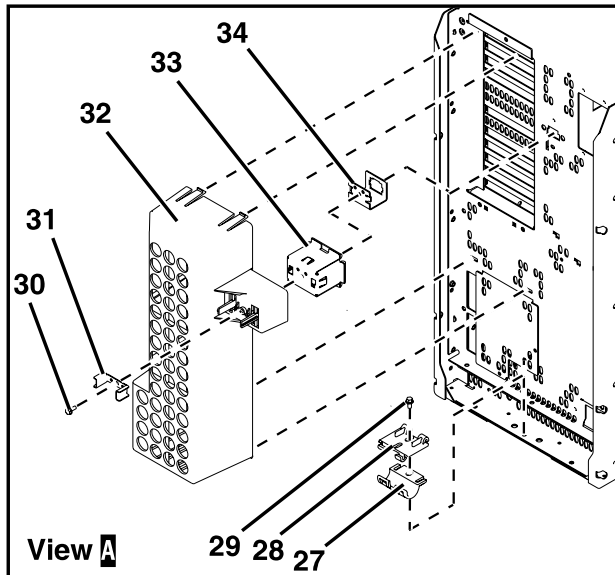
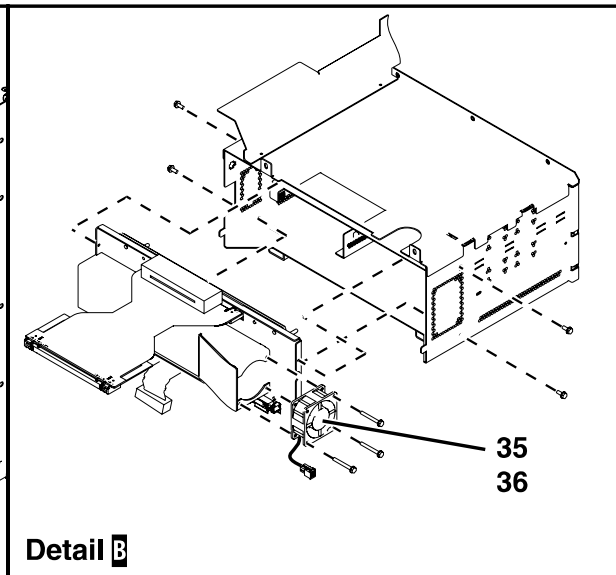
RV4B351-4

Asm- Index	Part Number	Units	Description
5-15	44H7756	1	AMDP Asm
-16	44H8317	1	Air Baffle
-17	21H9364	1	Power Supply, 480W
-18	1621811	4	Screw
-19	44H8536	1	Main storage card
-19	44H8167	1	• Main Storage Filler Card
-20	1621811	2	Screw
-21	44H7934	1	Card Guide
-22	1621811	3	Screw
-23	45H1226	1	Card/Stiffener Asm
-24	1621811	4	Screw
-25	44H4568	1	Side EMC Access Plate
-26	44H8681	15	Screw
-27	44H8640	1	Power Cord Clamp - Lower
-28	44H8641	1	Power Cord Clamp - Upper
-29	1621811	1	Screw
-30	1621811	1	Screw*
-31	44H8315	1	Latch Stop*
-32	44H8290	1	Safety Cover*
-33	44H8289	1	EMC Shield/Jumper Plug*
-34	44H8288	1	Bracket*
			*— Some models do not have these parts.
-35	44H4650	1	AMD 9
-36	1621816	3	Screw
