Migrated Expansion Tower Problem Analysis, Repair and Parts

Version 4

First Edition (June 2000)

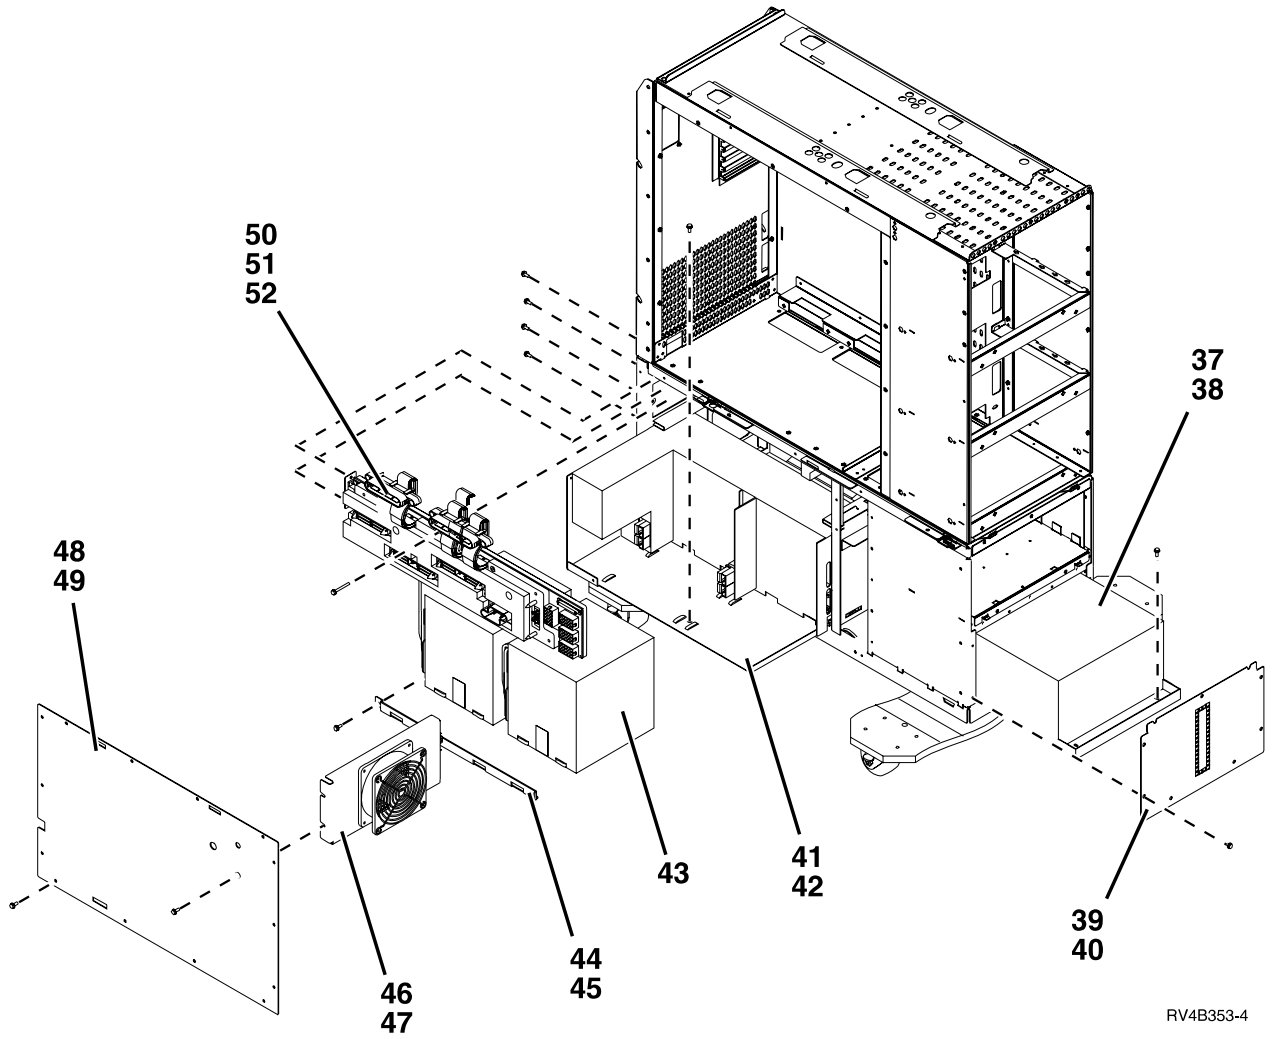
RV4B353-4

Asm- Index	Part Number	Units	Description
5-37	44H7786	1	Transformer
-38	1621811	3	Screw, M4 x 10mm
-39	44H8402	1	Plate, UPS
-40	1621811	9	Screw, M4 x 10mm
-41	44H7784	1	Power Supply, UPS
-42	1621811	9	Screw, M4 x 10mm
-43	44H7785	2	Battery
-44	44H8245	1	Bar, Battery pack retaining
-45	1621811	1	Screw, M4 x 10mm
-46	44H7889	1	AMD2 Asm
-47	1621811	2	Screw, M4x 10mm
-48	44H7886	1	Side EMC Access Plate
-49	1621811	14	Screw, M4 x 10mm
-50	44H8400	1	Power Distribution Card
-51	1621811	8	Screw, M4 x 35mm
-52	90H6284	4	Screw, M4 x 8mm

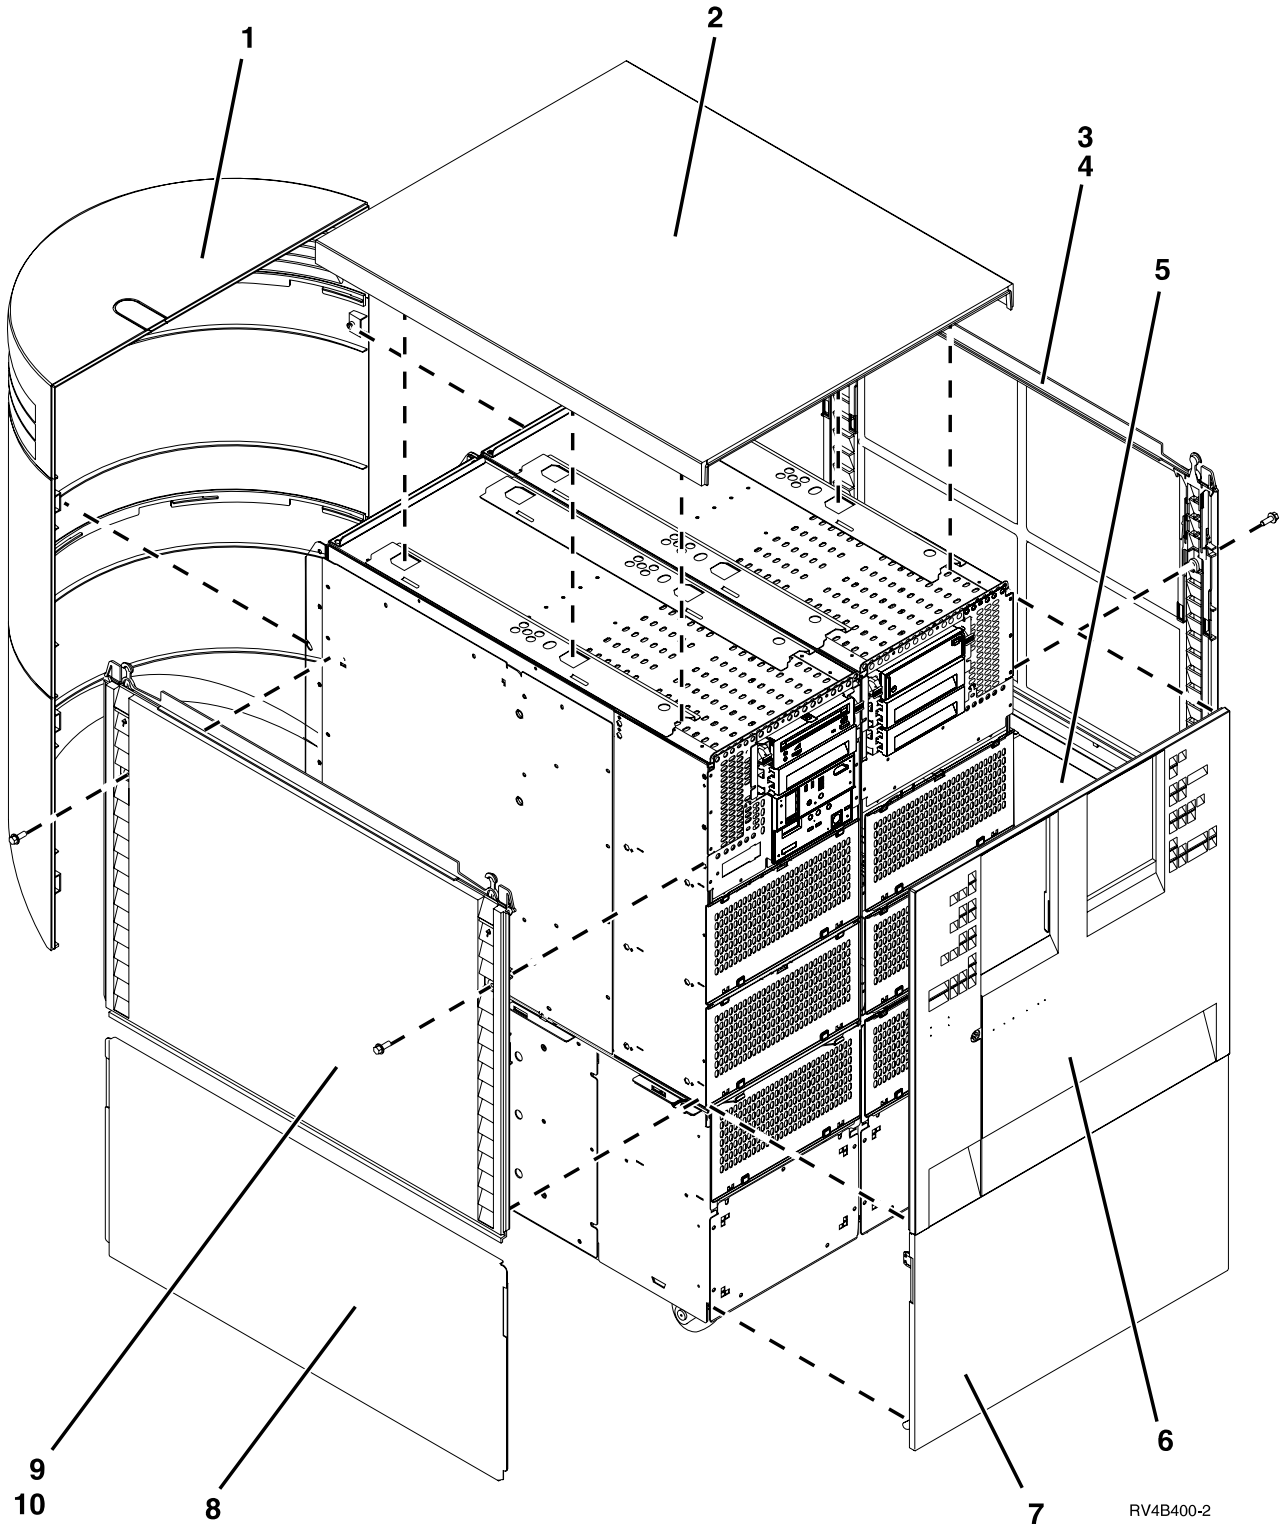
Assembly 6: Cover Assemblies for FC 5034 and FC 5035 migrated towers with Expansion Unit

Asm- Index	Part Number	Units	Description
6-1	44H8205	1	Cover Asm, Rear (if migrated from model 620)
-1	44H8586	1	Cover Asm, Rear (if migrated from model S20 or 720)
-2	44H7760	1	Cover, Top
-3	44H7743	1	Cover, Side Upper
-4	1621811	2	Screw (10mm)
-5	44H7895	1	Cover, Side Lower
-6	44H8135	1	Cover Asm, Front (if migrated from model 620)
-6	90H6586	1	Cover Asm, Front (if migrated from model S20)
-6	97H7770	1	Cover Asm, Front (if migrated from model 720)
-7	44H7884	1	Cover, Front Lower
-8	44H7895	1	Cover, Side Lower
-9	44H7743	1	Cover, Side
-10	1621811	2	Screw (10mm)

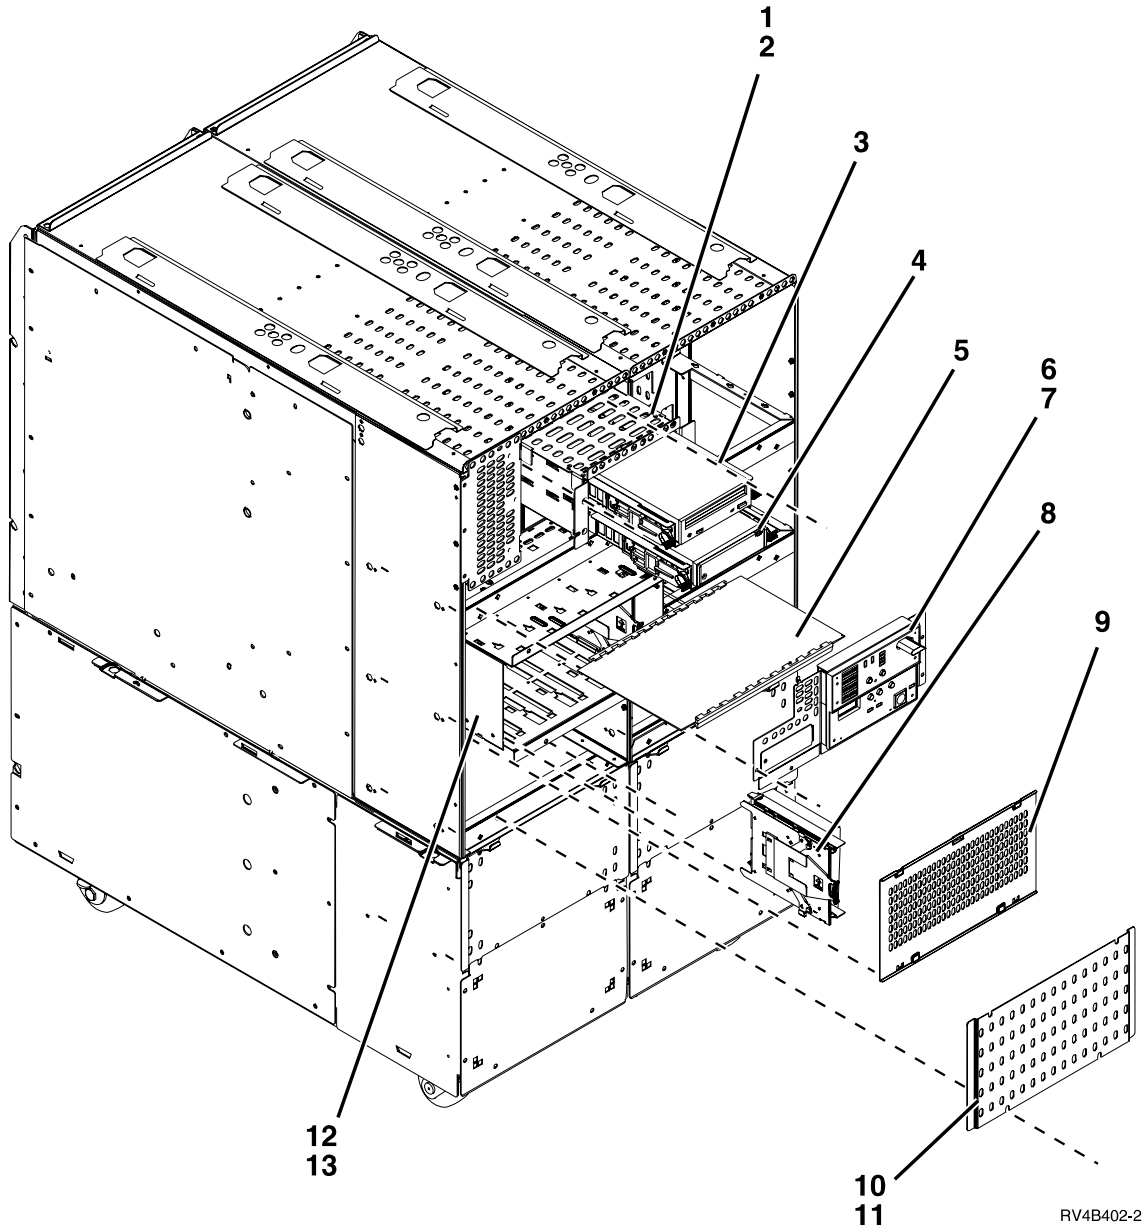
Assembly 7: Final Assemblies for FC 5034 and FC 5035 migrated towers with Expansion Unit

Asm- Index	Part Number	Units	Description
7-1	44H8421	1	Removable Media Frame Asm
-2	1621812	5	Screw (8mm)
-3		1	Optical Device/Holder Asm See "Type, Model, and Part Number List" on page 750.
-4		1	Removable Media/Holder Asm See "Type, Model, and Part Number List" on page 750.
-4	44H4636	AR	Connector Cover (when media is not installed)
-4	44H8406	AR	Removable Media Filler Asm
-			Optical and tape bracket — model 600
-			Screw
-5		1	not applicable
-6	NONUM	1	Control Panel Asm
-7	1621811	4	Screw M4 (10mm)
-8		AR	Disk Unit/Holder Asm See "Disk Unit Type, Model, and Part Number List" on page 756.
-8	44H4636	AR	Connector Cover (when media is not installed)
-9	44H7997	1	Disk Unit EMC access plate
-10	44H7924	1	Disk Unit Blank Cover
-11	1621811	4	Screw M4 (10mm)
-12	91H3905	1	Disk Unit Frame Asm, Base
-12	91H3906	1	Disk Unit Frame Asm, Feature
-13	1621811	4	Screw (10mm)

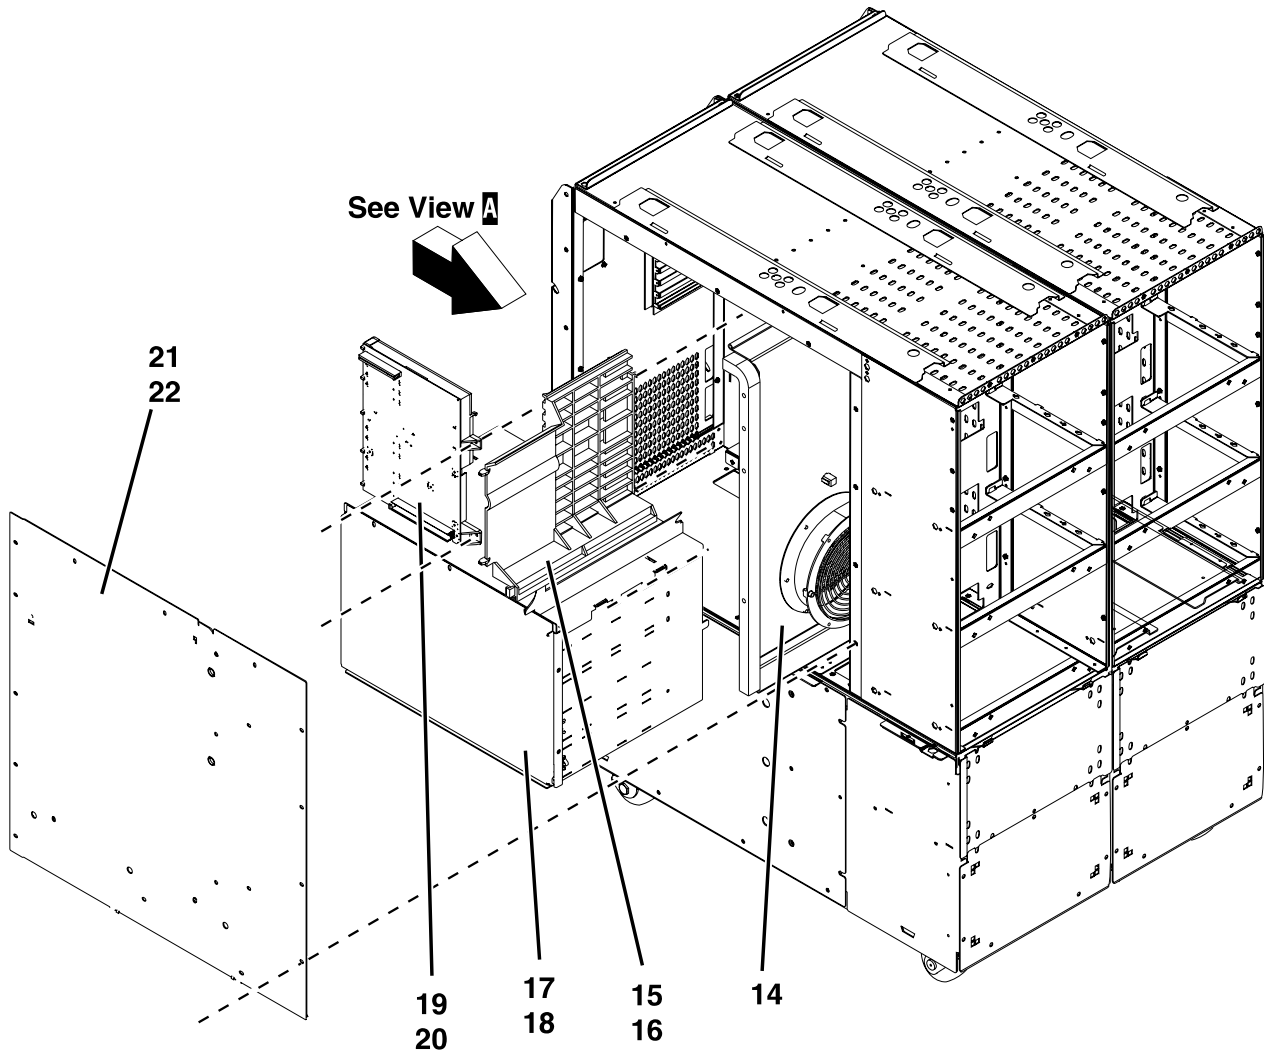
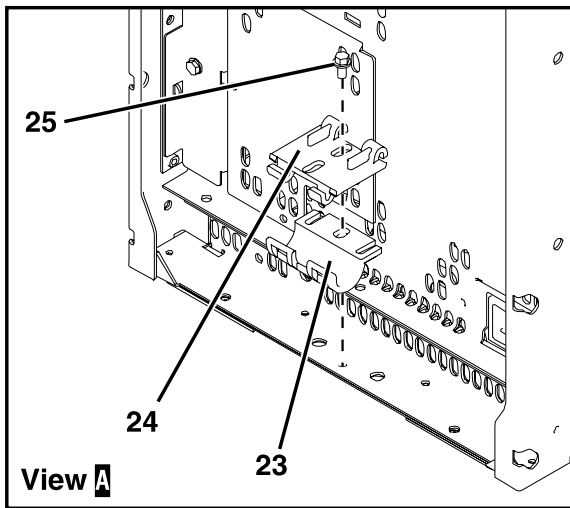
RV4B401-3

Asm- Index	Part Number	Units	Description
7-14	44H8336	1	AMD1 Asm
-15	44H7934	1	Card Guide
-16	1621812	3	Screw (8mm)
-17	44H8167	1	• Main Storage Filler Card
-18	1621811	6	Screw M4 (10mm)
-19	45H1226	1	Card/Stiffener Asm
-20	1621812	4	Screw (8mm)
-21	44H4568	1	Side EMC Access Plate
-22	44H8681	15	Screw (10mm)
-23	44H8640	1	Power Cord Clamp - Lower
-24	44H8641	1	Power Cord Clamp - Upper
-25	1621811	1	Screw M4 (10mm)

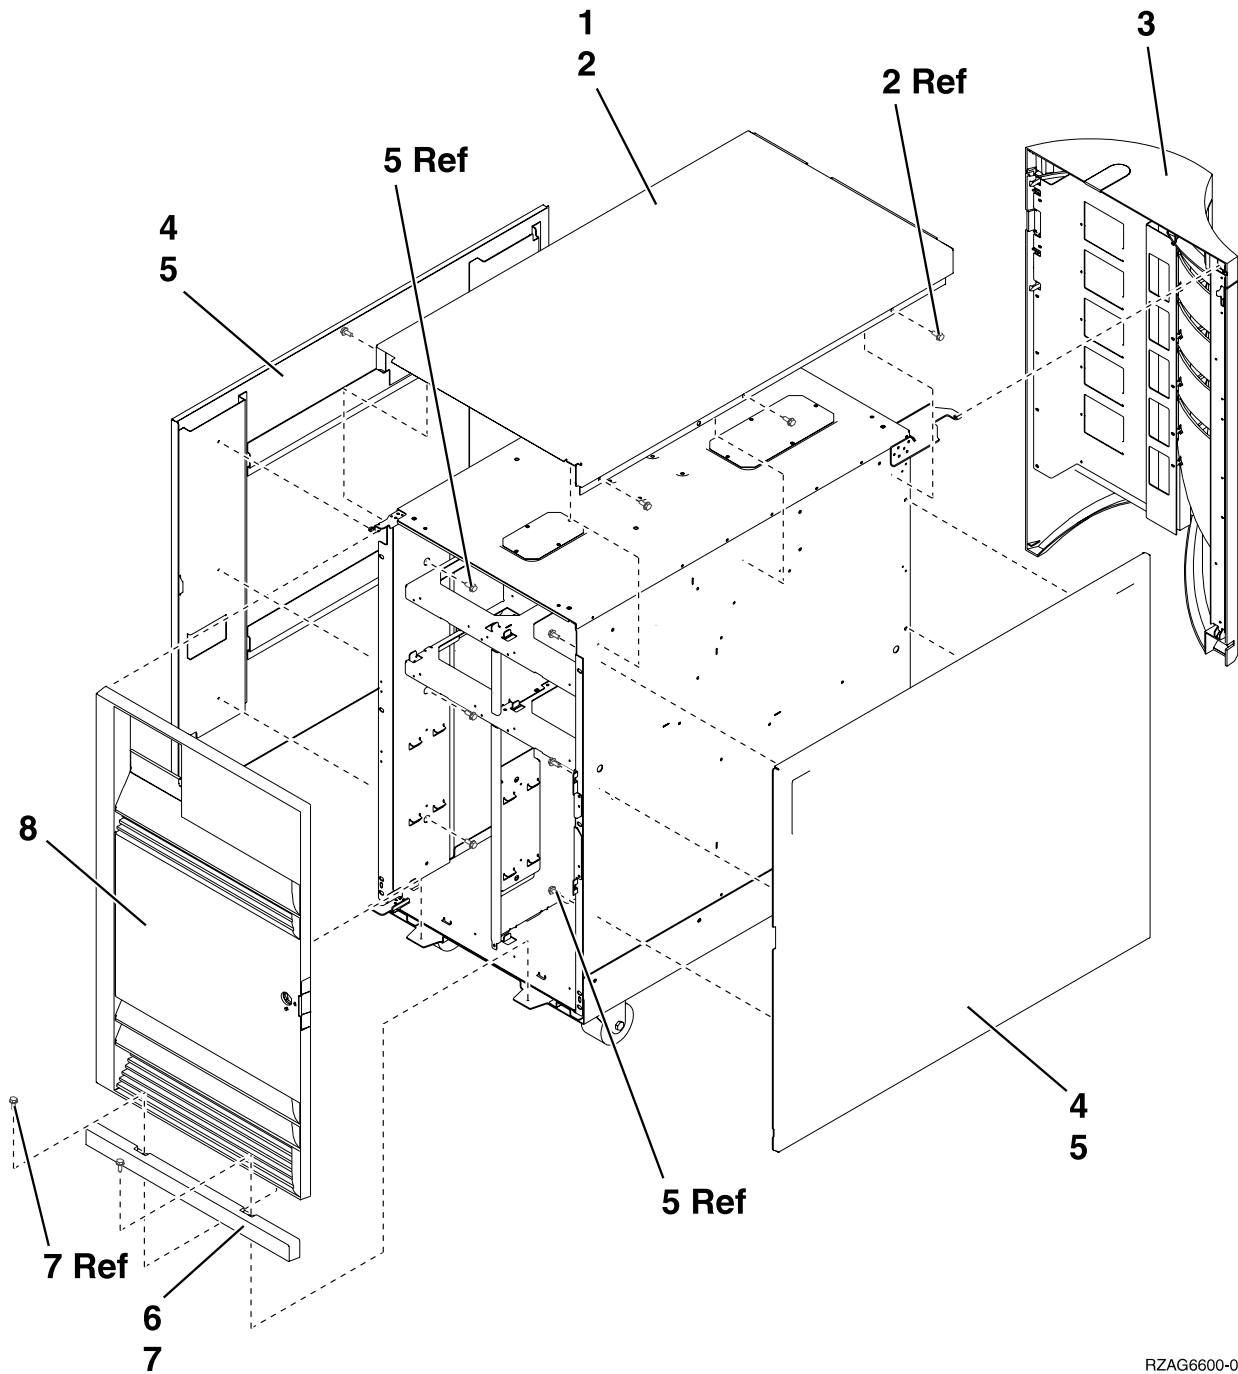
RZAG6600-0

Assembly 8: Cover Assemblies for FC 5065 or FC 5066 expansion tower

Asm- Index	Part Number	Units	Description
8-1	24L0825	1	Top cover
-2	1621811	4	Screw
-3	24L1079	1	Rear cover
-4	24L0824	1	Side cover
-5	1621811	12	Screw
-6	24L1078	1	Front filler cover
-7	1621811	2	Screw
-8	24L1069	1	Front cover

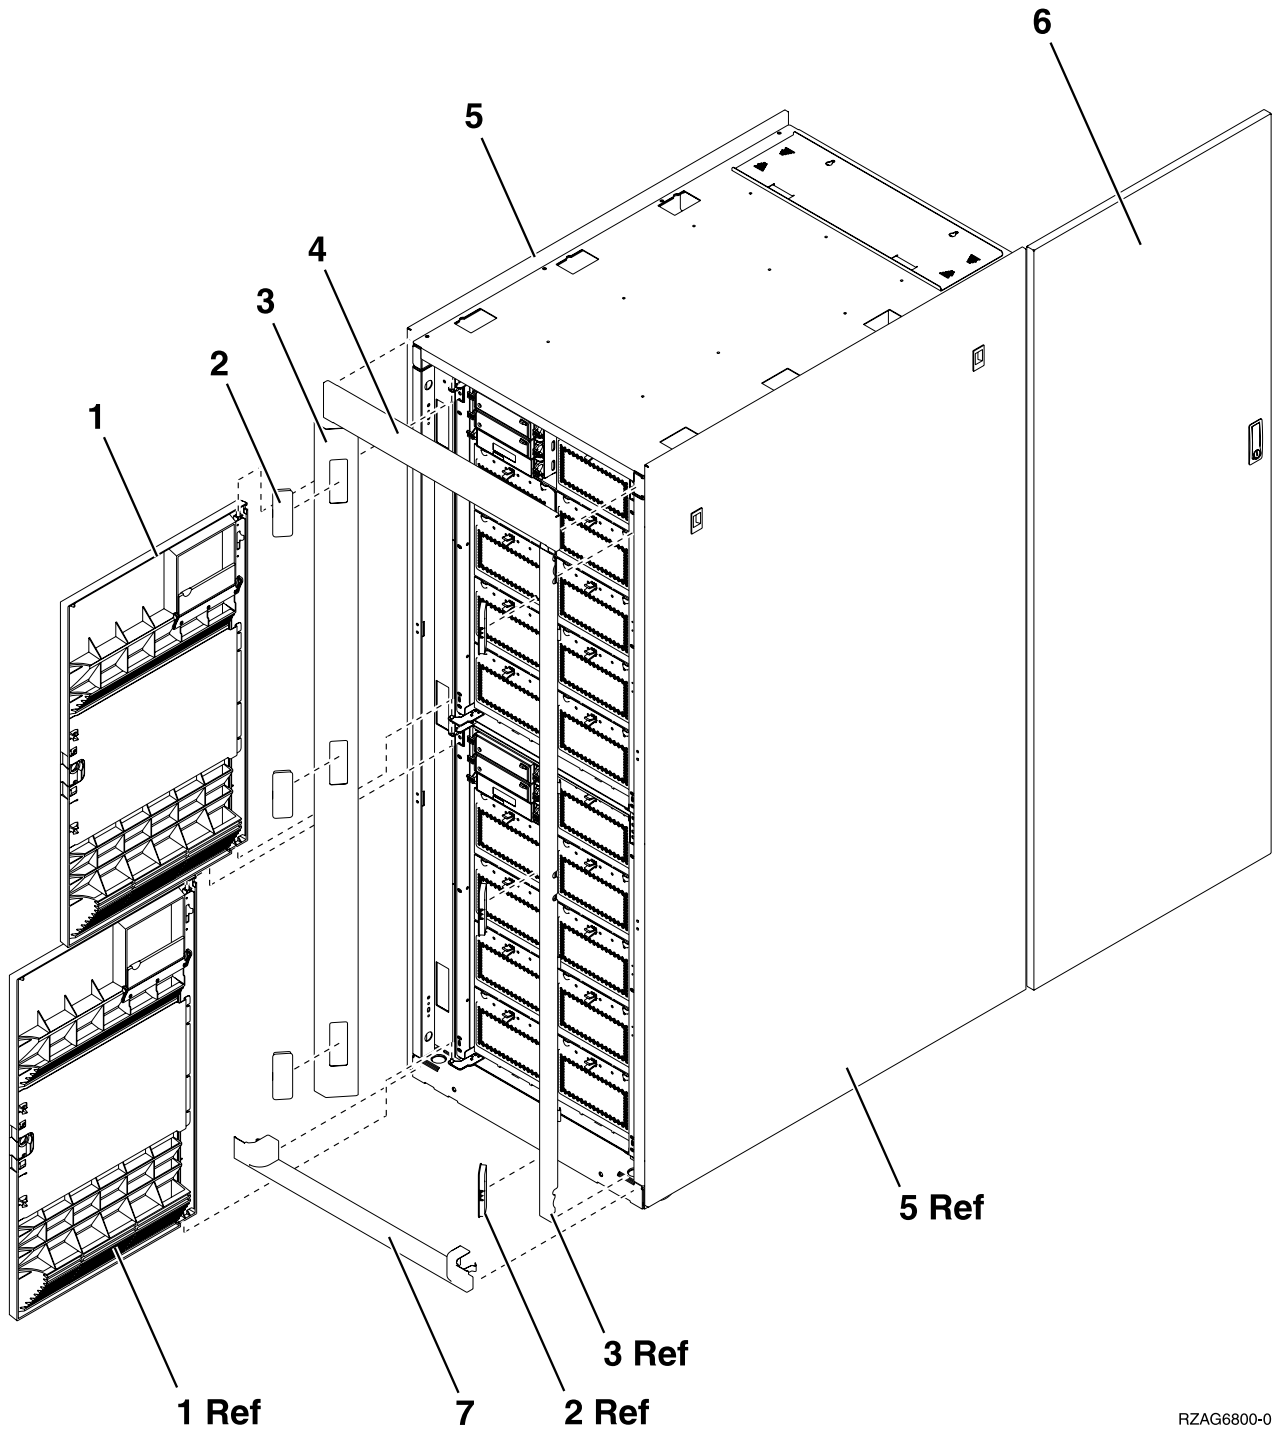
RZAG6800-0

Asm- Index	Part Number	Units	Description
8-1	24L1069	2	Cover Asm, Front
-2	05N6809	6	Cover, Trim Kit
-3	12K0034	2	Side Bezel, Trim Kit
-4	12K0032	1	Top Bezel, Trim Kit
-5	31L7519	2	Cover, Side
-6	31L7523	1	Cover, Rear
-7	12K0024	1	Bottom Bezel, Trim Kit

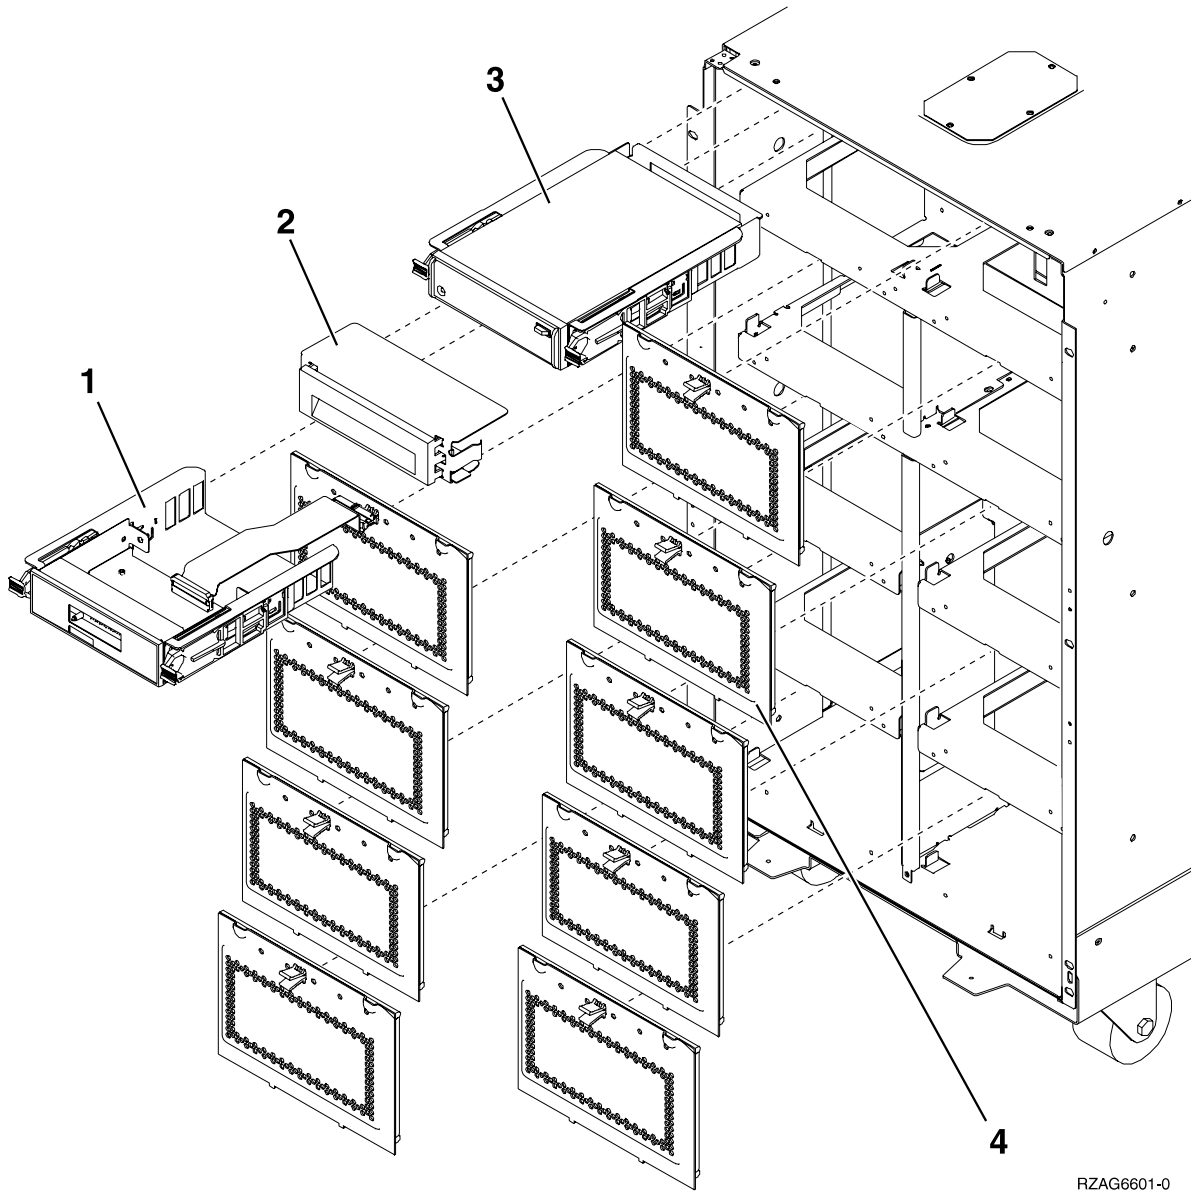
RZAG6601-0

Assembly 9: Final Assemblies for FC 5065 or FC 5066 expansion tower

Asm- Index	Part Number	Units	Description
9-1	24L0946	1	Control Panel
-2	44H8406	AR	Filler (Removable media)
-2		AR	Optical Storage Unit See "Type, Model, and Part Number List" on page 750.
-3		AR	Removable media See "Type, Model, and Part Number List" on page 750.
-4	24L0821	AR	Disk Unit EMC access plate

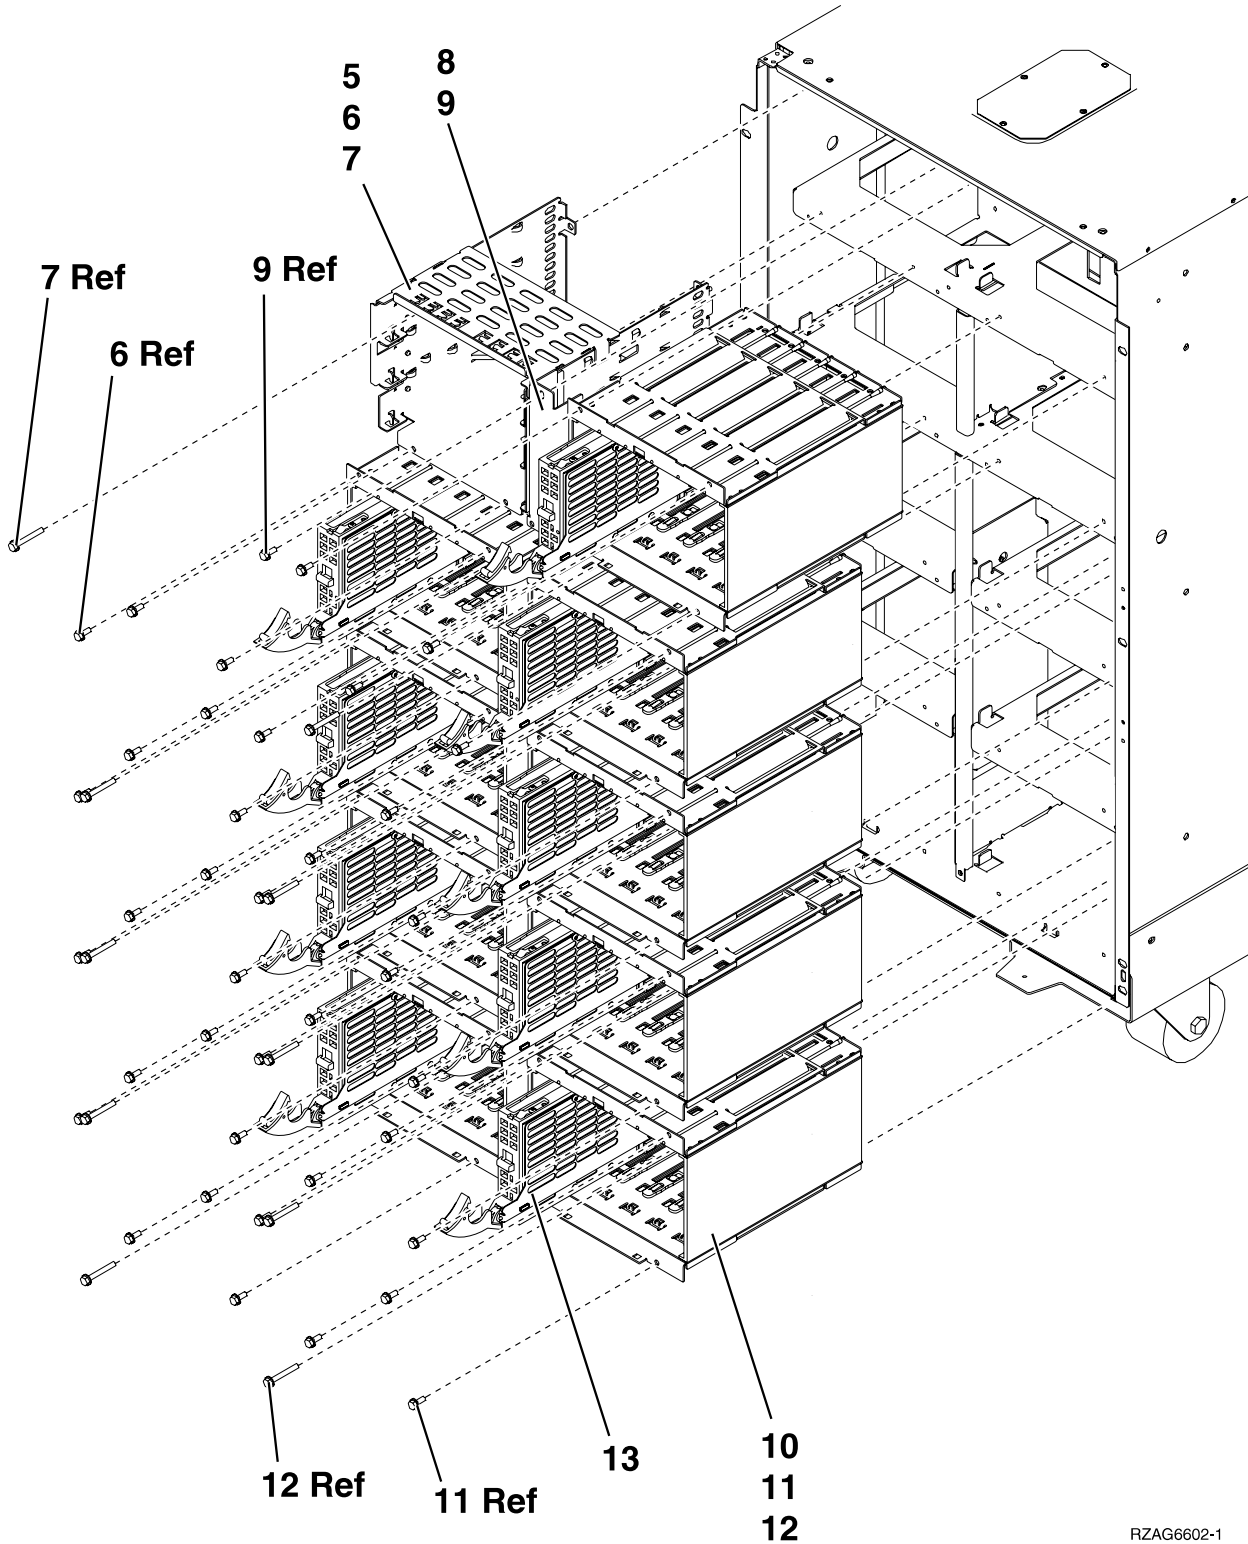
RZAG6602-1

Asm- Index	Part Number	Units	Description
9-5	NONUM	1	Removable media cage assembly
-6	1621811	2	Screw
-7	1621817	2	Screw
-8	24L1067	1	Center Support Bracket
-9	1621811	2	Screw
-10	NONUM	AR	5 disk unit cage assembly
-11	1621811	12	Screw
-12	1621817	6	Screw
-13		AR	Disk unit assembly See "Disk Unit Type, Model, and Part Number List" on page 756.

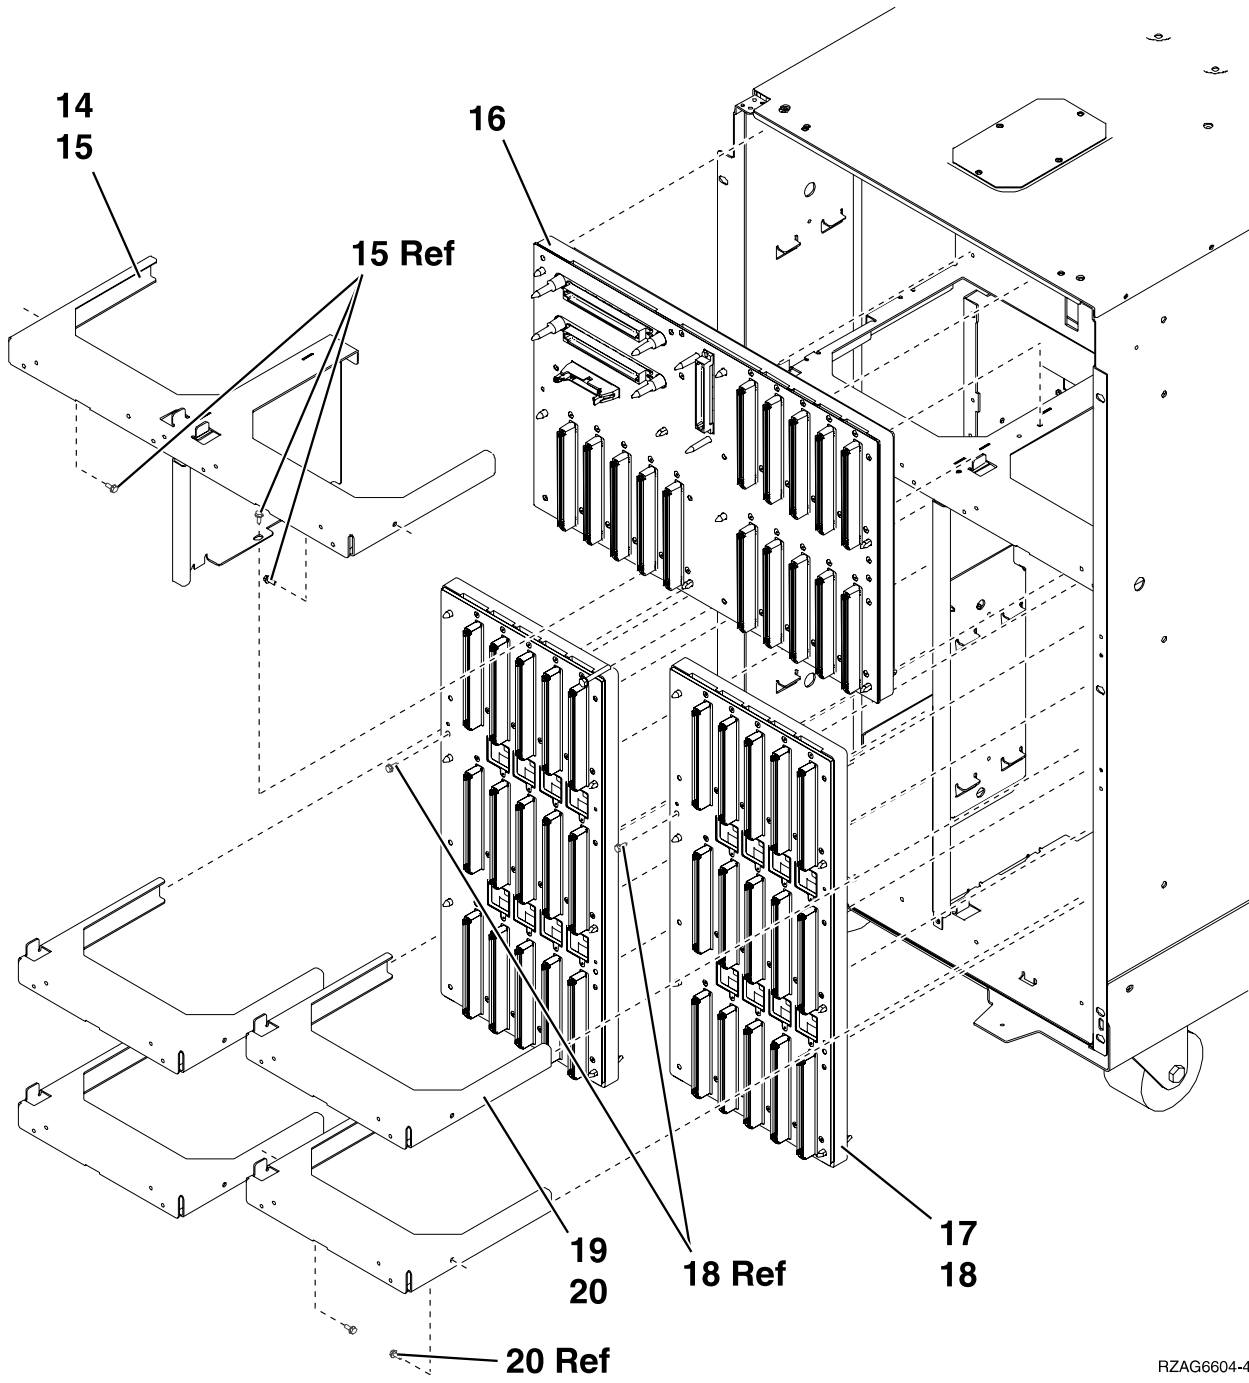
RZAG6604-4

Asm- Index	Part Number	Units	Description
9-14	NONUM	1	Shelf, Base Disk Unit
-15	1621811	3	Screw
-16	24L0892	1	Base Disk Unit Bd/Stiff. Asm. (DB3)
-17	24L1029	AR	Disk Unit Bd/Stiff. Asm. (DB1 & DB2)
-18	1621838	1	Screw
-19	NONUM	AR	Shelf, Disk Unit
-20	162811	2	Screw

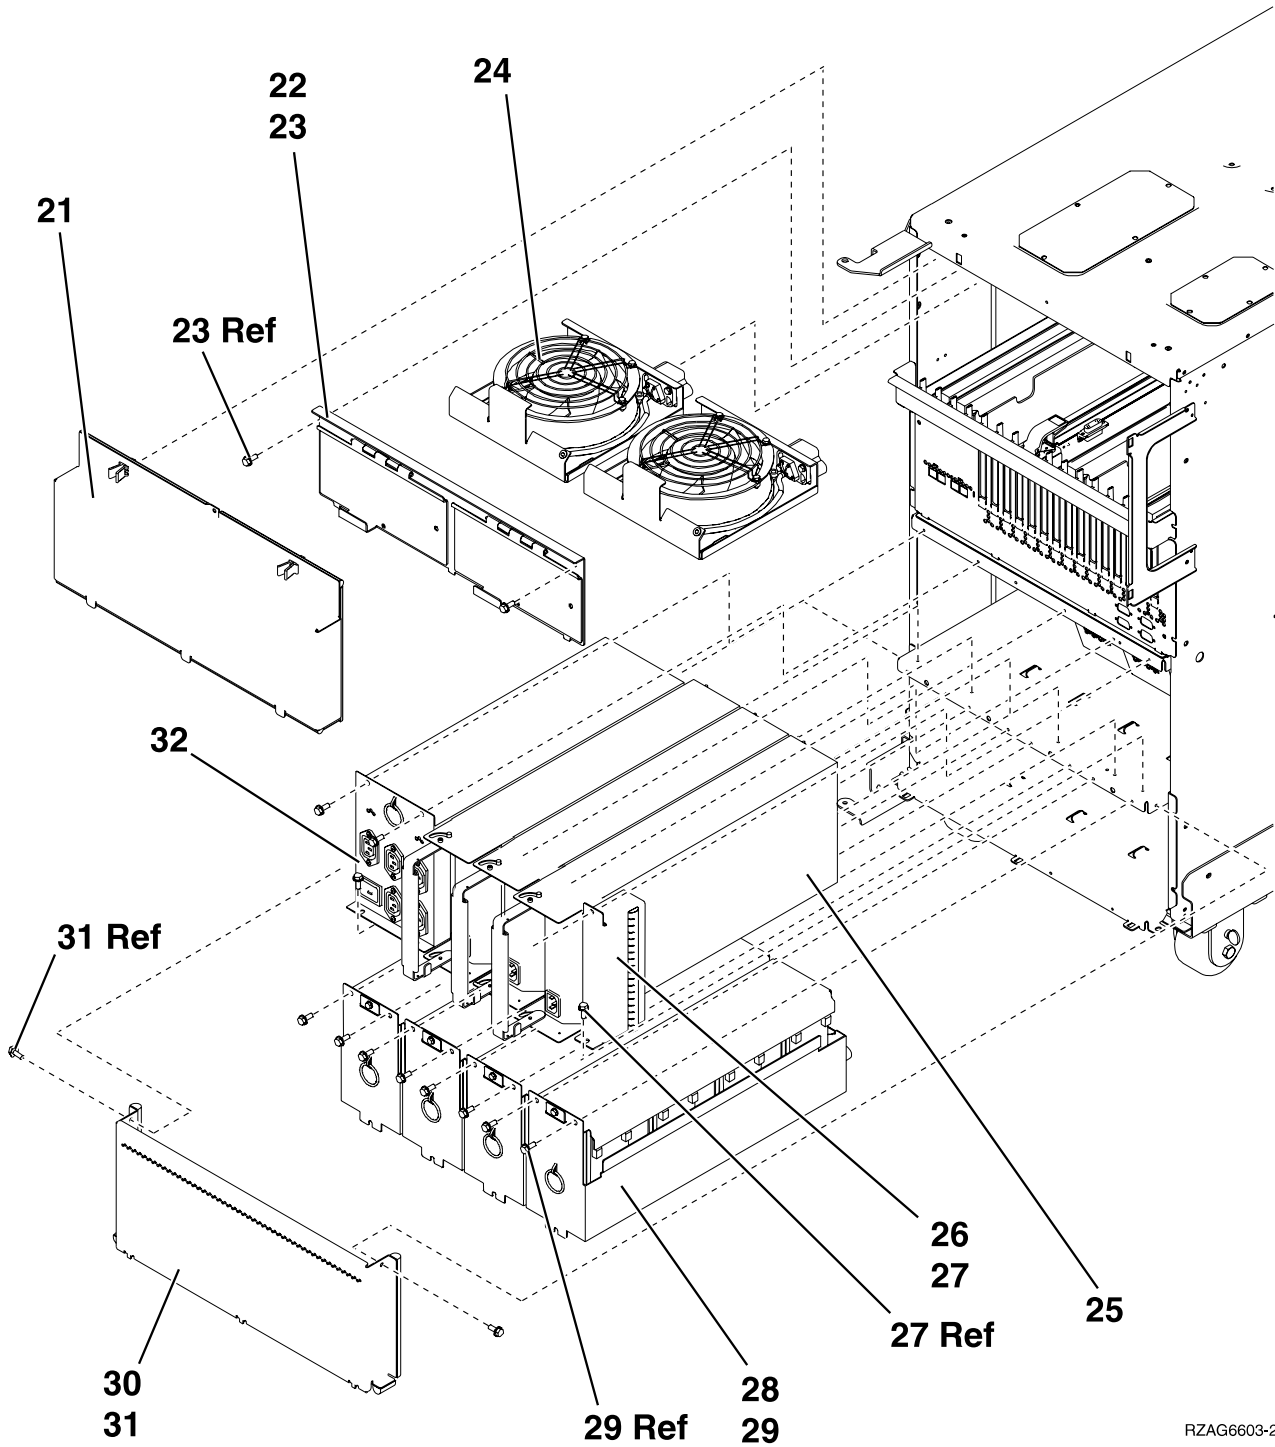
RZAG6603-2

Asm- Index	Part Number	Units	Description
9-21	24L0823	1	EMC access plate
-22	NONUM	1	AMD door assembly
-23	1621811	2	Screw
-24	44L0023	2	AMD
-25	90H6629	3	Power supply — 765 watts
-26	24L0940	AR	Filler for power supply
-27	1621811	2	Screw
-28	97H7320	4	Battery pack
-29	1621811	12	Screw
-30	NONUM	1	EMC access plate
-31	1621811	2	Screw
-32	97H7316	1	Battery Charger

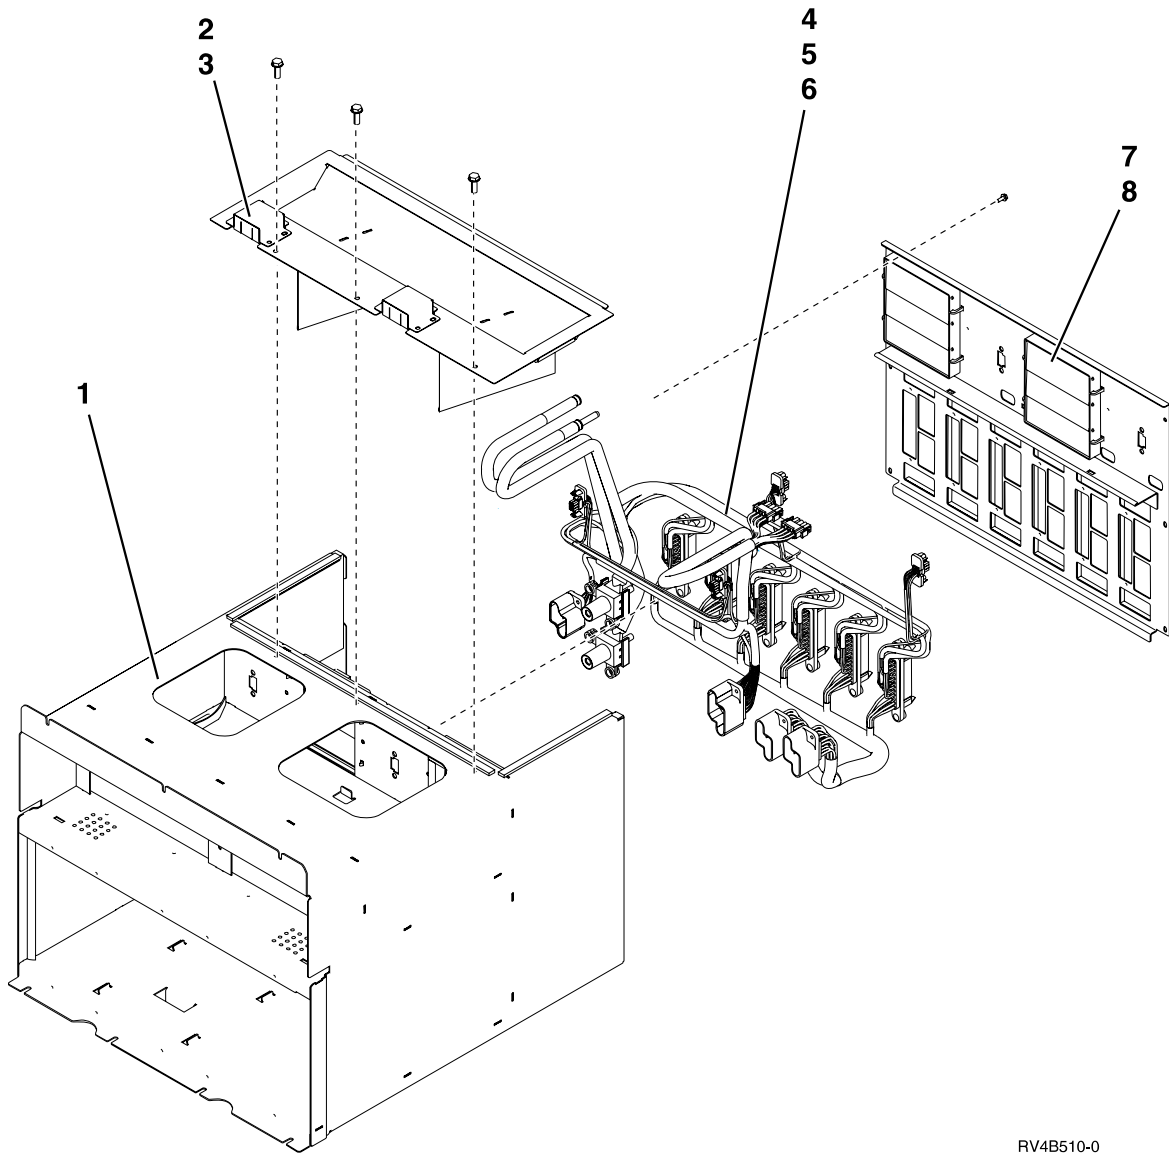
RV4B510-0

Assembly 10: FC 5077 Power Subframe Assembly

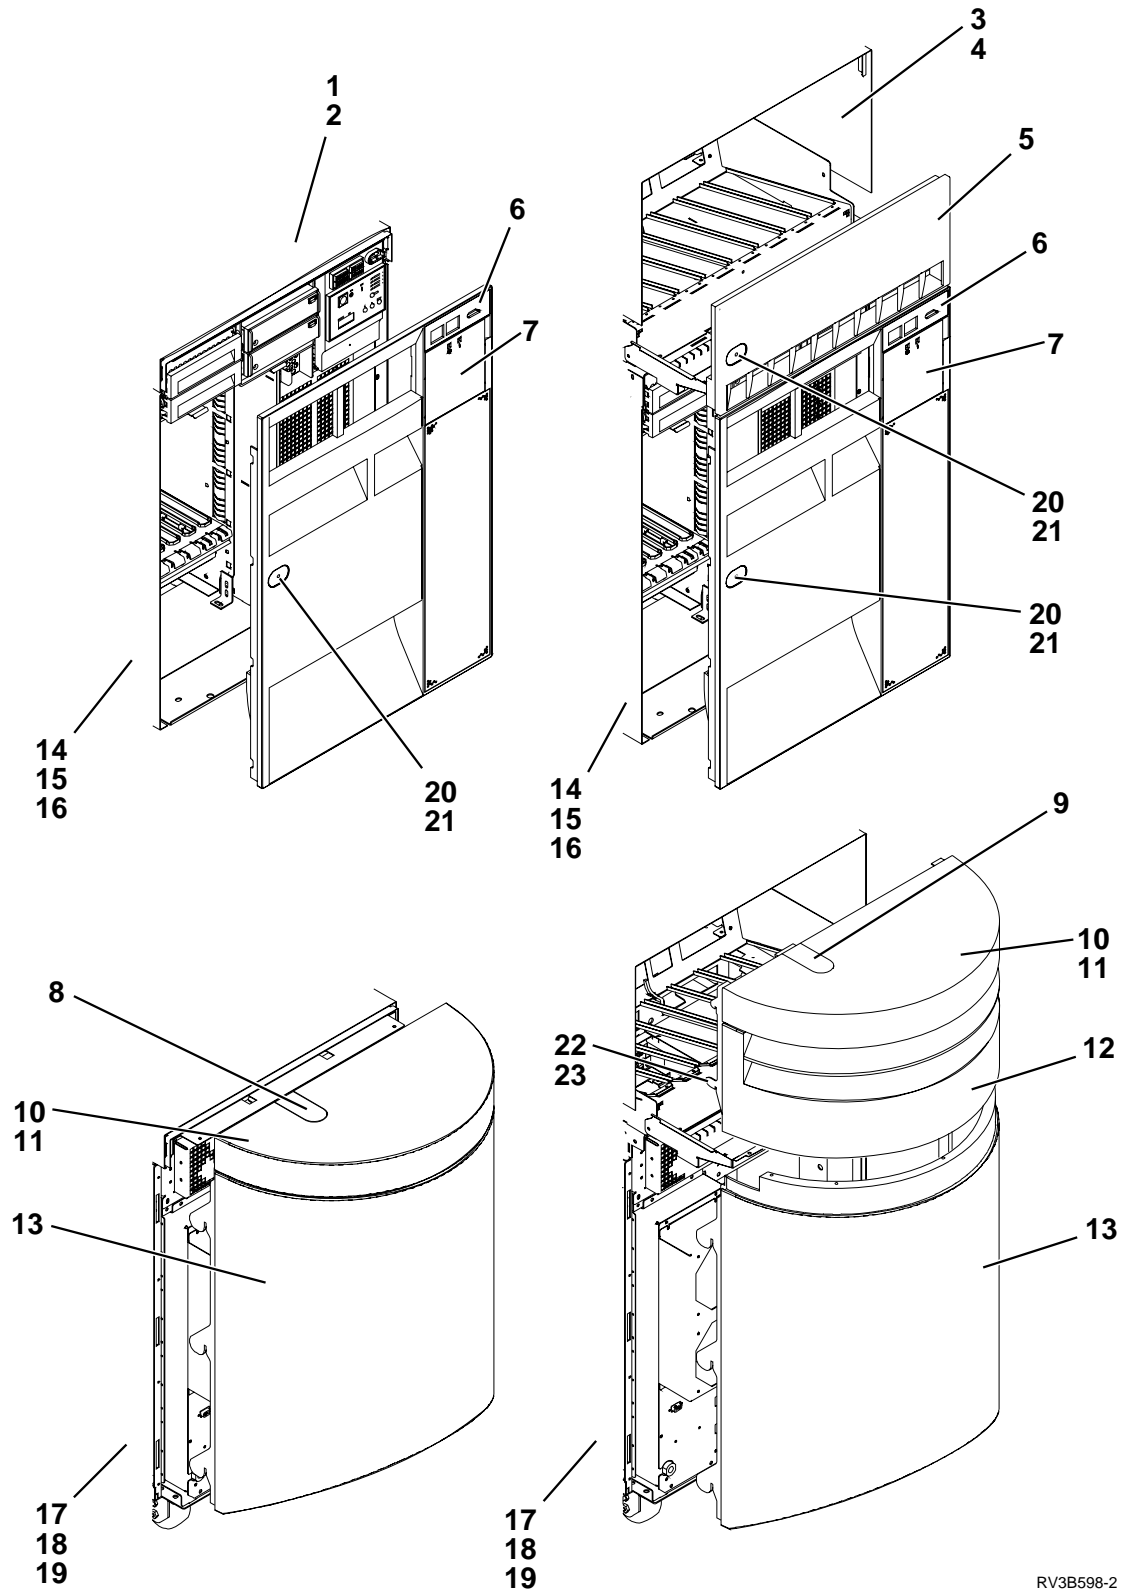
RV3B598-2

Assembly 11: Cover Assemblies - FC 5077, 507x & 508x Expansion Units

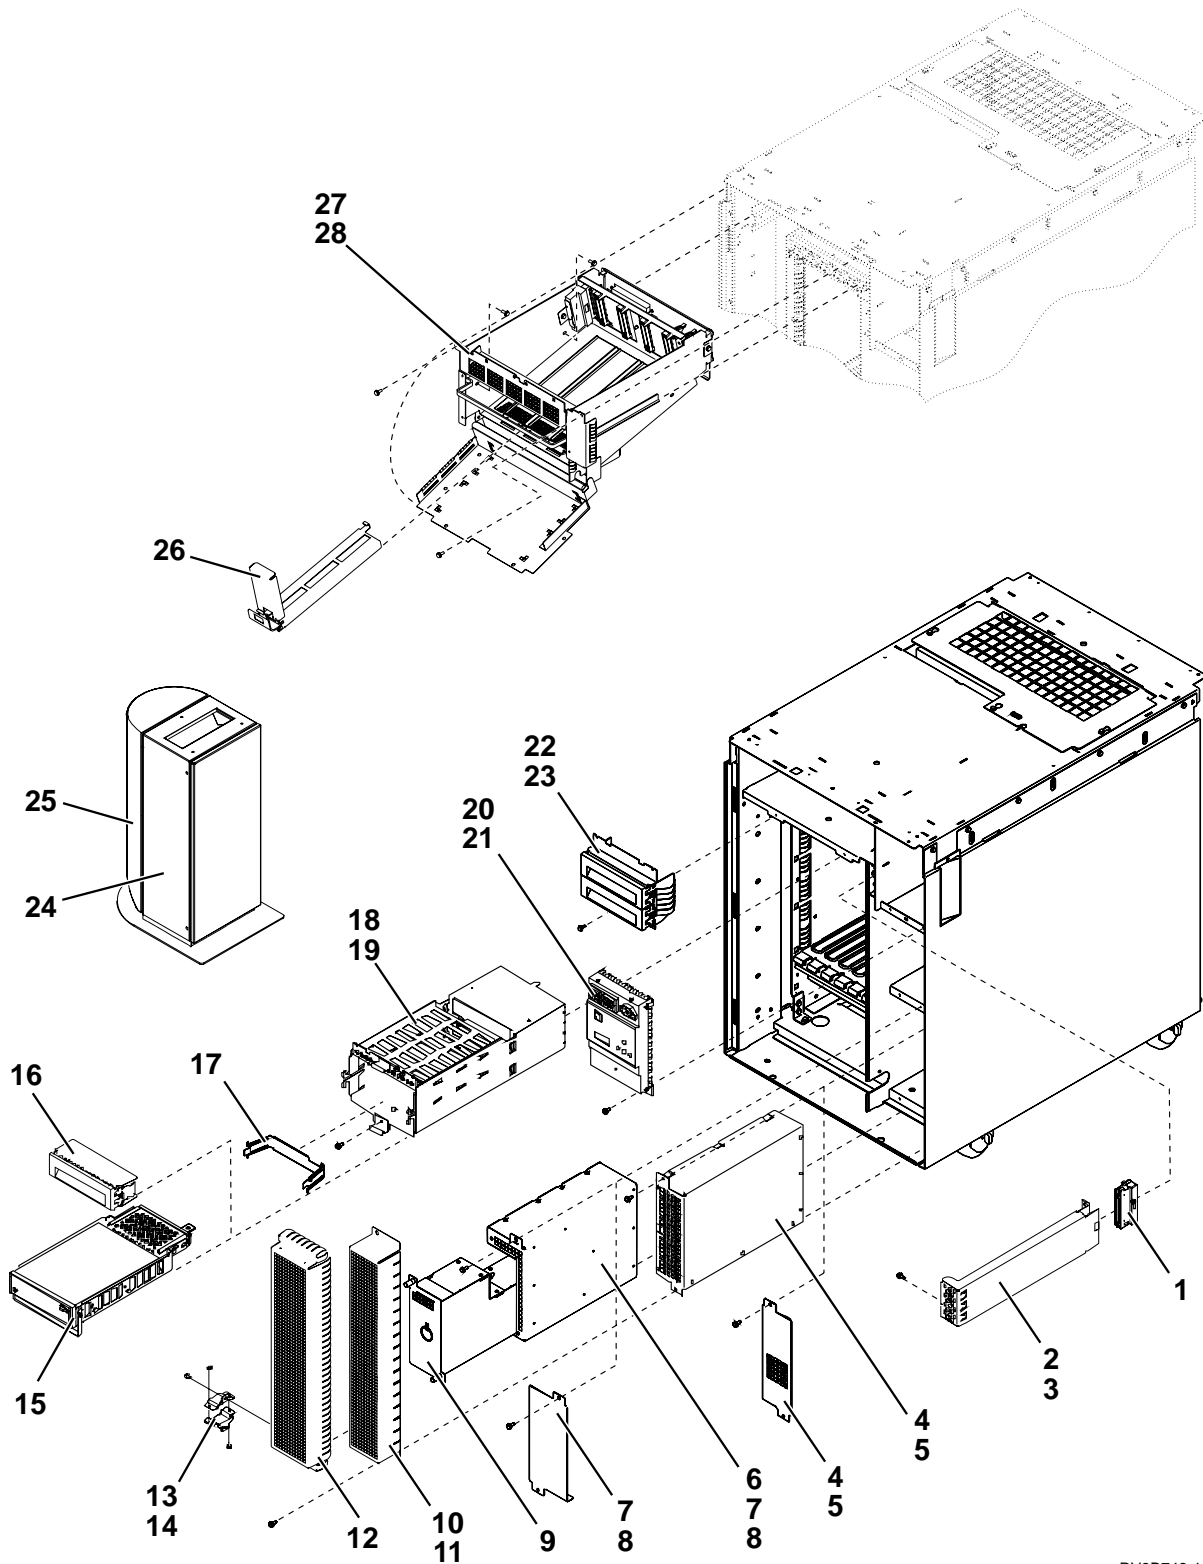
RV3B743-1

Assembly 12: Final Assembly - FC 5077, 507x & 508x Expansion Towers

-16	86G7623	AR	Removable Media Filler Bezel
-17	86G7656	AR	Key - Tape Unit
-18	46G3700	AR	Removable Media Tray Asm
-18	46G3620	AR	Removable Media Tray Asm, Empty
-19	1621811	6	Screw, M4 (10mm)
-20	17G0574	NP	Secondary Control Panel
-21	1621811	2	Screw, M4 (10mm)
-22	86G7865	1	Filler Bezel Asm
-23	1621811	1	Screw, M4 (10mm)
-24	86G7714	1	External Battery Power Unit Battery Asm
-25	46G0321	1	External Battery Power Unit Battery Rear Cover Asm
-26	46G3529	AR	Filler Asm, Disk Unit
-27	87G4362	1	Disk Unit Guide Asm, (508x Only)
-28	1621811	8	Screw, M4 (10mm)
-29	87G6049	1	507x Expansion Regulator
-29	17G1209	1	508x Expansion Regulator
