Migrated Expansion Tower Problem Analysis, Repair and Parts

Version 4

First Edition (June 2000)

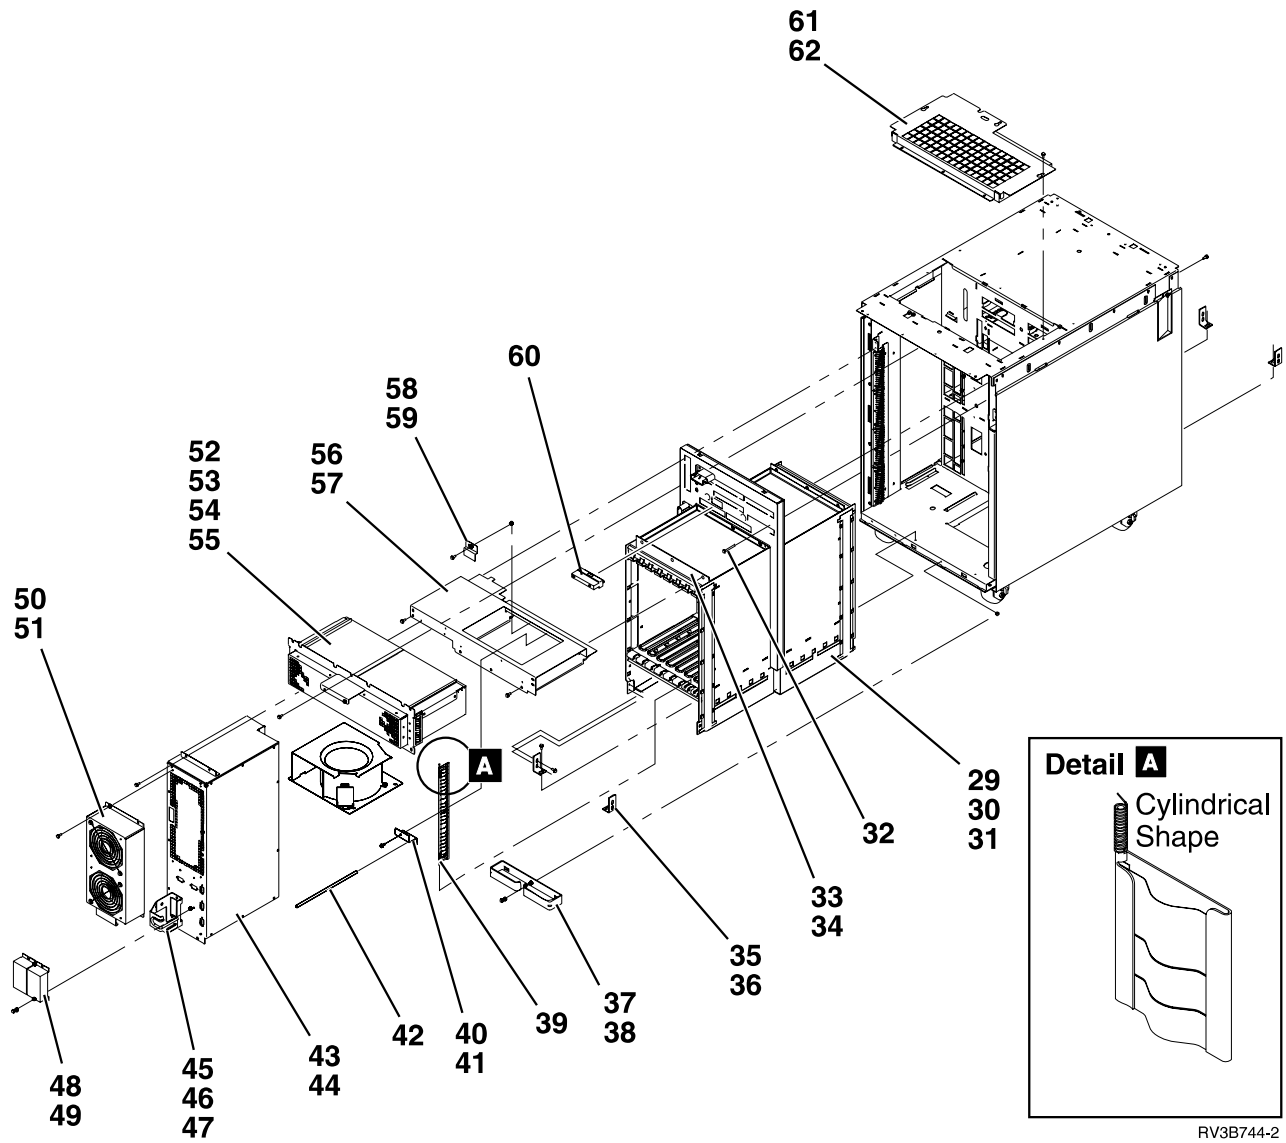
Asm- Index	Part Number	Units	Description
12-29	86G7633	1	Expansion Unit Card Enclosure Asm, Models 5070 and 5072 (lower)
-29	90H6425	1	Expansion Unit Card Enclosure Asm, Models 5071 and 5073 (lower)
-29	87G4357	1	Expansion Unit Card Enclosure Asm, Models 5080 and 5082 (lower)
-29	87G4362	1	Expansion Unit Card Enclosure Asm, Models 5080, 5081, 5082, and 5083 (upper)
-29	90H6426	1	Expansion Unit Card Enclosure Asm, Models 5081 and 5083 (lower)
-29	21H7465	1	Feature 9251 Base I/O Tower Card Enclosure Asm
-30	21H3759	AR	Enclosure Spring
-31	1621811	11	Screw, M4 (10mm)
-32	1621838	4	Screw (35mm)
-33	46G3646	2	Card Retaining Bar
-34	1621811	3	Screw, M4 (10mm)
-35	46G3663	4	Bracket, Cage Mounting
-36	1621811	12	Screw, M4 (10mm)
-37	46G3666	1	Bracket, Rear I/O cable ret.
-38	1621811	1	Screw, M4 (10mm)
-39	91H0250	AR	Card Spring (verticle SPD card separators)
-40	21H3473	1	Clamp, Light Pipe
-41	1621811	1	Screw, M4 (10mm)

-42	21H3472	1	Light Pipe
-43	87G6300	1	AC Module Asm (FC 5070, 5072, 5080, 5082)
-43	21H7697	1	AC Module Asm (FC 9251, 5071, 5073, 5081, 5083)
-44	1621811	4	Screw, M4 (10mm)
-45	NONUM	NP	Power Cord Retaining Bracket
-46	NONUM	NP	Power Cord Retaining Clamp
-47	NONUM	4	Screw, Torx M3 x 10 Lg
-48	90H6287	2	SPCN Optical Adapter Asm
-49	1621811	4	Screw, M4 (10mm)
-50	46G3510	1	AMD Asm - AC Module (AMD 1 and AMD2)
-51	1621811	4	Screw, M4 (10mm)
-52	46G3509	1	AMD Asm (AMD 3 and AMD 4)
-53	46G3587	2	• AMD
-54	1621811	4	• Screw, M4 (10mm)
-55	1621811	4	Screw, M4 (10mm)
-56	NONUM	NP	AMD Mounting Asm
-57	1621811	7	Screw, M4 (10mm)
-58	46G3667	1	Bracket - Term Ret
-59	1621811	1	Screw, M4 (10mm)
-60	NONUM	NP	Terminator/Redrive plug
-61	1621811	3	Screw, M4 (10mm)

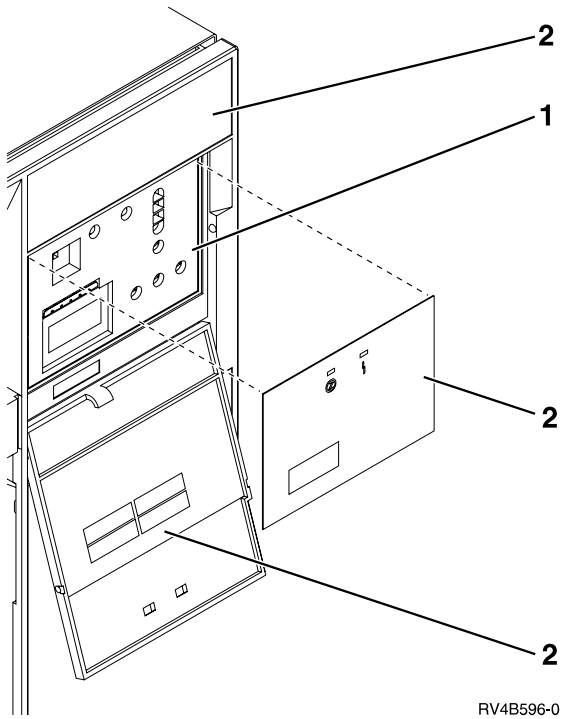
RV4B596-0

Assembly 13: FC 5077, 507x, 508x Expansion Tower(s) Control Panel

Asm- Index	Part Number	Units	Description
13-1	NONUM	NP	Control Panel
-	17G0574	1	Circuit Card
-2	46G3570	1	Control Panel Overlay

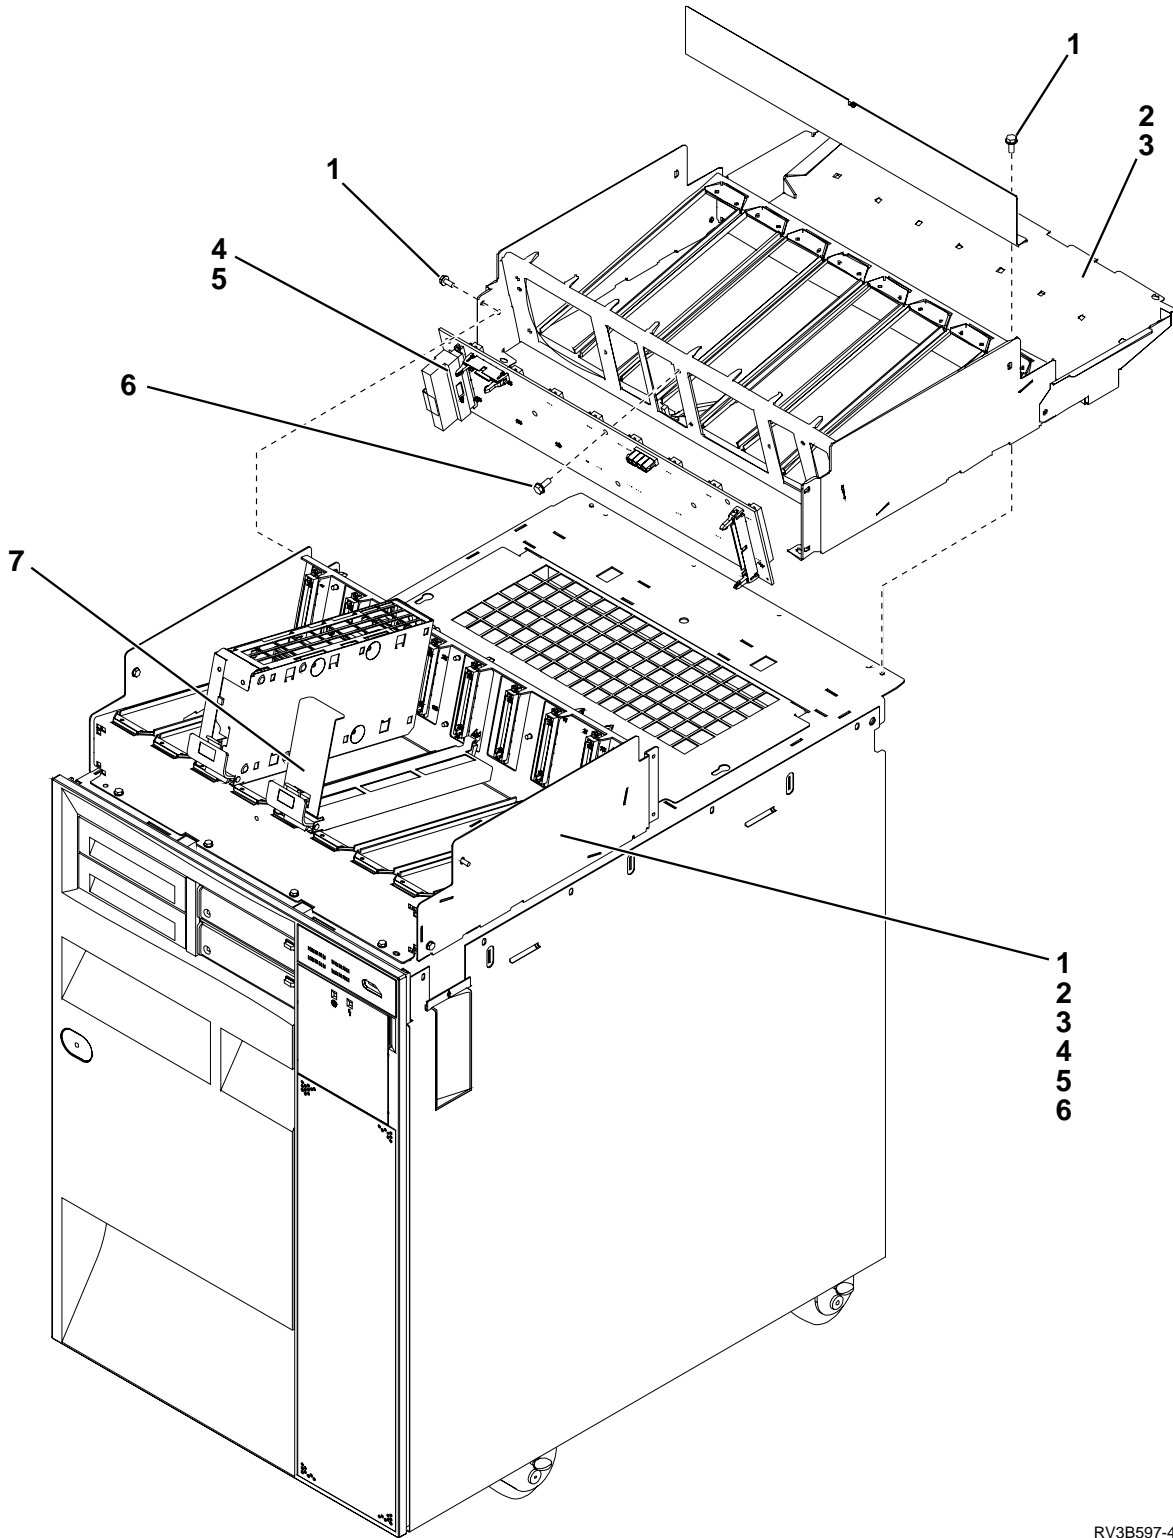
RV3B597-4

Assembly 14: Storage Expansion Unit Assembly

Asm- Index	Part Number	Units	Description
-2	46G3581	2	• Cover
-3	1621811	5	• Screw, M4 (10mm)
-4	16G6496	1	• Backplane (front) K1 - K8 FC 5052
-4	86G7872	1	• Backplane (rear) K9 - K16 FC 5052
-4	21H7750	1	• Backplane (front) K1 - K8 FC 5055
-4	21H6938	1	• Backplane (front) K1 - K8 FC 5058
-4	21H6940	1	• Backplane (front) K1 - K8 FC 5057
-4	21H6940	1	• Backplane (rear) K9 - K16 FC 5057 and 5058
-5	NONUM	AR	• Terminating Plug (See "DEVTERM" on page 568.)
-6	1621811	8	• Screw, M4 (10mm)
-7	46G3529	AR	• Disk Unit Filler Asm

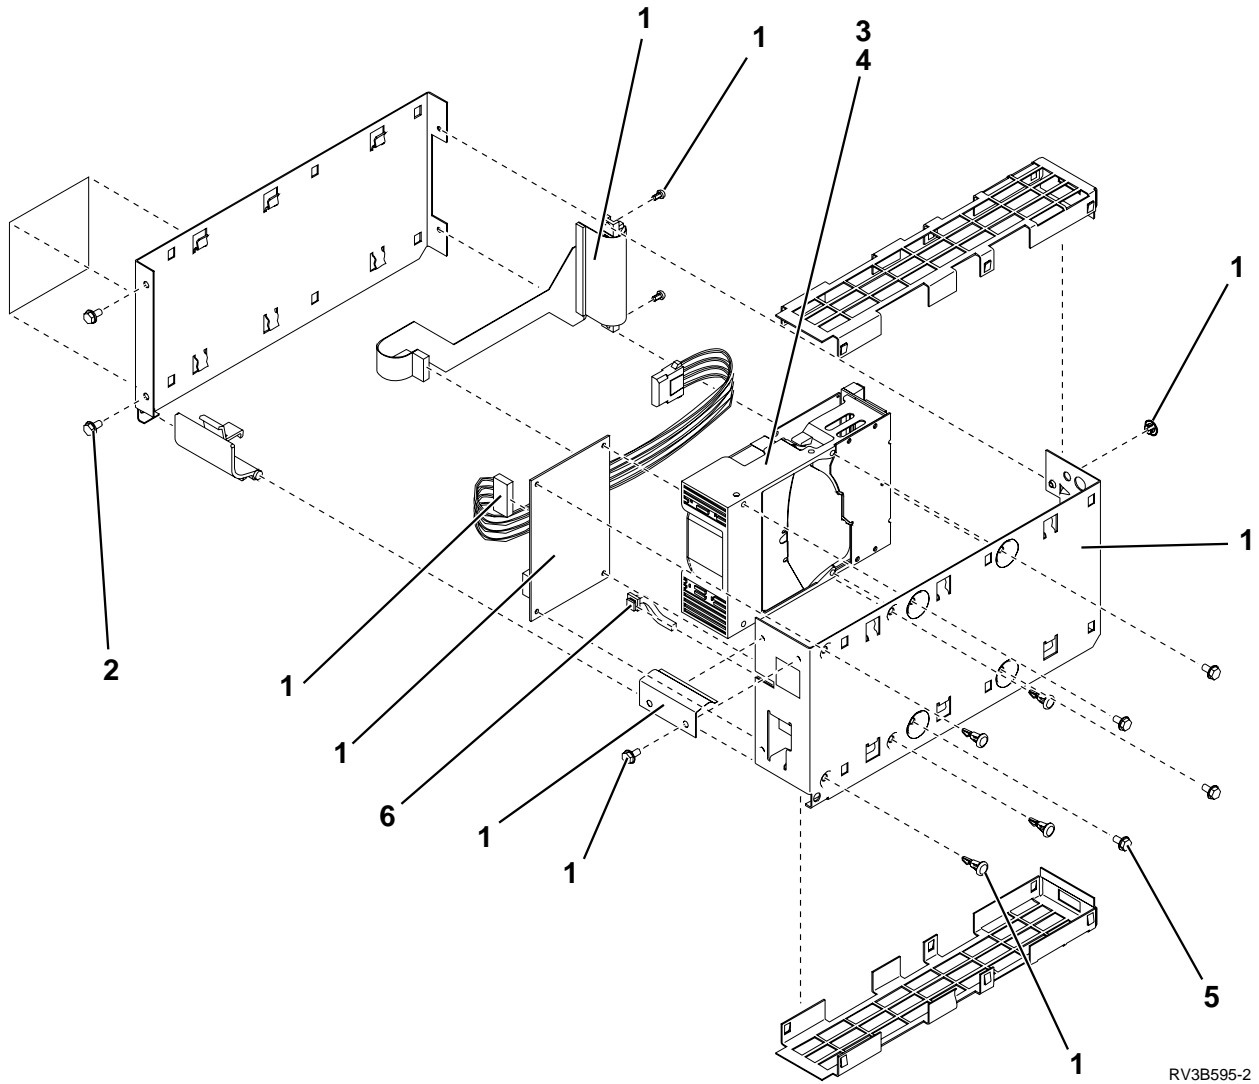
Assembly 15: Disk Unit Assemblies

Asm- Index	Part Number	Units	Description
15- -1 -2 -3 -4 -5 -6	NONUM NONUM 1621811 NONUM NONUM 60X8709 46G3530	NP AR 2 AR AR 4 1	Disk Unit Assembly • Tray Asm * • Screw, M4 (10mm) Thd-Form Hx Wshr Hd • Disk Drive * • • Disk Drive Logic Card * • • Screw (6mm) • Light Pipe * See "Disk Unit Type, Model, and Part Number List" on page 756 for part numbers for Tray Assembly and Disk Drives.

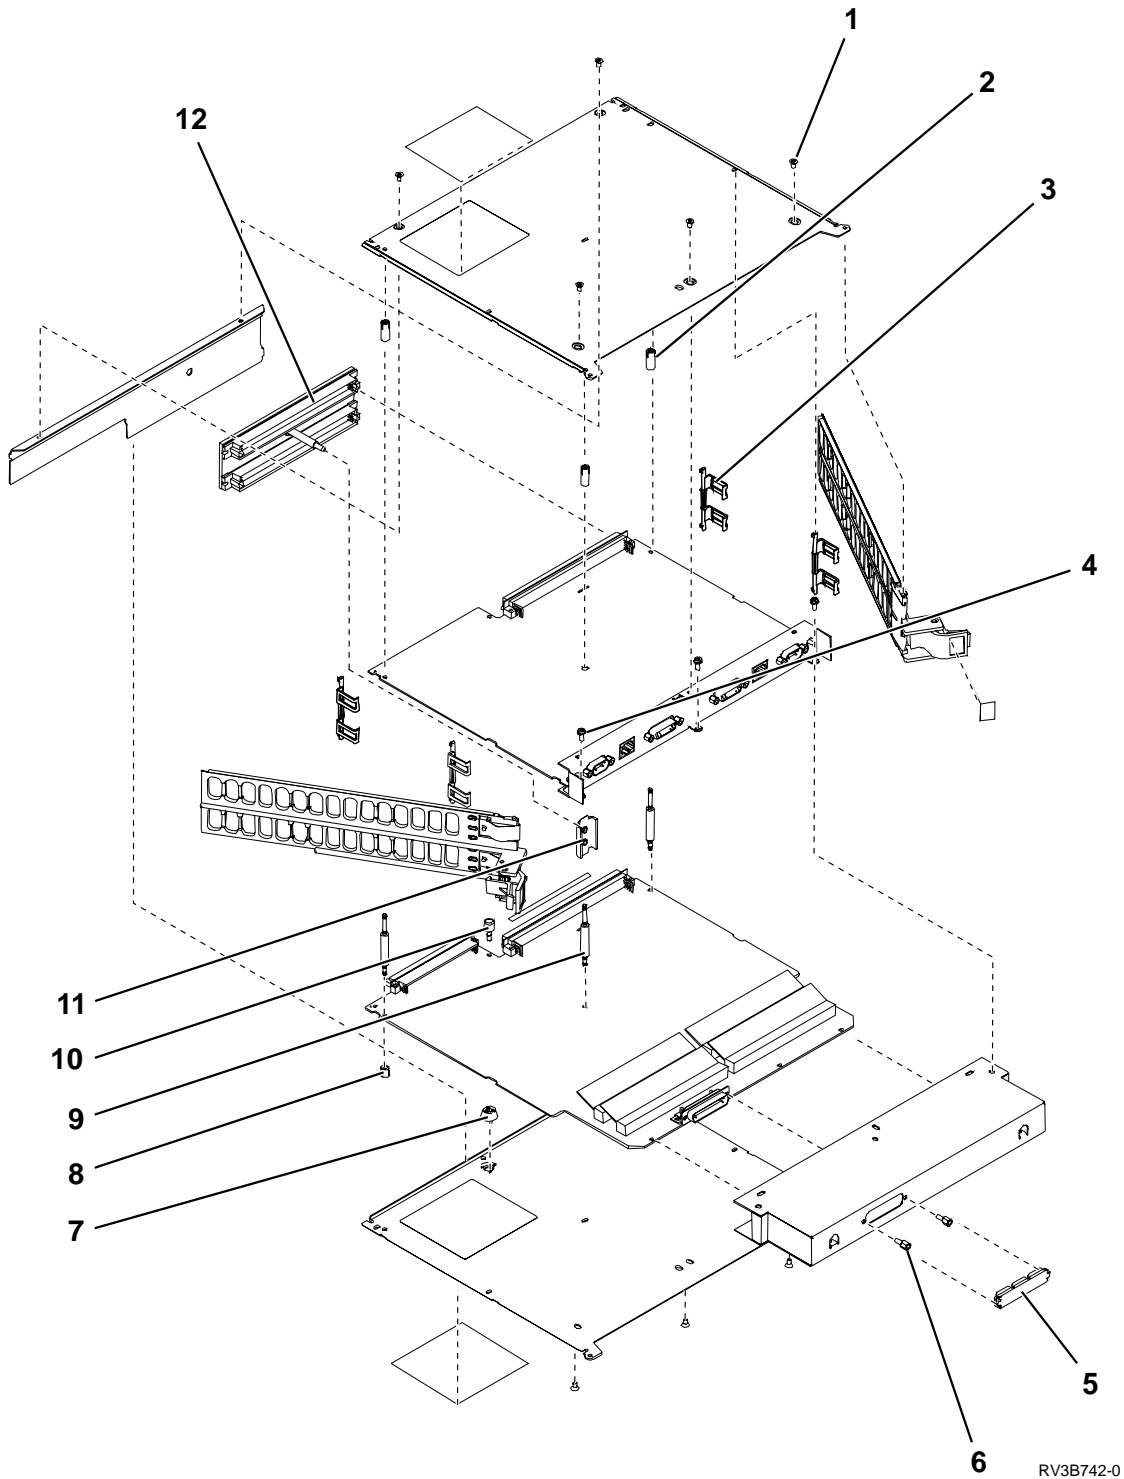
Assembly 16: File Server Book Assembly Type 6506

Asm- Index	Part Number	Units	Description
16-	NONUM	NP	File Server Book Asm
-1	21F9053	8	• Screw (4.5mm)
-2	86G7622	3	• Standoff, Right
-3	86G7619	4	• Rail Retainer
-4	21F4419	5	• Screw (6mm)
-5	17G2534	4	• Cover, Test Port
-6	72X6451	2	• Standoff
-7	86G7640	1	• Button, Card Support
-8	86G7621	3	• Standoff, Left
-9	86G7620	3	• Standoff, Middle
-10	86G7639	1	• Bow Clip Guide
-11	75G5716	1	• Stiffener, Docking
-12	86G7681	1	• Crossover Connector Asm

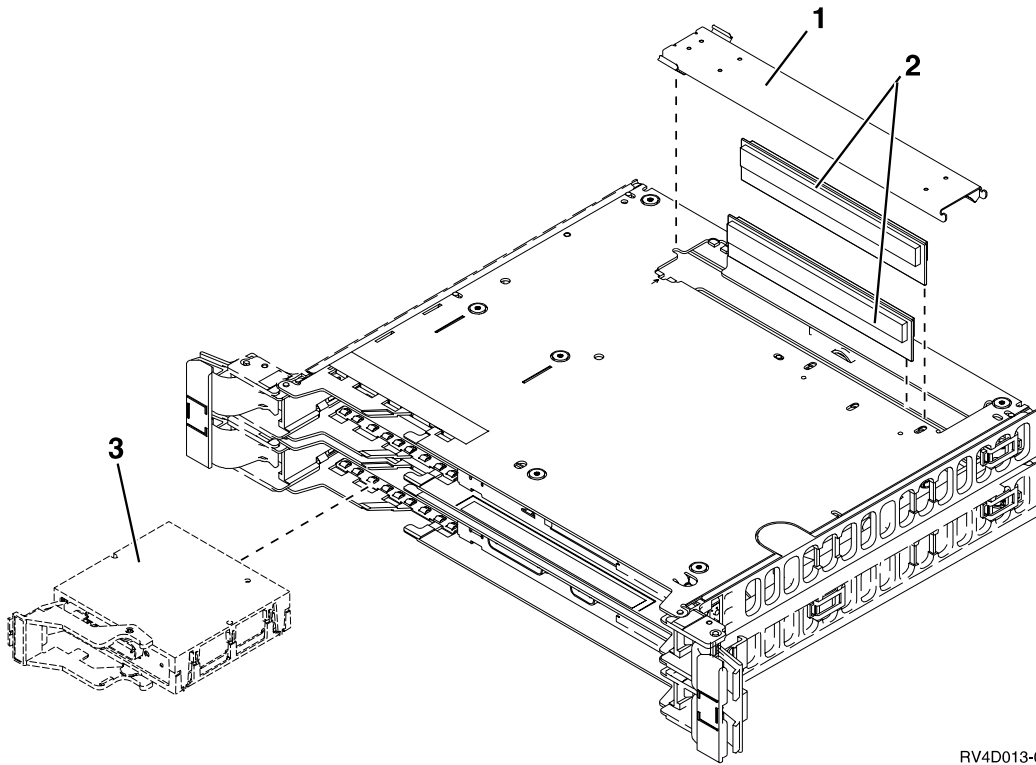
Assembly 17: File Server Book Assembly Type 6616

Asm- Index	Part Number	Units	Description
17-	91H0353	1	File Server Book Asm
-1	NONUM	1	• Access cover
-2	44H7558	1	• 32 MB Memory DIMM
-2	90H9075	1	• 128 MB Memory DIMM
-3	NONUM	1	• Adapter Card *
			* See "Type, Model, and Part Number List" on page 750 for part numbers for Adapter Card part numbers.

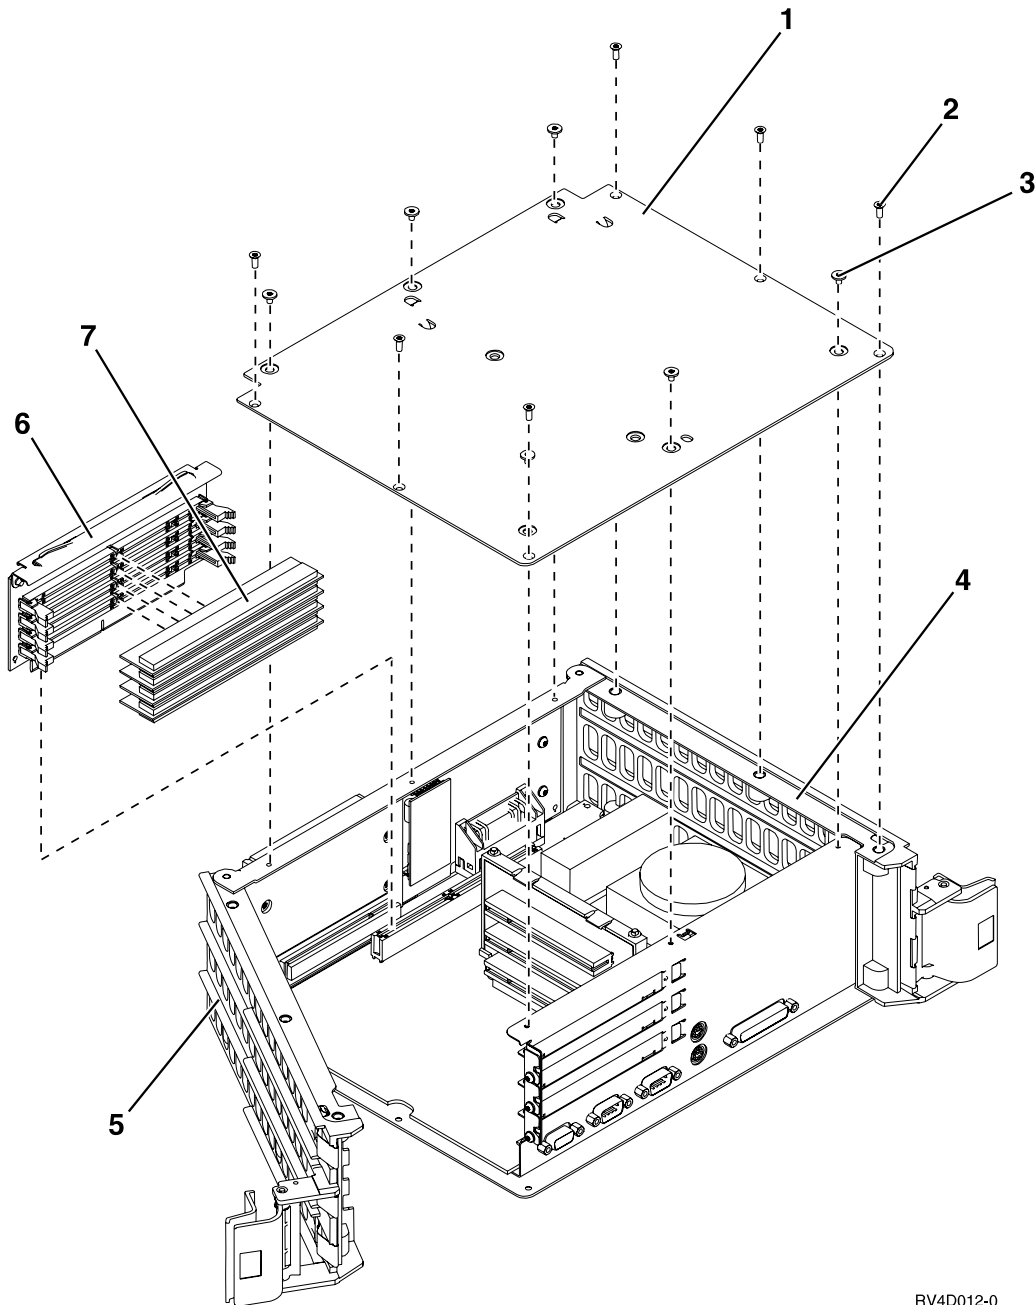
Assembly 18: File Server Book Assembly Type 6617

Asm-Index	Part Number	Units	Description
18-	97H7627	1	File Server Book Asm
-1	NONUM	1	• Access cover
-2	56F0346	6	• Cover screw (small, 3.35mm)
-3	21F9053	6	• Cover screw (large, 4.5mm)
-4	90H6464	1	• Lower rail
-5	90H6462	1	• Upper rail
-6	NONUM	1	• Riser for Memory DIMM
-7	44H7558	4	• 32 MB Memory DIMM
-7	90H9075	4	• 128 MB Memory DIMM
-7	97H7725	4	• 256 MB Memory DIMM

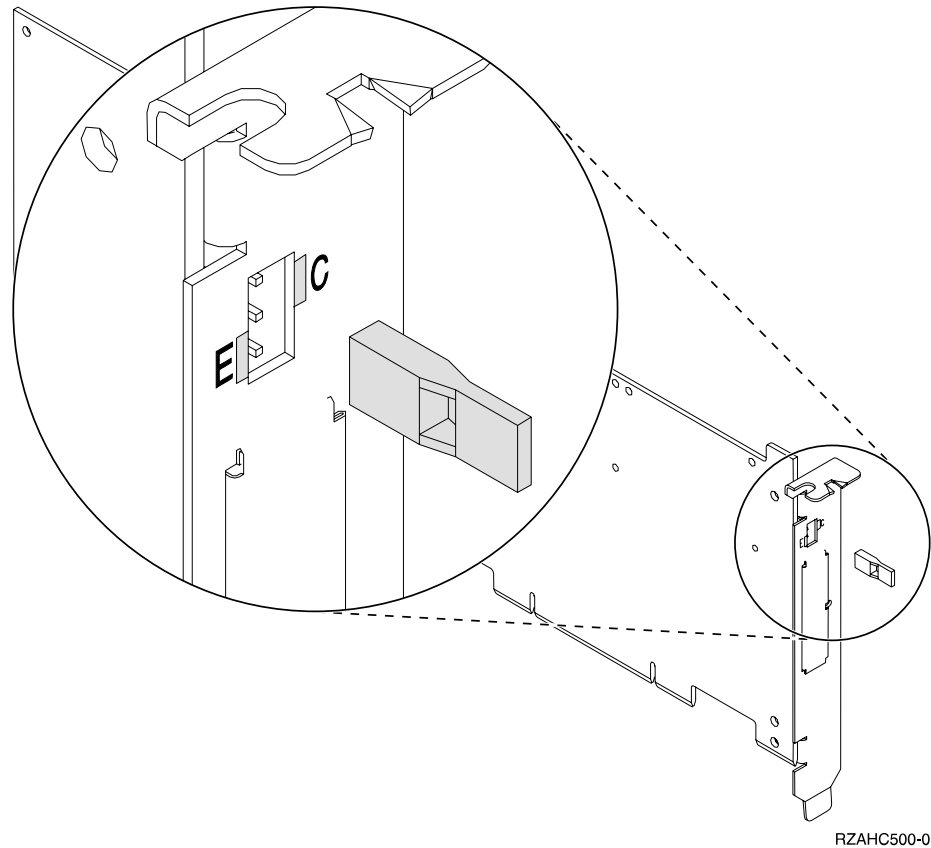
Storage I/O Card Modes and Jumpers

Refer to the illustration below while performing this procedure.

Set the mode of the card to Compressed (C) by placing the jumper on the top and middle pins. Set the mode of the card to Enhanced (E) by placing the jumper on the middle and bottom pins.

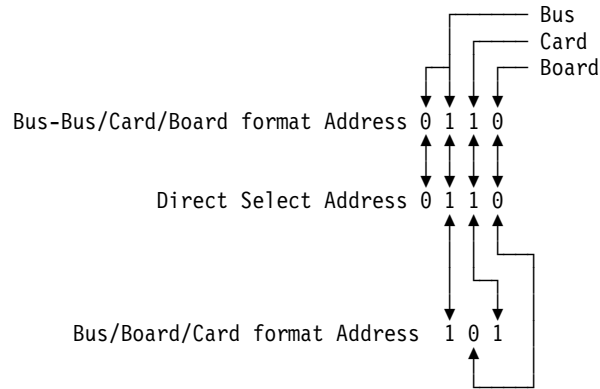
Figure 86. Format Conversion

- Use Figure 86 on page 881 to understand how addresses in the Bus/Board/Card format relate to the Bus-Bus/Card/Board format. You can also use Figure 86 on page 881 to understand how addresses in the Bus/Board/Card format relate to the direct select addresses used in “Expansion Tower Locations and Addresses” on page 687.

Value	Description
x1 = System bus	The one, two or three digit decimal representation of the hexadecimal Bus value of the Bus/Board/Card format Address at the bottom of Figure 86 on page 881.
x2 = System board	The one or two digit decimal representation of the hexadecimal Board value of the Bus/Board/Card format Address at the bottom of Figure 86 on page 881.
x3 = System card	The one or two digit decimal representation of the hexadecimal Card value of the Bus/Board/Card format Address at the bottom of Figure 86 on page 881.
x4 = Adapter location	The one or two digit decimal representation of the hexadecimal b Adapter value of the Communications unit address value in step 10 on page 881.

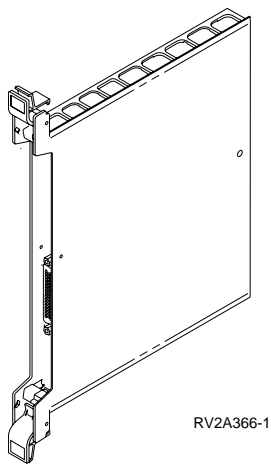
Figure 89. Type 2644 Card Connector

Type 2644

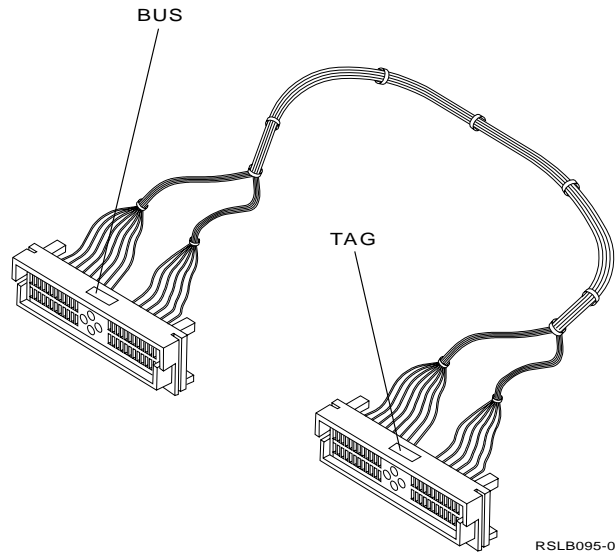
Figure 90. Channel Wrap Block 1, part 62X3403

Channel Wrap Block 1
