AS/400e server 600, 620, 720, S10 and S20 Problem Analysis, Repair and Parts

Version 4

Sixth Edition (July 2000)

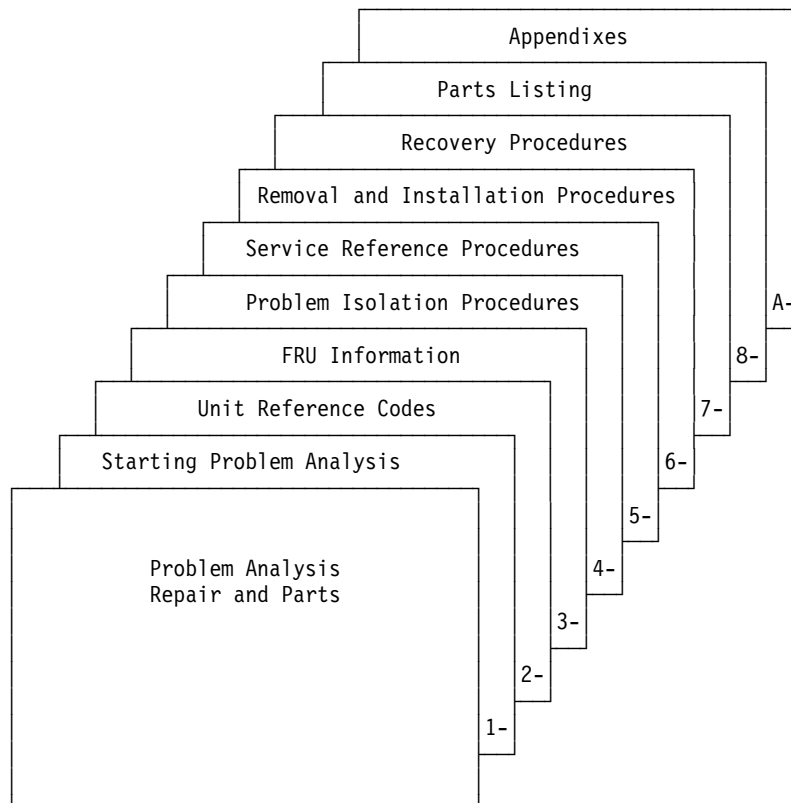
The following figure shows the structure of the Problem Analysis, Repair, and Parts book.

- Section 1 is the starting point for all service actions.
- Section 2 contains information about system reference codes (SRCs) and the unit reference code (URC) information that is contained within the SRCs.
- Section 3 contains:
 - Failing item information

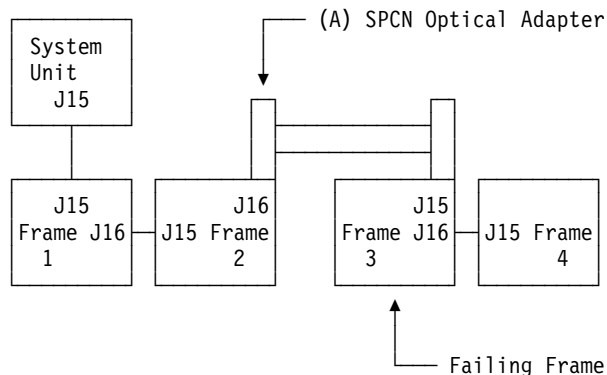
24. Remove the SPCN optical adapter **A** from the preceding frame in the string that cannot become powered on (see "Removal and Installation Procedures" in the *Repair and Parts* information for the system).

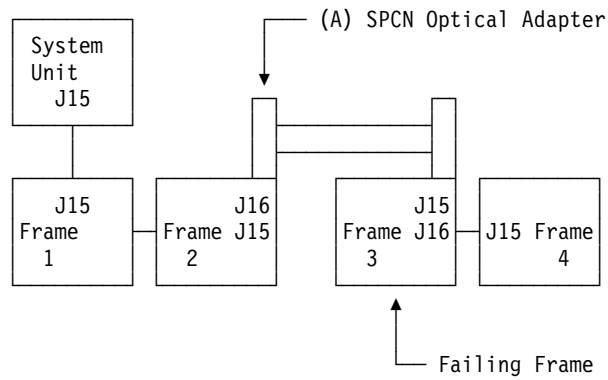
48. Remove the SPCN optical adapter **A** from the preceding frame in the string that cannot become powered on (see "Removal and Installation Procedures" in the *Repair and Parts* information for the system).

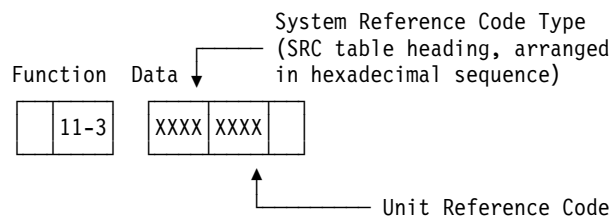
Figure 12. Determining the SRC and URC

System Control Panel Display or Problem Summary Form Information

3. You will be directed to find the appropriate SRC table for your SRC.
To correct the problem, perform the action indicated for the URC in the *Description/Action* column of the table. If this does not correct the problem, exchange the failing items or parts listed in *Failing Item* column in the order that they are listed.
If no action is indicated in the SRC table, exchange the failing items or parts listed in the table.

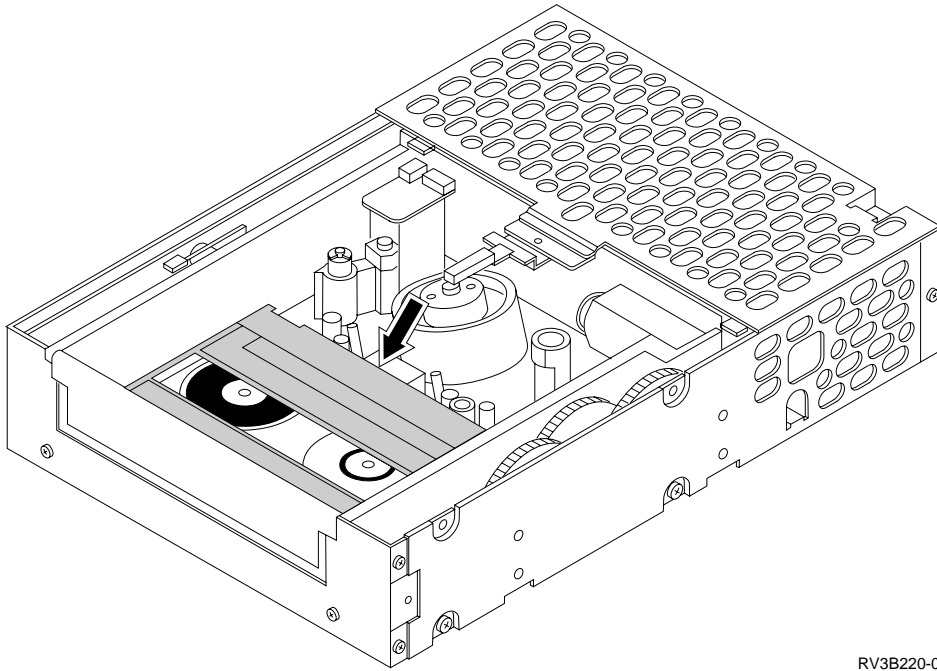
8. Perform the following:
 - a. Loosen the tape as shown **A**. Make sure not to damage or crease the tape. If the pinch roller **B** is engaged, push the pinch roller spring bracket as shown **C**. This releases the pinch roller and provides a gap from which the tape can be removed.

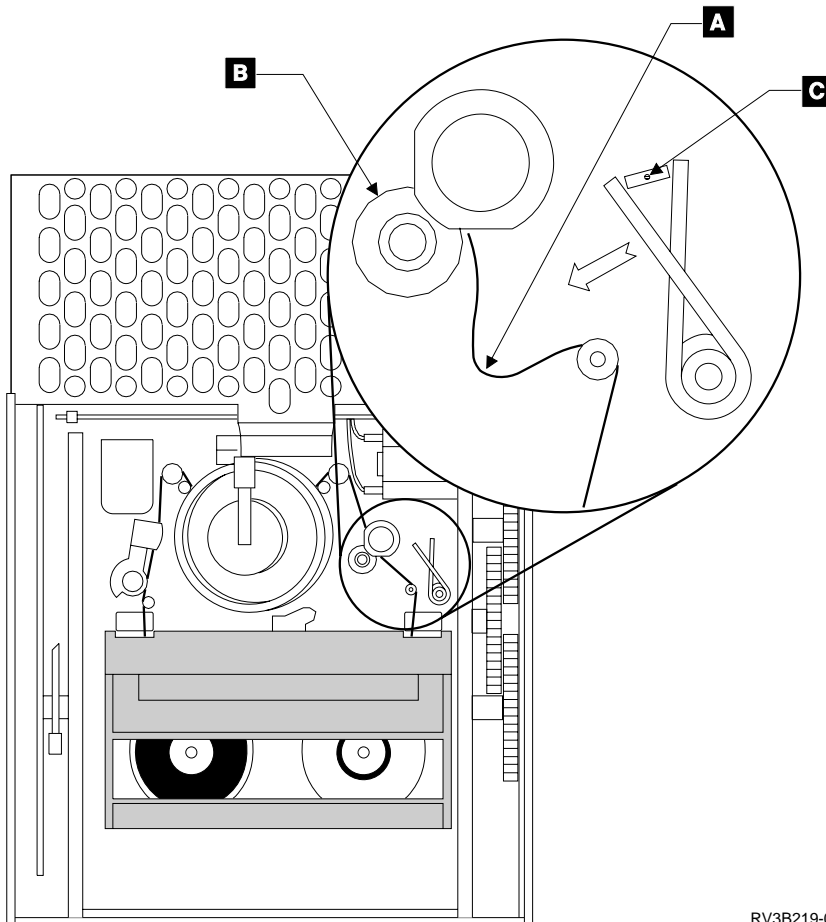
RV3B219-0

Removing Tape Cartridge

- b. Turn the drive assembly over. Remove the five screws from the bottom cover of the drive assembly. These screws are similar to the screws on the top cover.
- c. Wind the tape into the tape cartridge by following these steps:
 - 1) Using a small screwdriver, push and hold the reel motor gear **D** to the right as far as possible.
 - 2) Rotate the reel motor gear counter-clockwise while also maintaining pressure by holding the gear to the right.
 - 3) Continue to rotate the gear until all of the tape is wound into the tape cartridge and the tape is tight across the opening.

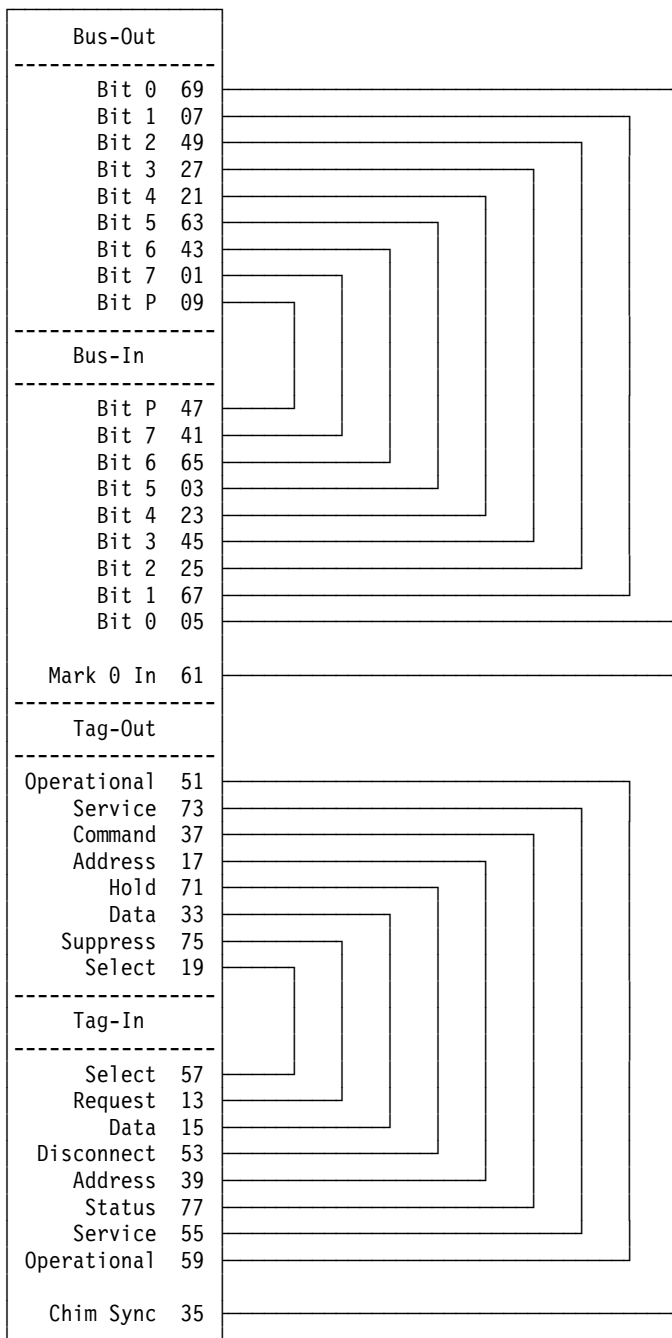
Figure 84. Card and Channel Wrap Layout (Type 2644)

Card and Channel Wrap Layout (Type 2644)

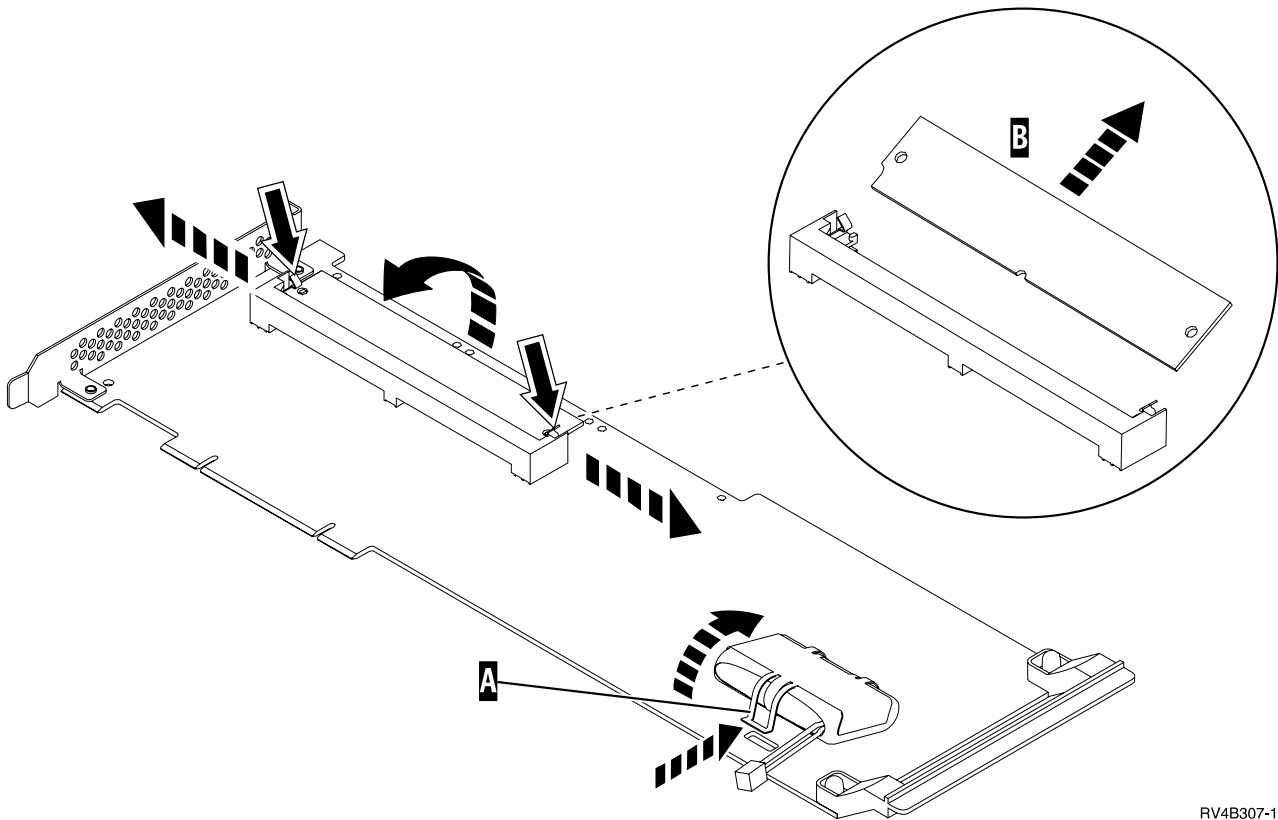
RV4B307-1

Figure 85. Cache Battery Pack and Cache Directory Card for Type 2740

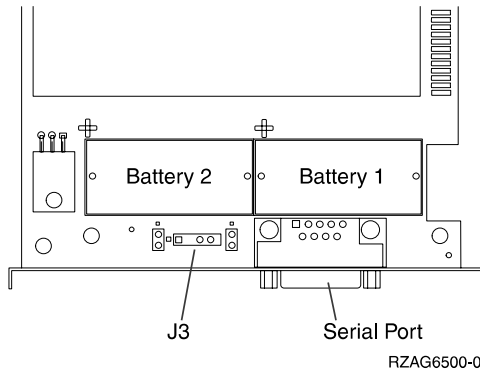
1. Power off the system or expansion tower (see “Powering Off and Powering On the System or Expansion Tower” on page 789).
2. If you are working in an expansion tower disconnect the power cord.
3. Remove the cover from the expansion slots. (See “Covers” on page 839 or if you are working in a FC 5065 or 5066 expansion tower see “Covers” on page 867.)
4. Remove the PCI Cryptographic Coprocessor card from the PCI-bus slot in the unit.
5. Find the location of the two lithium batteries. They are located in adjacent holders, with the left holder above the J3 connector. Refer to the illustration below.

Figure 88. Battery Locations on the 4758 PCI Cryptographic Coprocessor

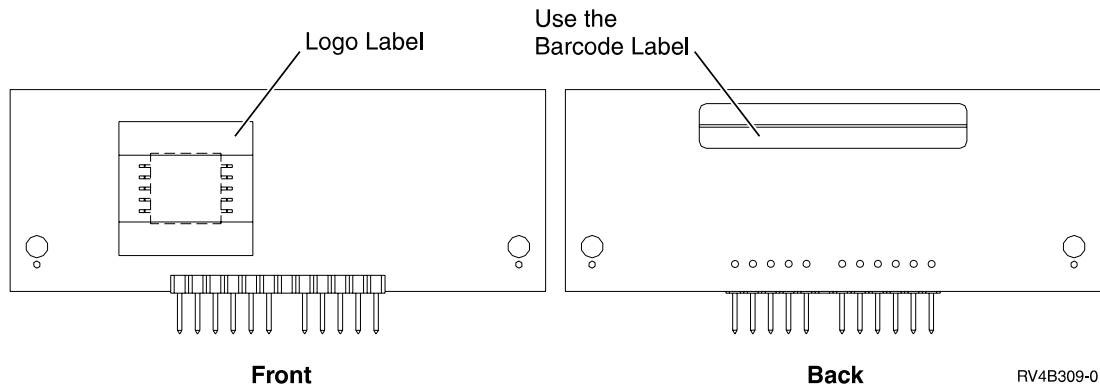
Figure 90. Interactive Card

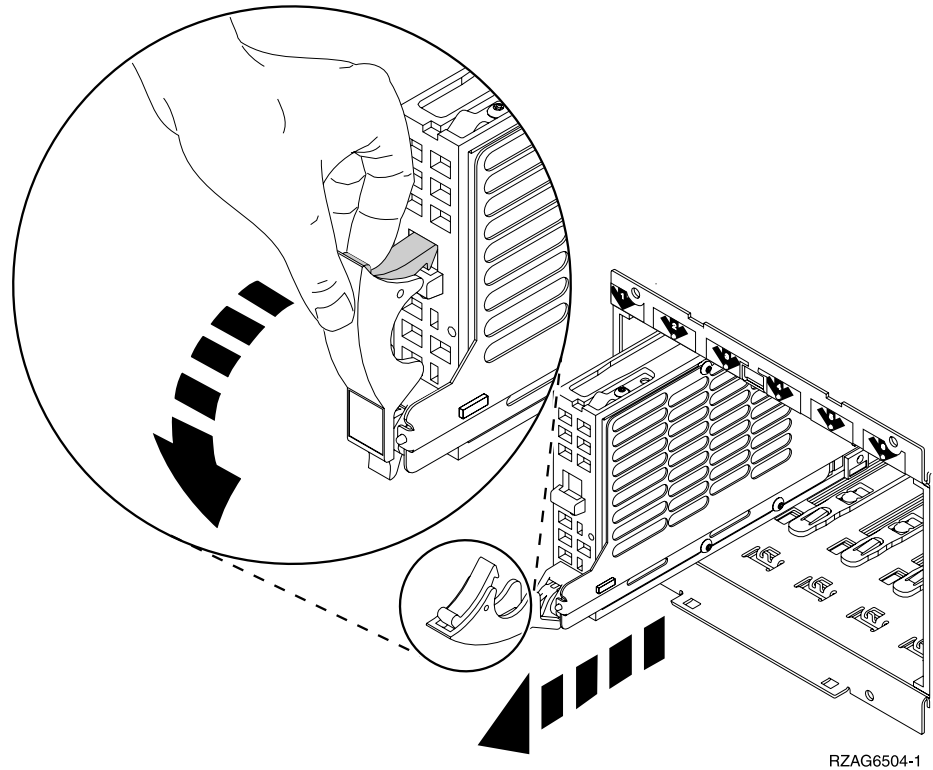
Attention: If you remove the device when the light is **not** flashing, data may be lost, the disk unit may be damaged, or the backplane may be damaged.

Note: The light above the device location will go off and remain off as soon as the device is no longer making contact with the backplane.

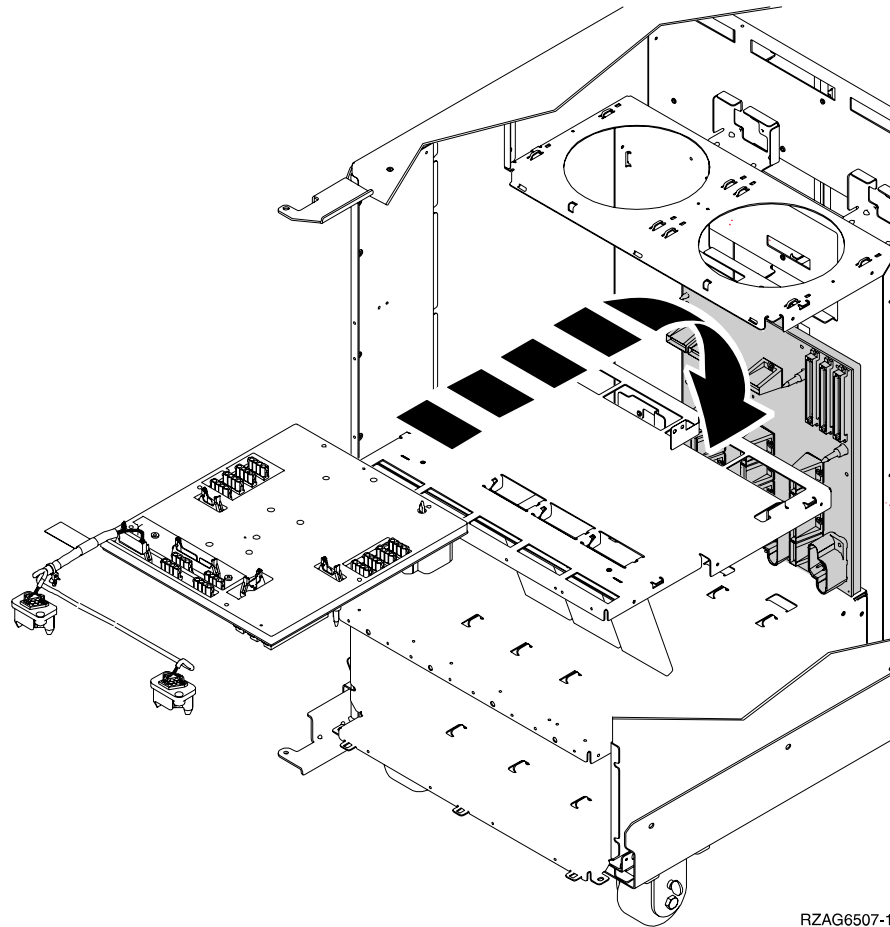
6. Pull the power distribution backplane slightly towards you and lift it up to remove it from the frame.

7. Install the power distribution backplane by reversing the removal procedure. After exchanging an item, go to "Verifying the Repair" on page 806.

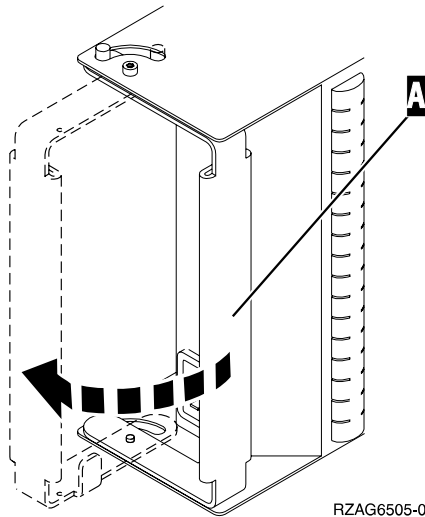
Note: Do not slam the power supply in when installing it into the system. Insert it until the power supply engages the frame, then rotate the handle from left to right.

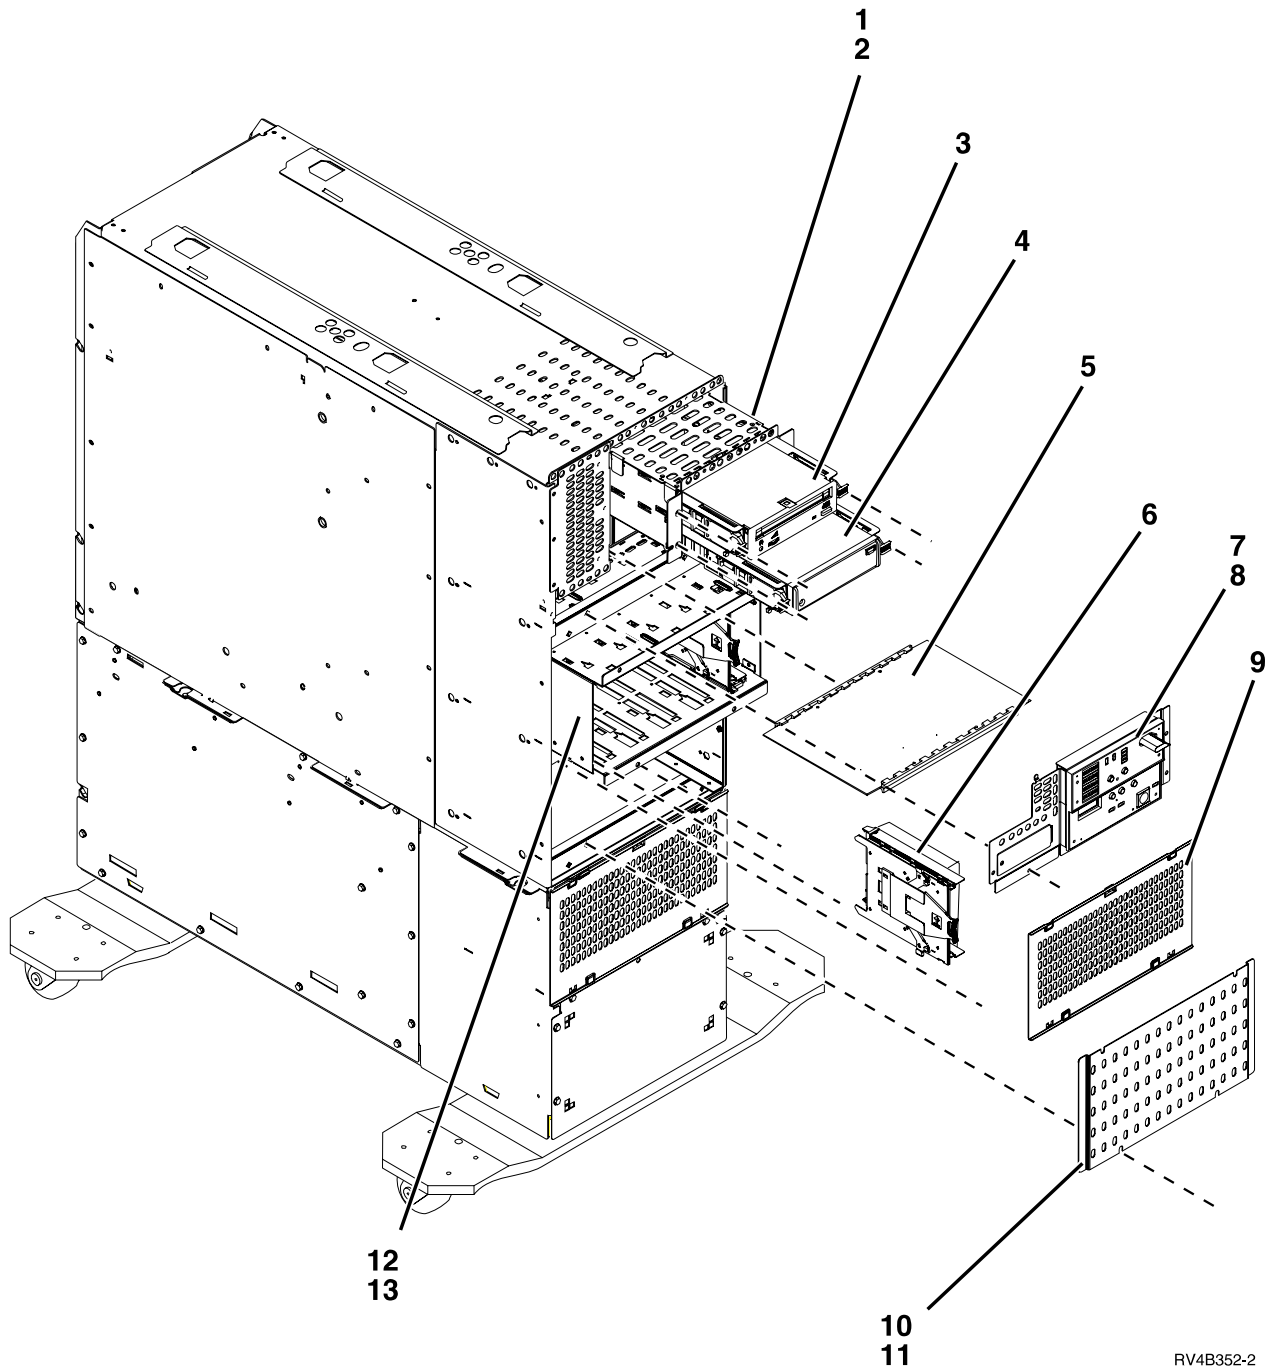
RV4B352-2

Assembly 7: Model 620, 720, or S20 System Unit

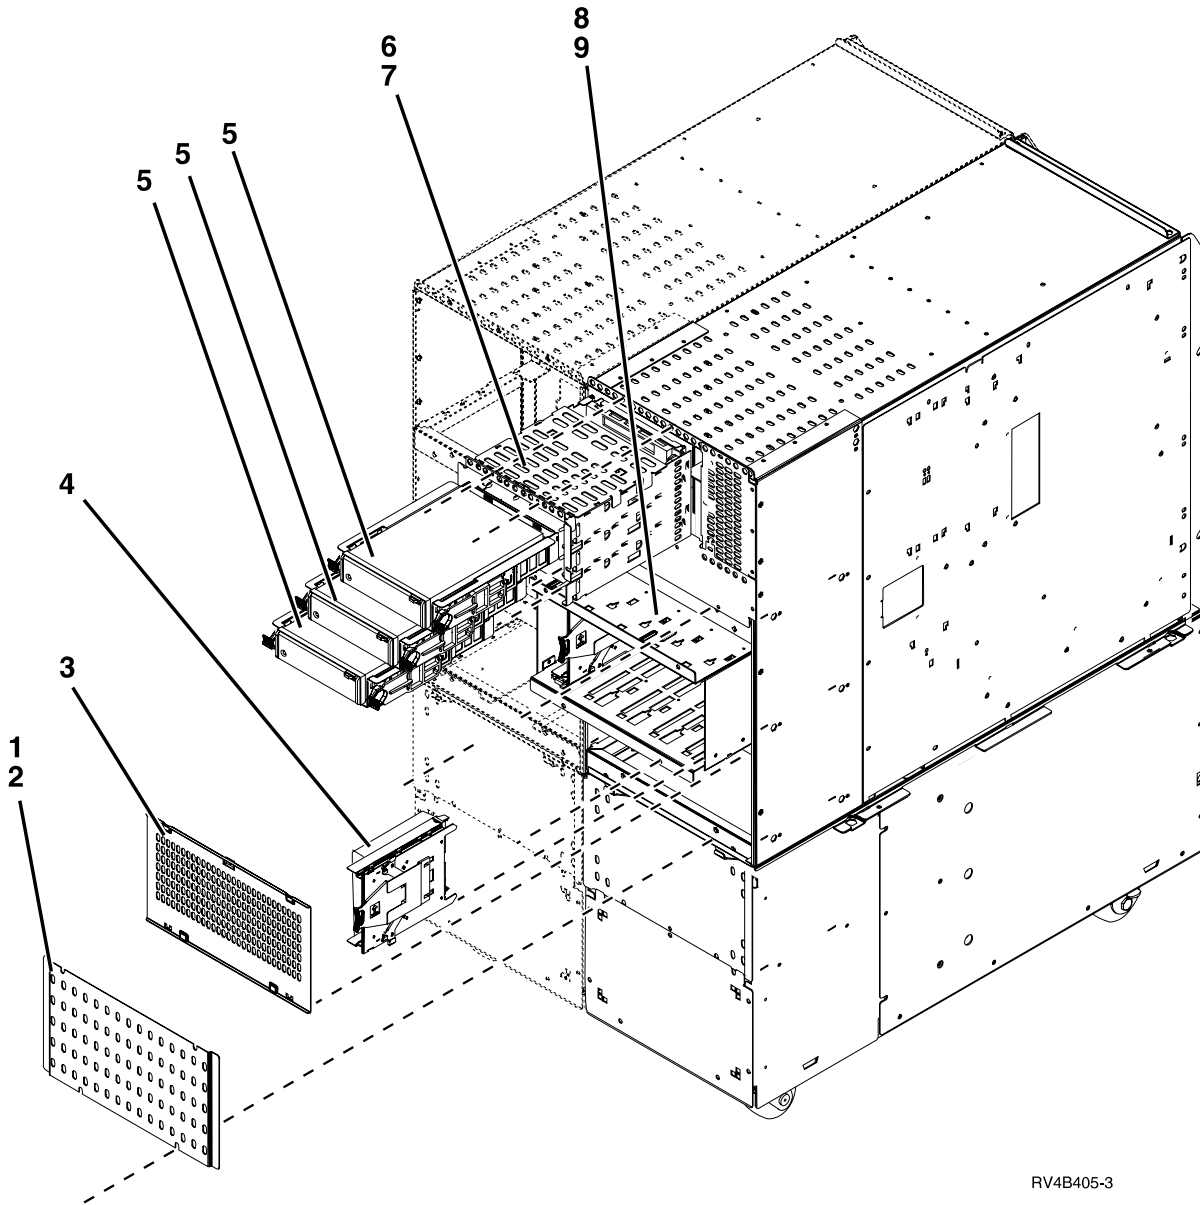
RV4B405-3

Assembly 11: Models 620, 720, or S20 Expansion Unit

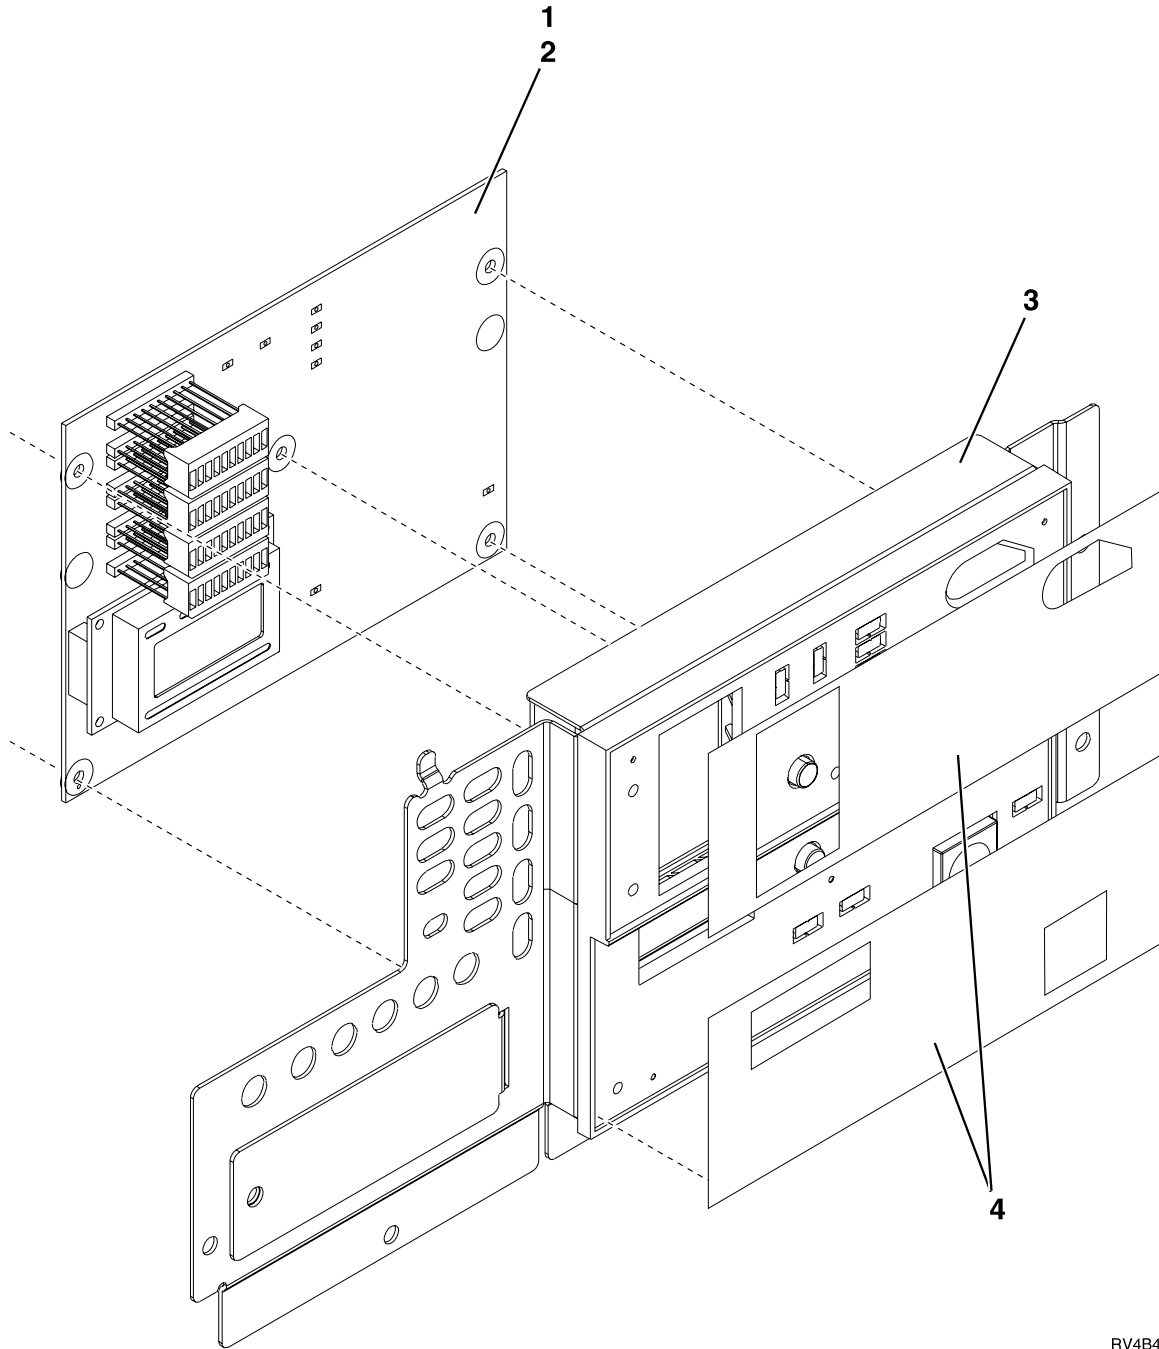
RV4B408-2

Assembly 12: Control Panel Assembly - Model 620, 720, or S20 System Unit (N-way Processor)

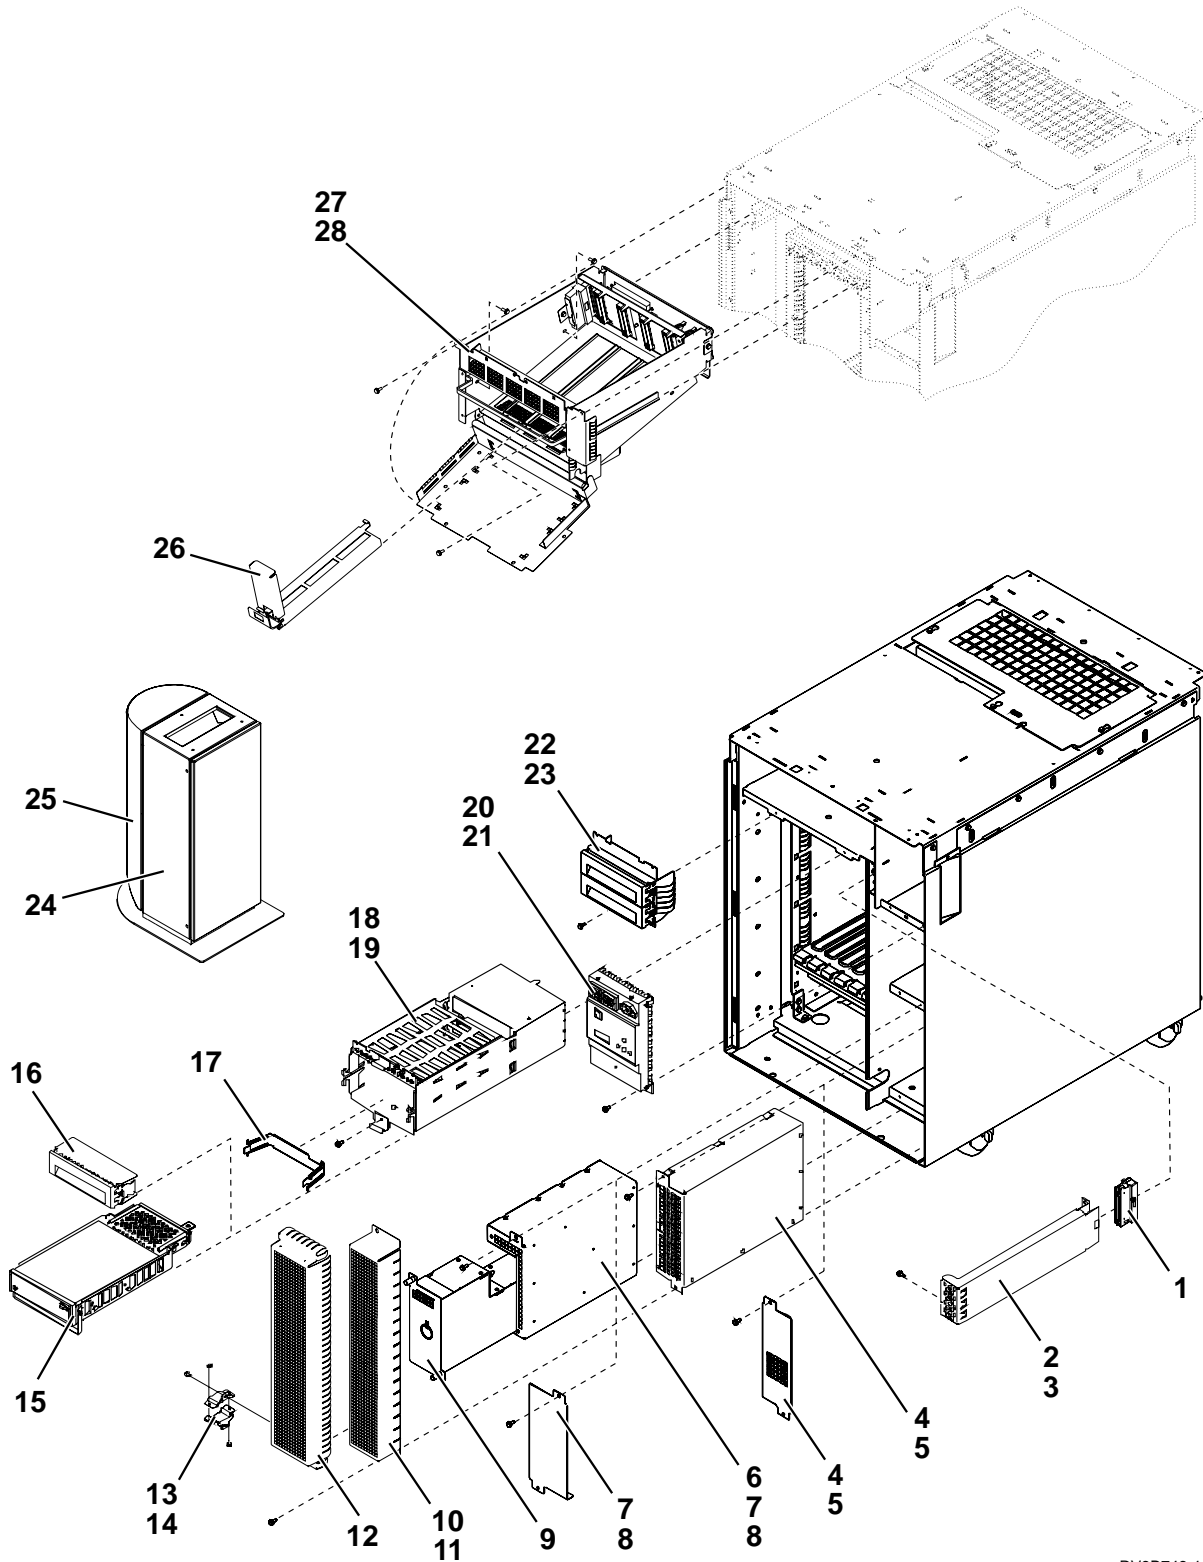
RV3B743-1

Assembly 16: Final Assembly - 9251 Base I/O, 507x & 508x Expansion Towers

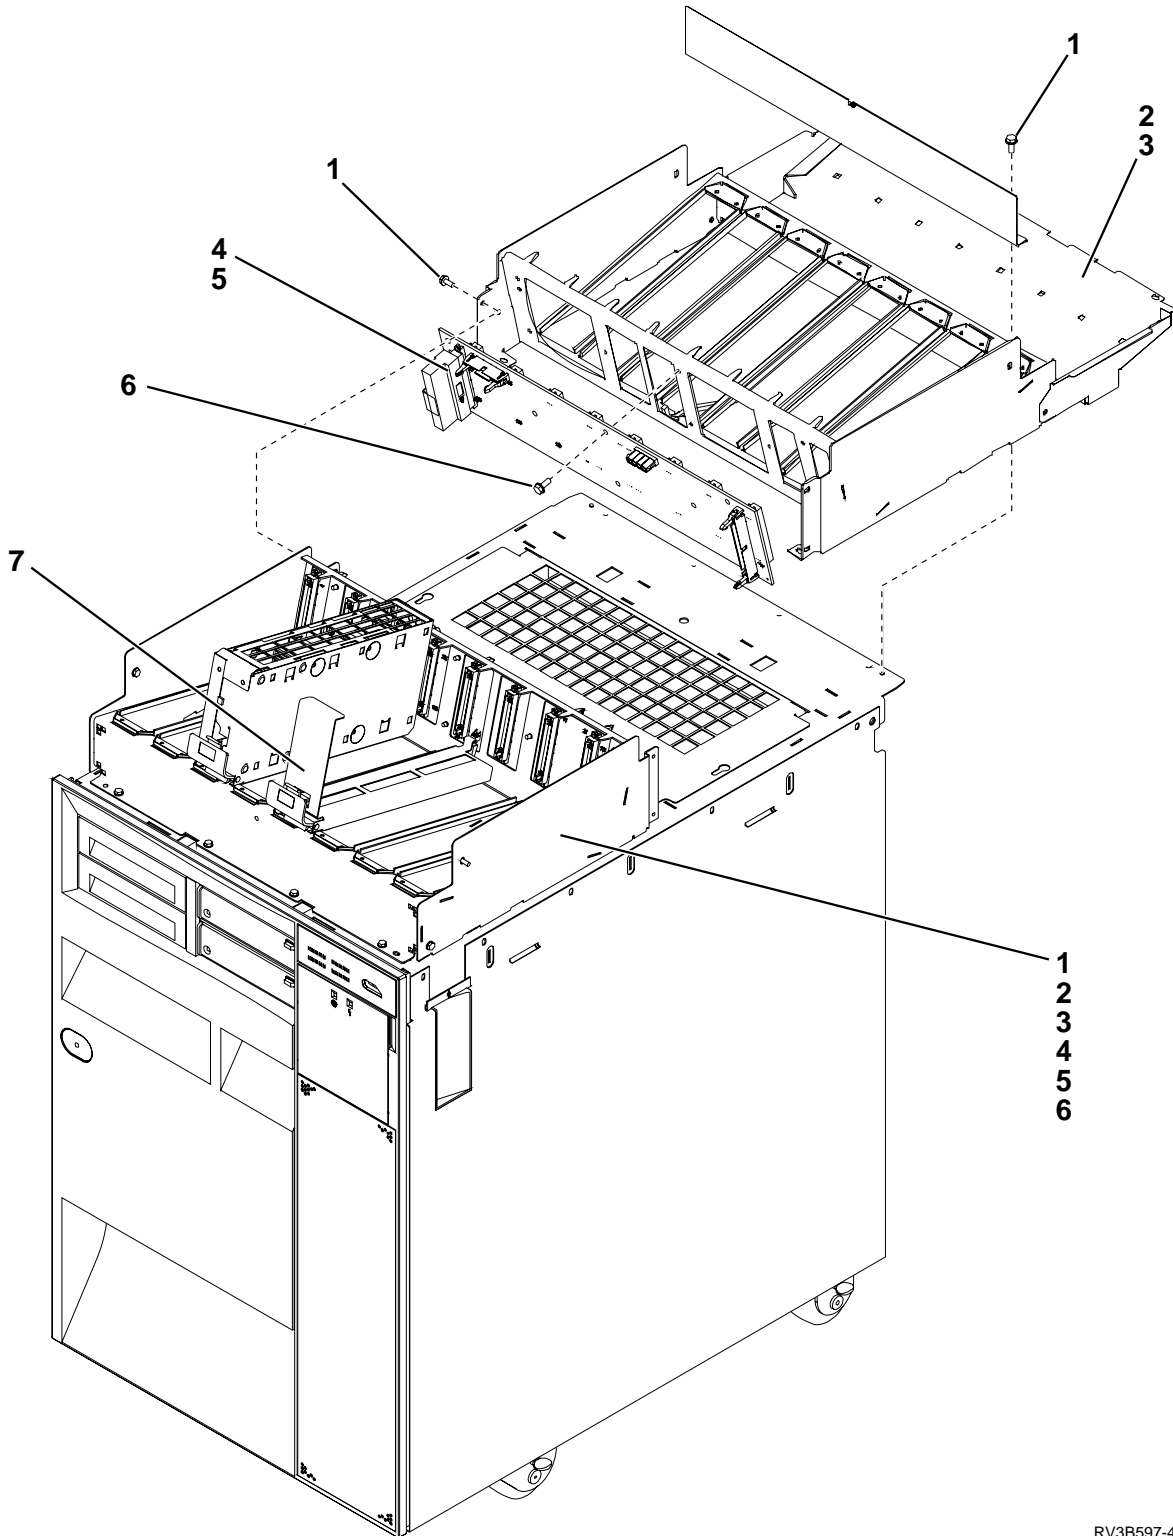
RV3B597-4

Assembly 17: Storage Expansion Unit Assembly
