iSeries Model 830, 840, SB2, and SB3
Problem Analysis, Repair and Parts

Version 5

SY44-5969-01

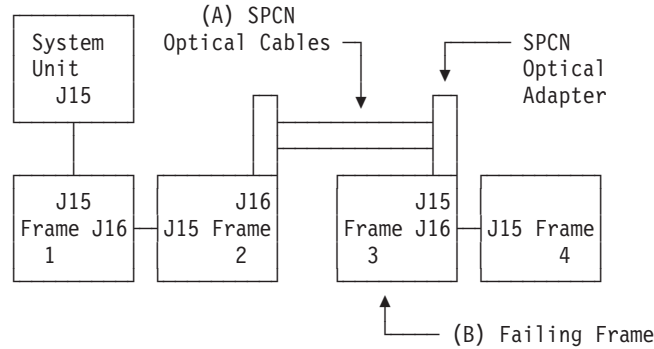
23. Do SPCN optical cables **A** connect the failing frame **B** to the preceding frame in the string?

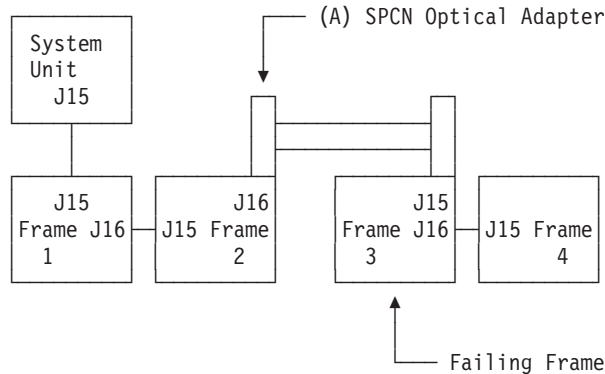
24. Remove the SPCN optical adapter **A** from the preceding frame in the string that cannot become powered on. See the removal and installation procedures in this book or in the *Migrated Expansion Tower Problem Analysis, Repair and Parts*, depending on the secondary frame you are working on.

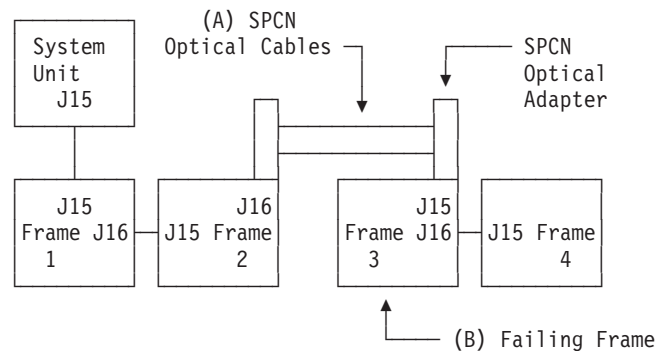
62. Do SPCN optical cables A connect the failing frame B to the preceding frame in the string?

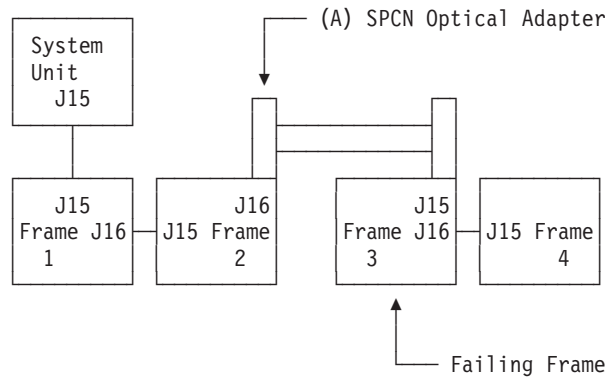
63. Remove the SPCN optical adapter **A** from the preceding frame in the string that cannot become powered on. See "Removal and Installation Procedures" in the Repair and Parts information for the system.

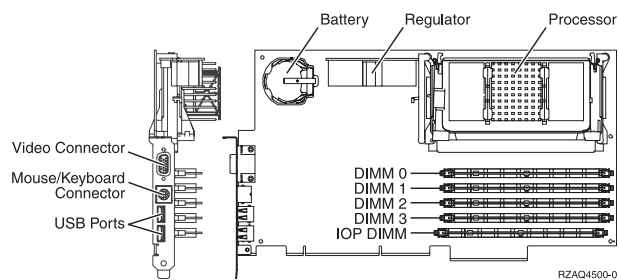
DIMM 0

Figure 8. Locations of DIMM 0, DIMM 1, DIMM 2 and DIMM 3 on 2890 Integrated xSeries Server (IXS) card.

The *first* DIMM from the top of the IXS card is the failing item. To determine the part number, go to symbolic FRU “MEMORY” on page 558.

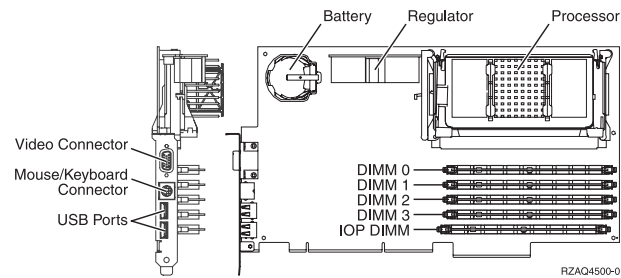
DIMM 1

Figure 9. Locations of DIMM 0, DIMM 1, DIMM 2 and DIMM 3 on 2890 Integrated xSeries Server (IXS) card.

The *second* DIMM from the top of the IXS card is the failing item. To determine the part number, go to symbolic FRU "MEMORY" on page 558.

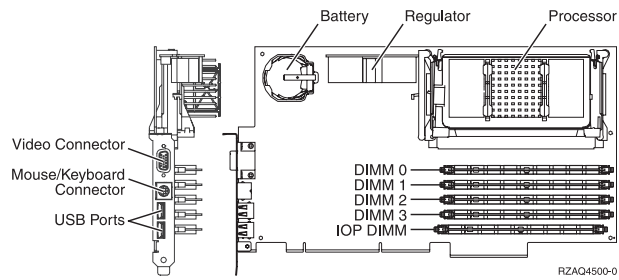
Figure 10. Locations of DIMM 0, DIMM 1, DIMM 2 and DIMM 3 on 2890 Integrated xSeries Server (IXS) card.

The *third* DIMM from the top of the IXS card is the failing item. To determine the part number, go to symbolic FRU "MEMORY" on page 558.

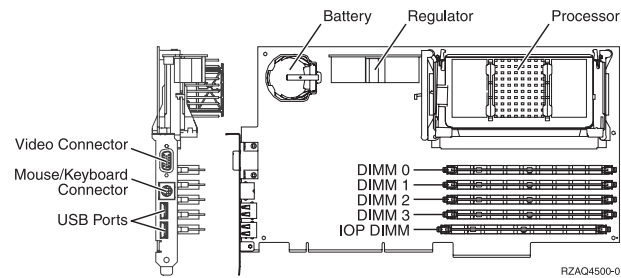
Figure 11. Locations of DIMM 0, DIMM 1, DIMM 2 and DIMM 3 on 2890 Integrated xSeries Server (IXS) card.

The *fourth* DIMM from the top of the IXS card is the failing item. To determine the part number, go to symbolic FRU “MEMORY” on page 558.

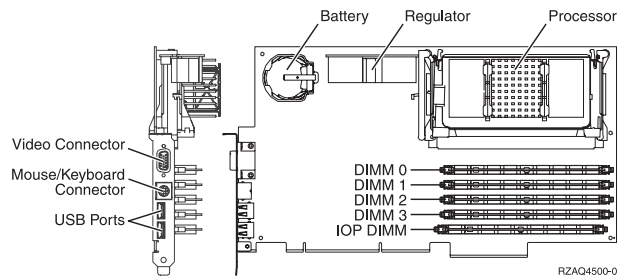
Figure 13. Locations of DIMM 0, DIMM 1, DIMM 2 and DIMM 3 on 2890 Integrated xSeries Server (IXS) card.

One of the Pentium memory modules (DIMM 0, DIMM 1, DIMM 2, or DIMM 3) may be the failing item.

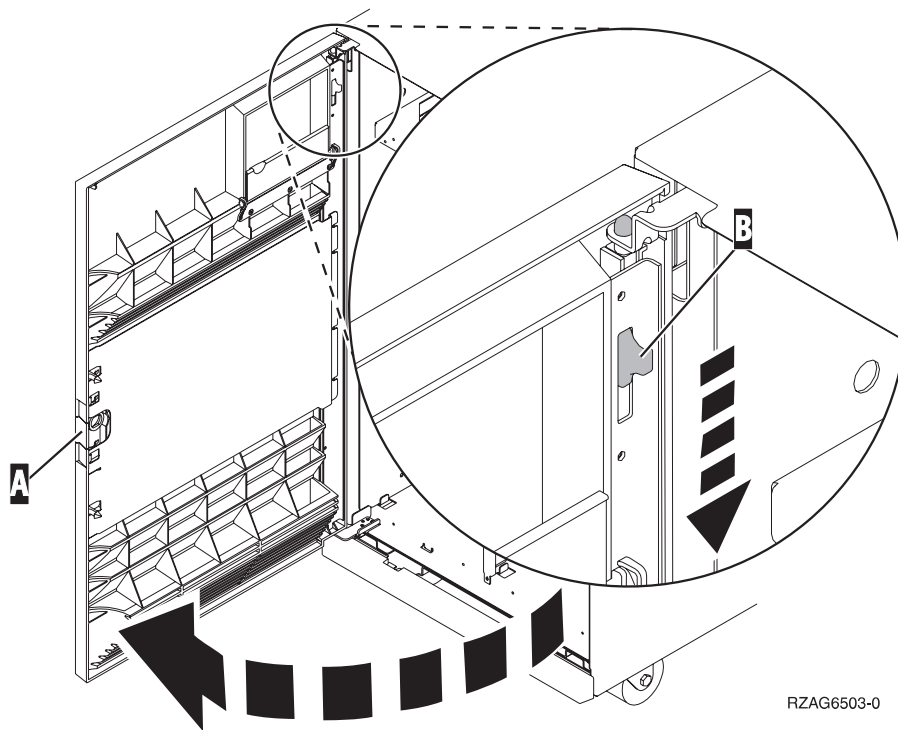
Figure 14. Front Cover - Removal

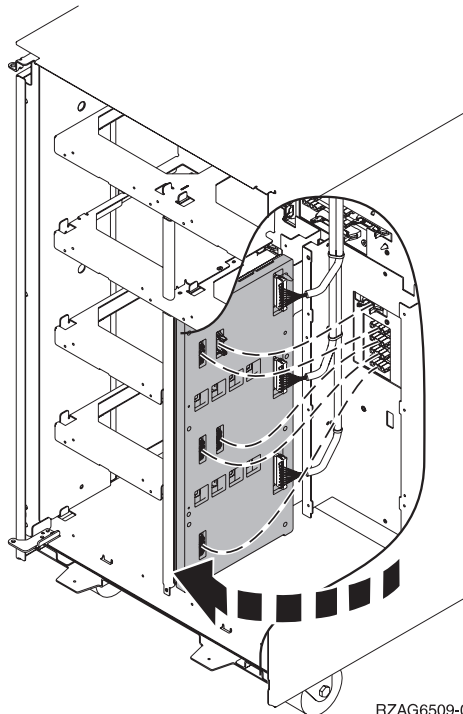
6. Pull the DASD board assembly out until it slides off the guide pins, then rotate the DASD board assembly 90° to remove the cables that are located on the backside of it.

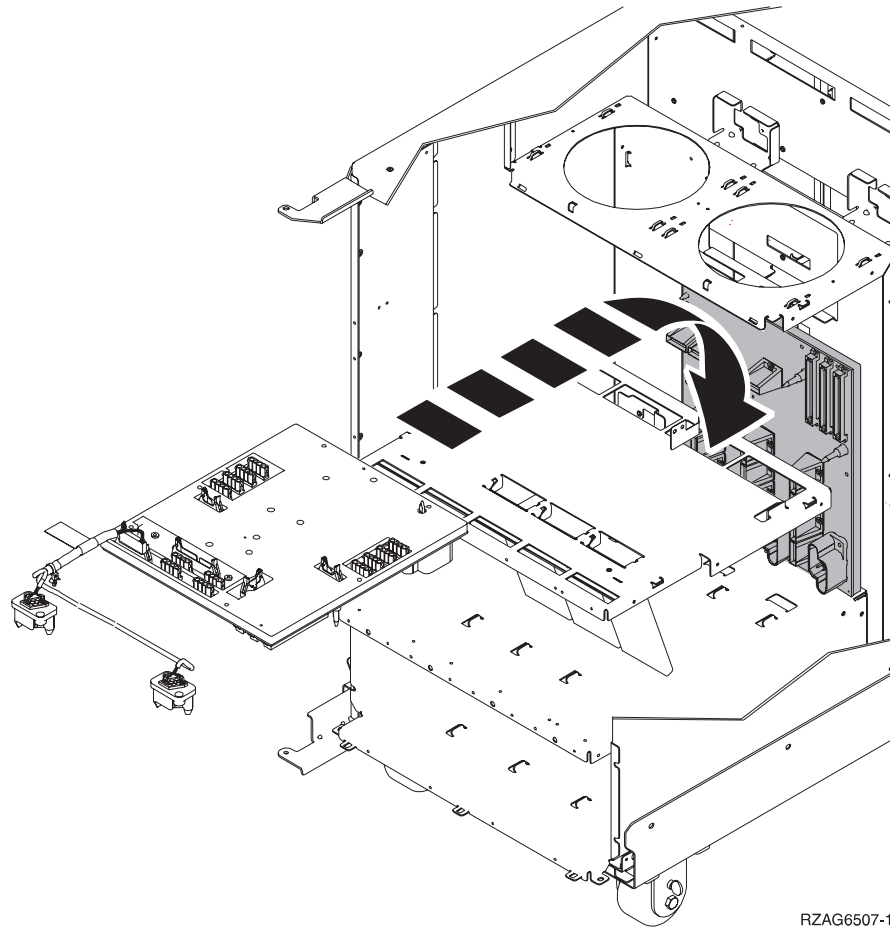
6. Pull the power distribution backplane slightly towards you and lift it up to remove it from the frame.

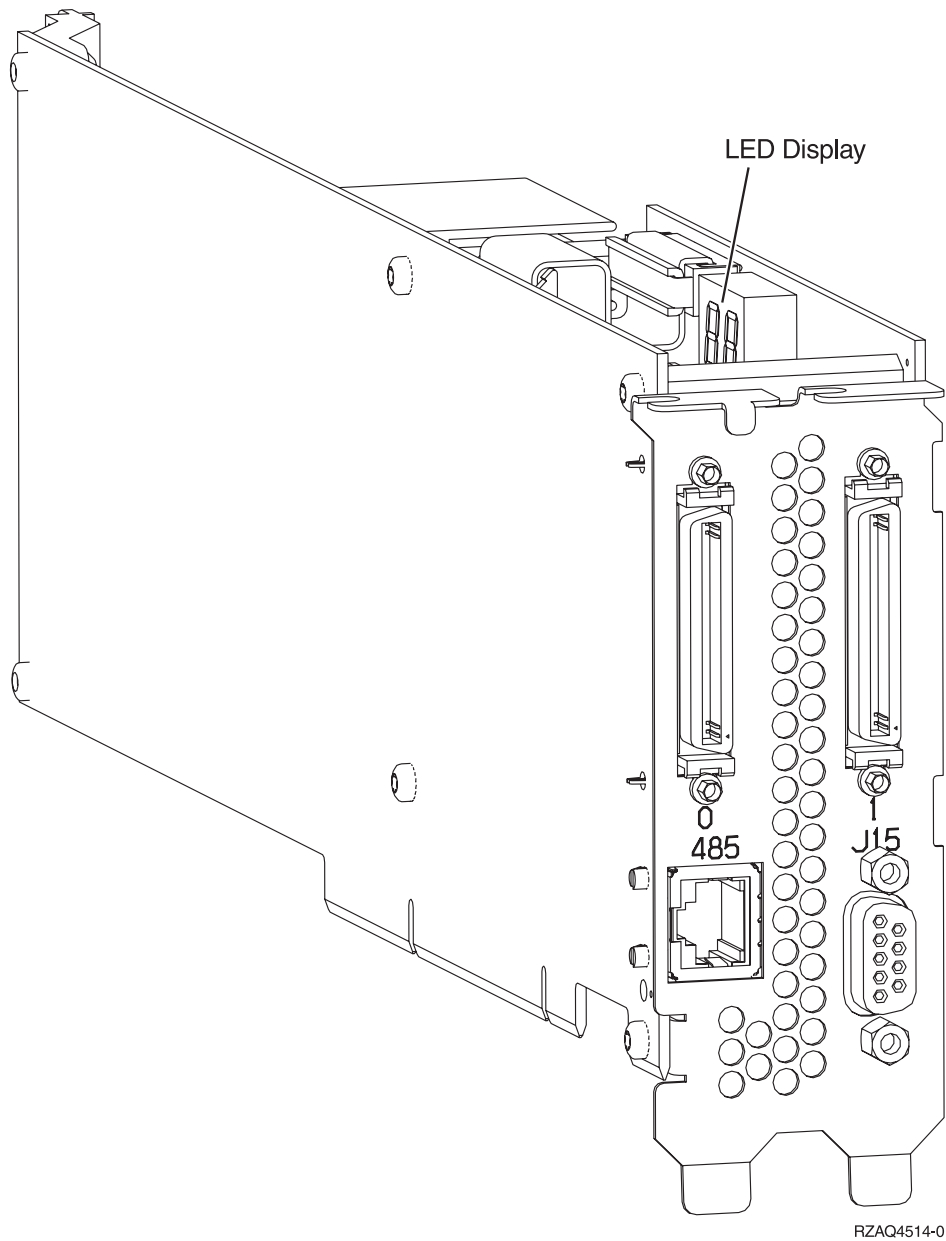
Figure 22. Integrated xSeries Adapter (IXA) Card

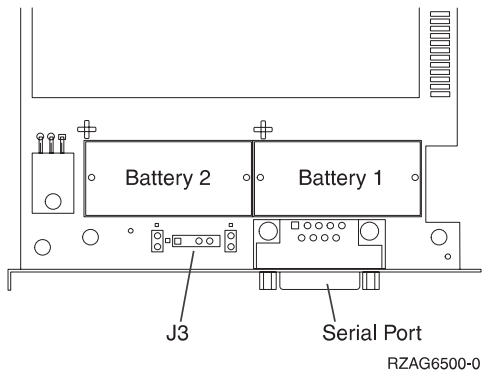
1. Remove the 4758 PCI Cryptographic Coprocessor card from the system (see “Models 830/SB2 with FC 9074 – Cards – Concurrent” on page 655, “Models 840/SB3, FC 8079 (lower half), FC 9079 Cards — Concurrent” on page 678, “FC 5074, FC 5079 – Cards – Concurrent” on page 620, or “FC 5075 – Cards – Concurrent” on page 638).
2. Find the location of the 4 lithium batteries. They are located in adjacent holders, with the Battery 2 holder above the J3 connector. Refer to the illustration below.

Figure 24. Battery Locations on the 4758 PCI Cryptographic Coprocessor

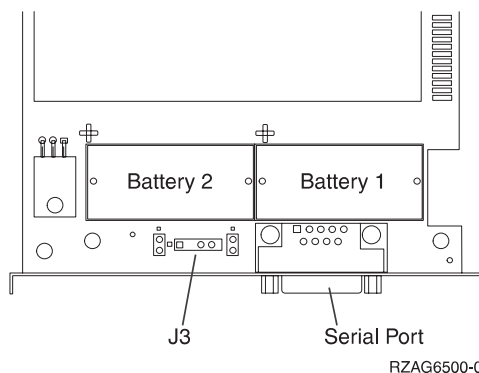
- Remove the 4758 PCI Cryptographic Coprocessor card from the system (see "Models 830/SB2 with FC 9074 – Cards – Concurrent" on page 655, "Models 840/SB3, FC 8079 (lower half), FC 9079 Cards — Concurrent" on page 678, "FC 5074, FC 5079 – Cards – Concurrent" on page 620, or "FC 5075 – Cards – Concurrent" on page 638).
- Find the location of the four lithium batteries. They are located in adjacent holders, with the Battery 2 above the J3 connector. Refer to the illustration below.

Figure 25. Battery Locations on the 4758 PCI Cryptographic Coprocessor

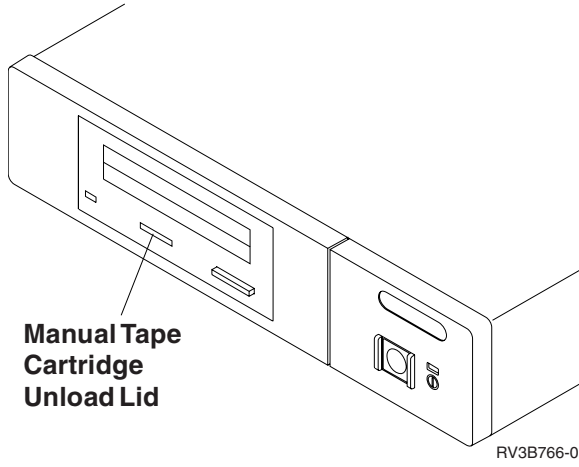
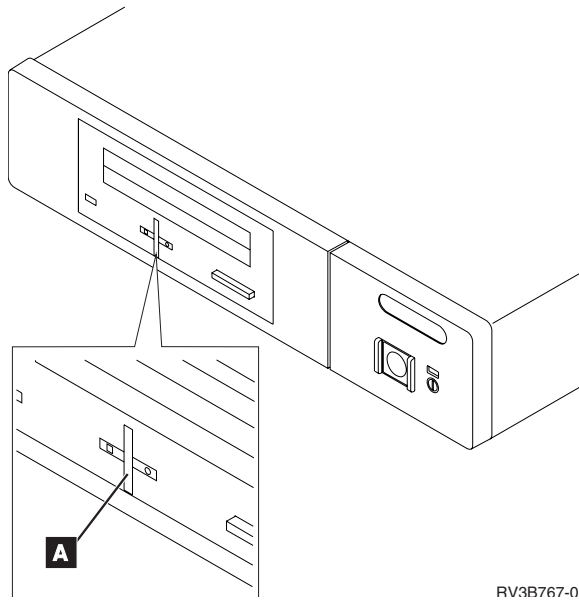
1. Power off the tape unit.
2. Carefully lift and turn the manual tape cartridge unload lid **A**.

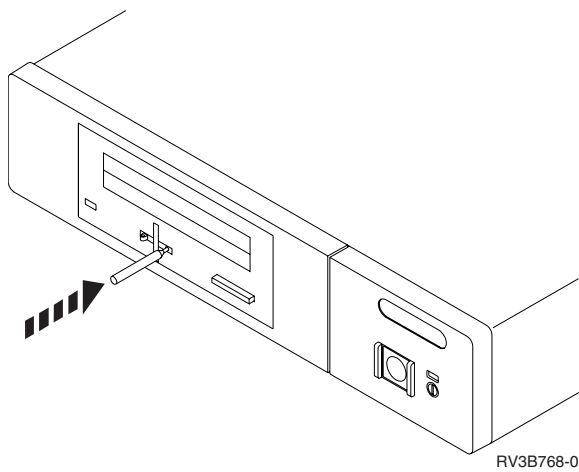
3. Insert a solid metal rod (like a bristol wrench) into the manual tape cartridge unload hole and push in until it stops and the arm appears.

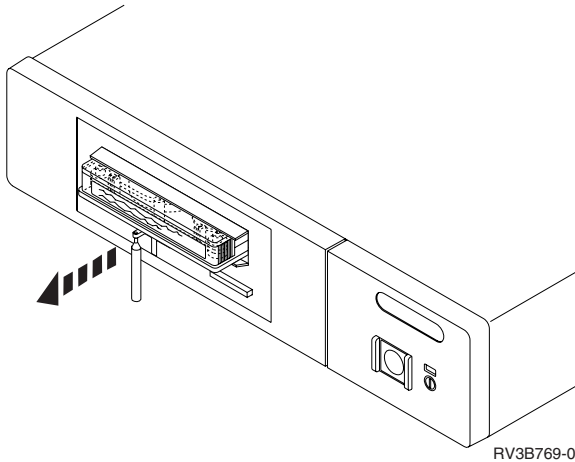
4. Pull the arm out until it stops. Insert the solid metal rod into the hole of the arm and pull out until the tape cartridge comes out.

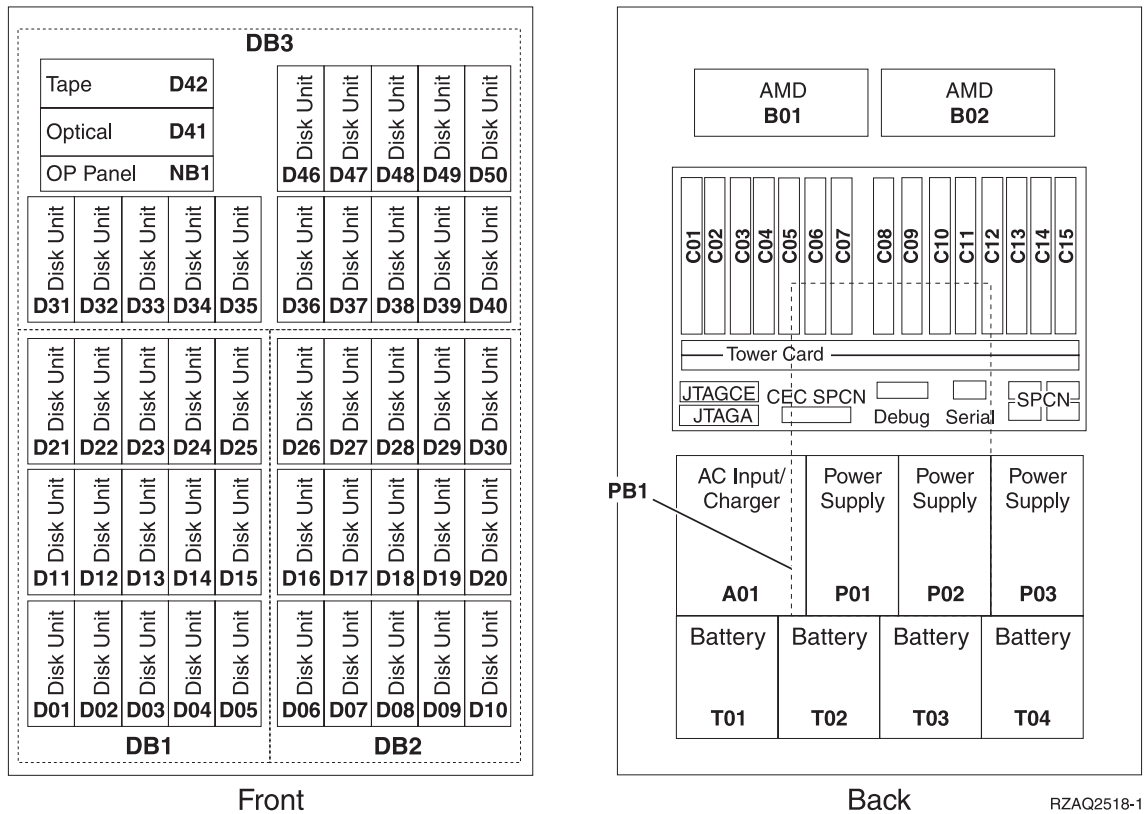
Figure 36. Locations for FC 9079 Base I/O Tower (On Models 840, SB3 System Unit)

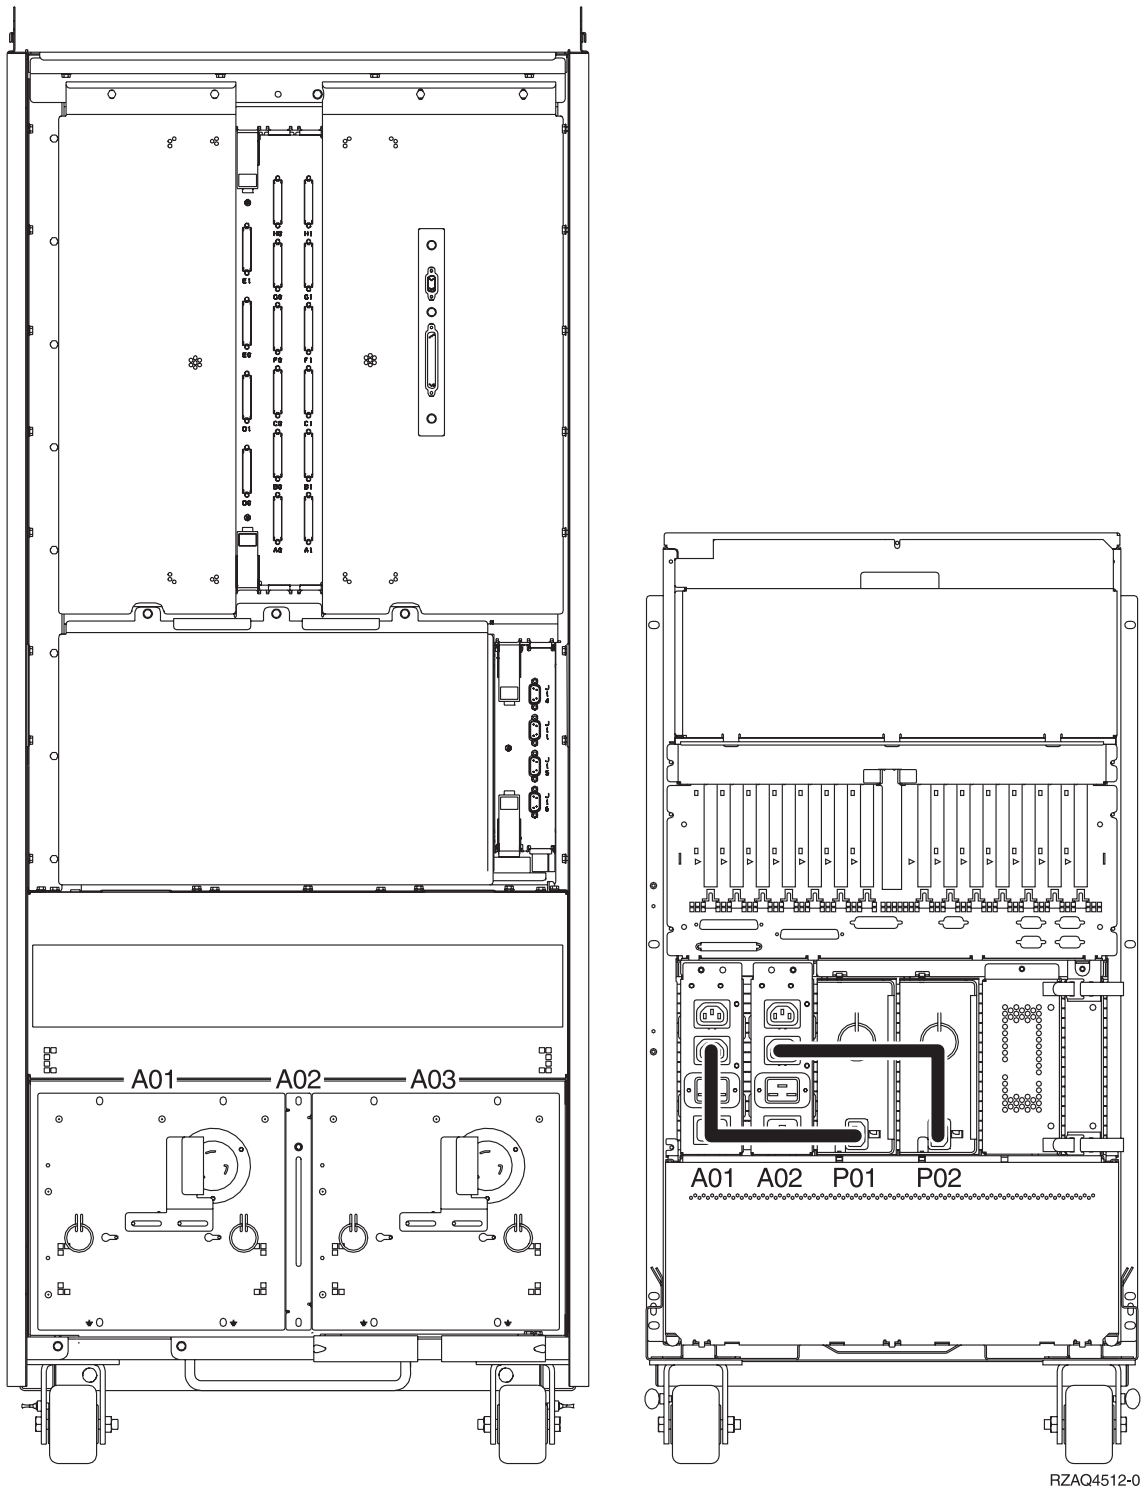
Figure 37. Dual Line Cord Drawing for System Models 840, SB3

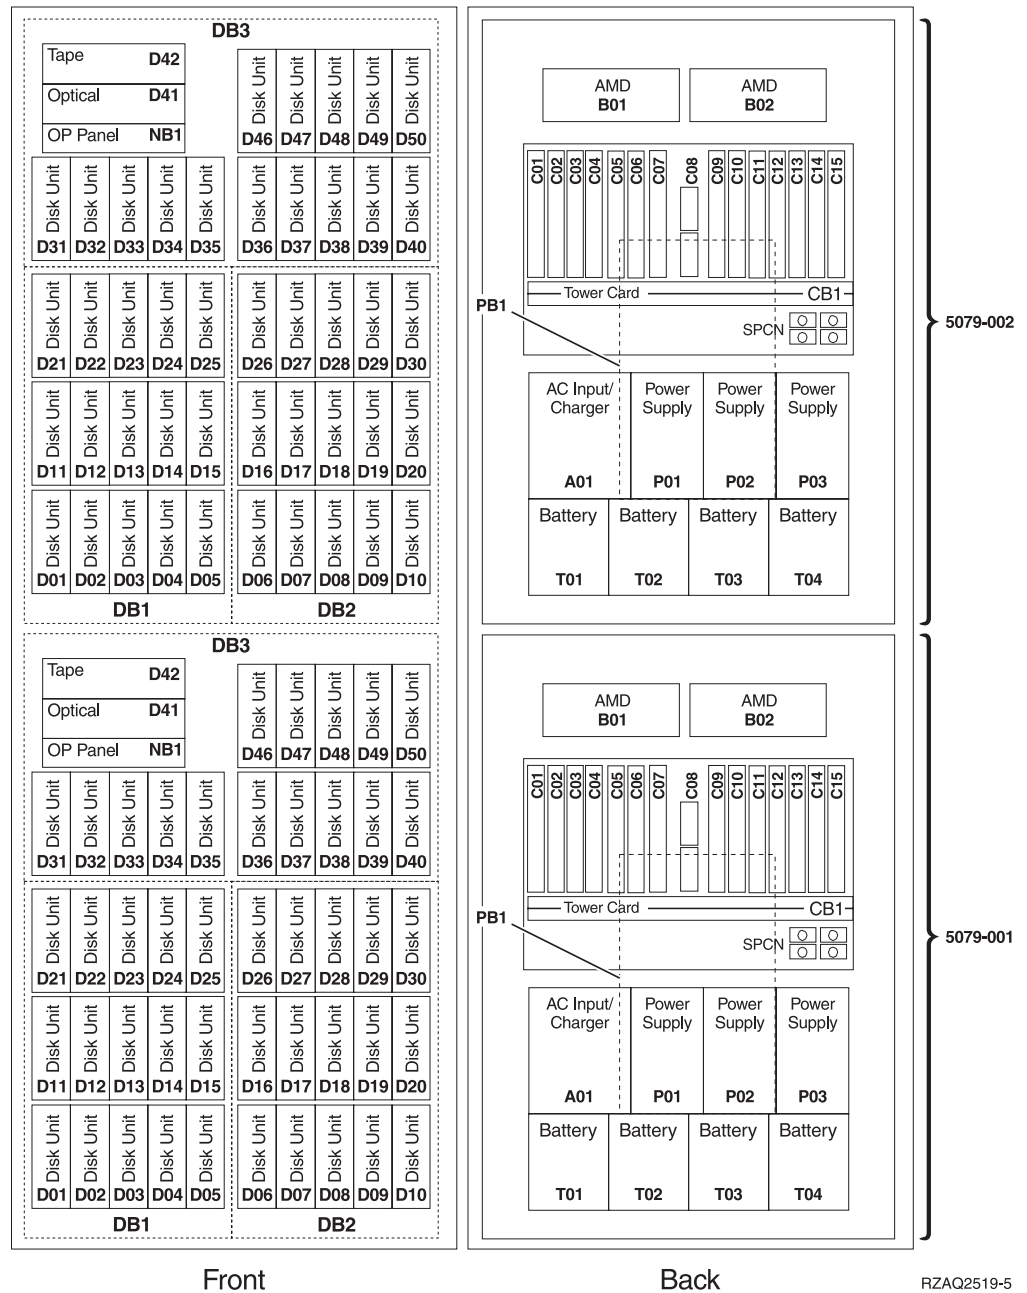
Figure 48. Locations for FC 5079 I/O Tower

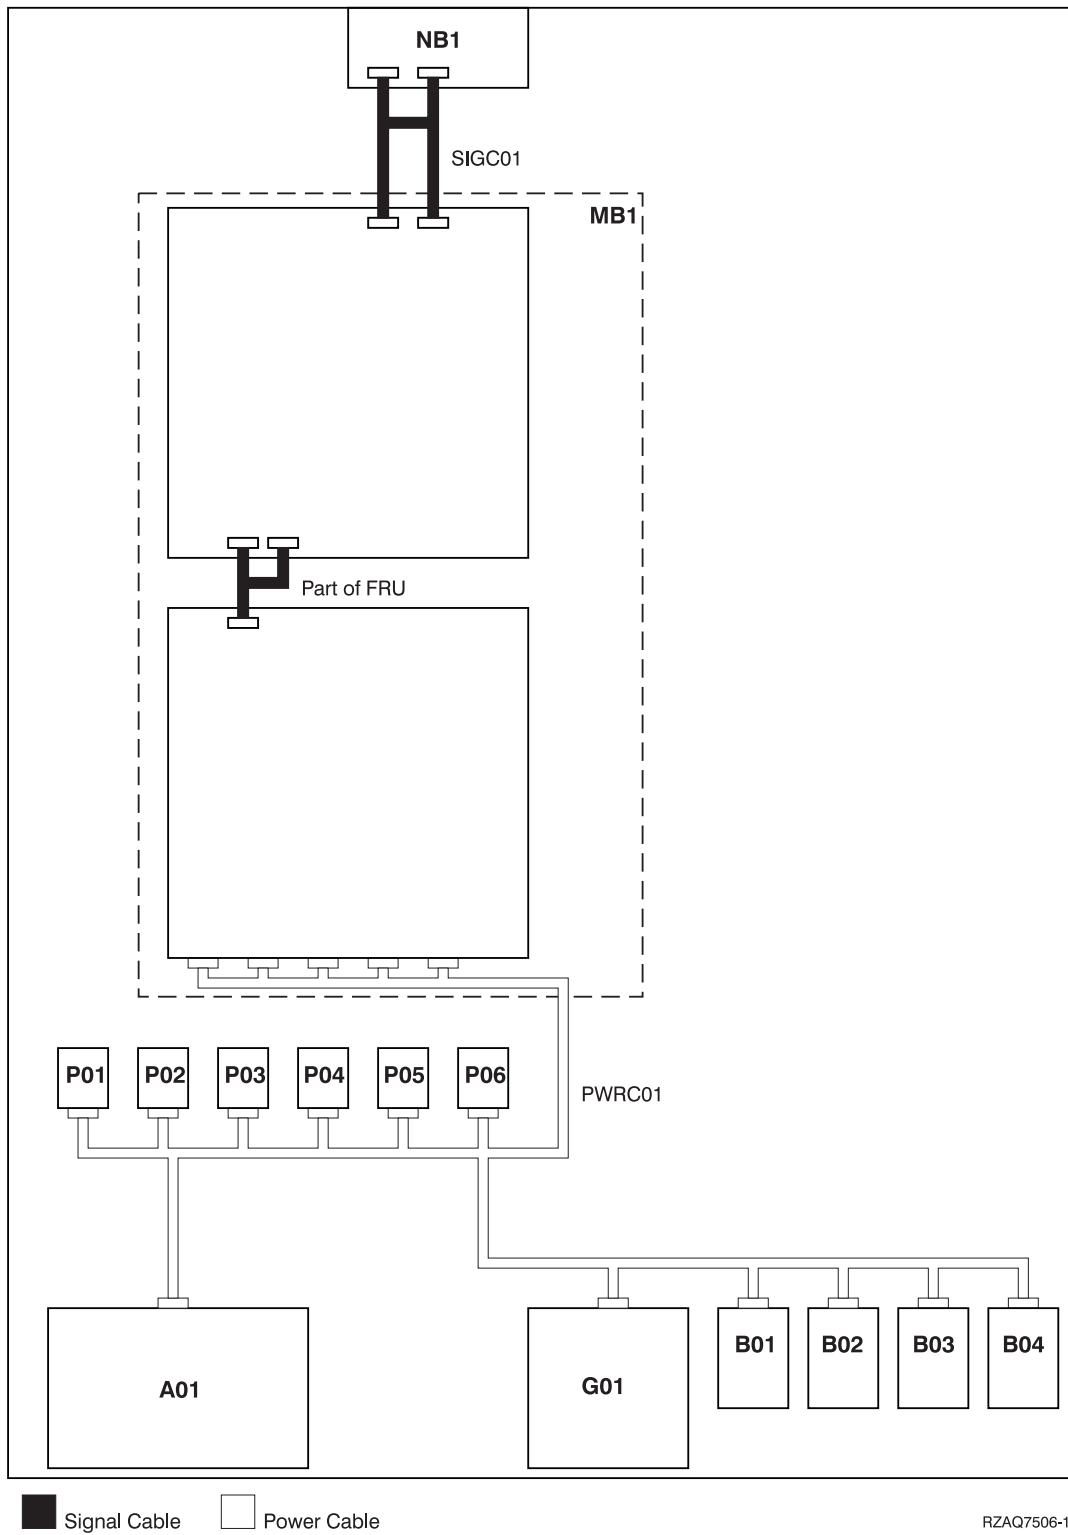
Figure 54. Model 840 and Model SB3 Processor Tower – Single Line Cord Power and Signal Cables

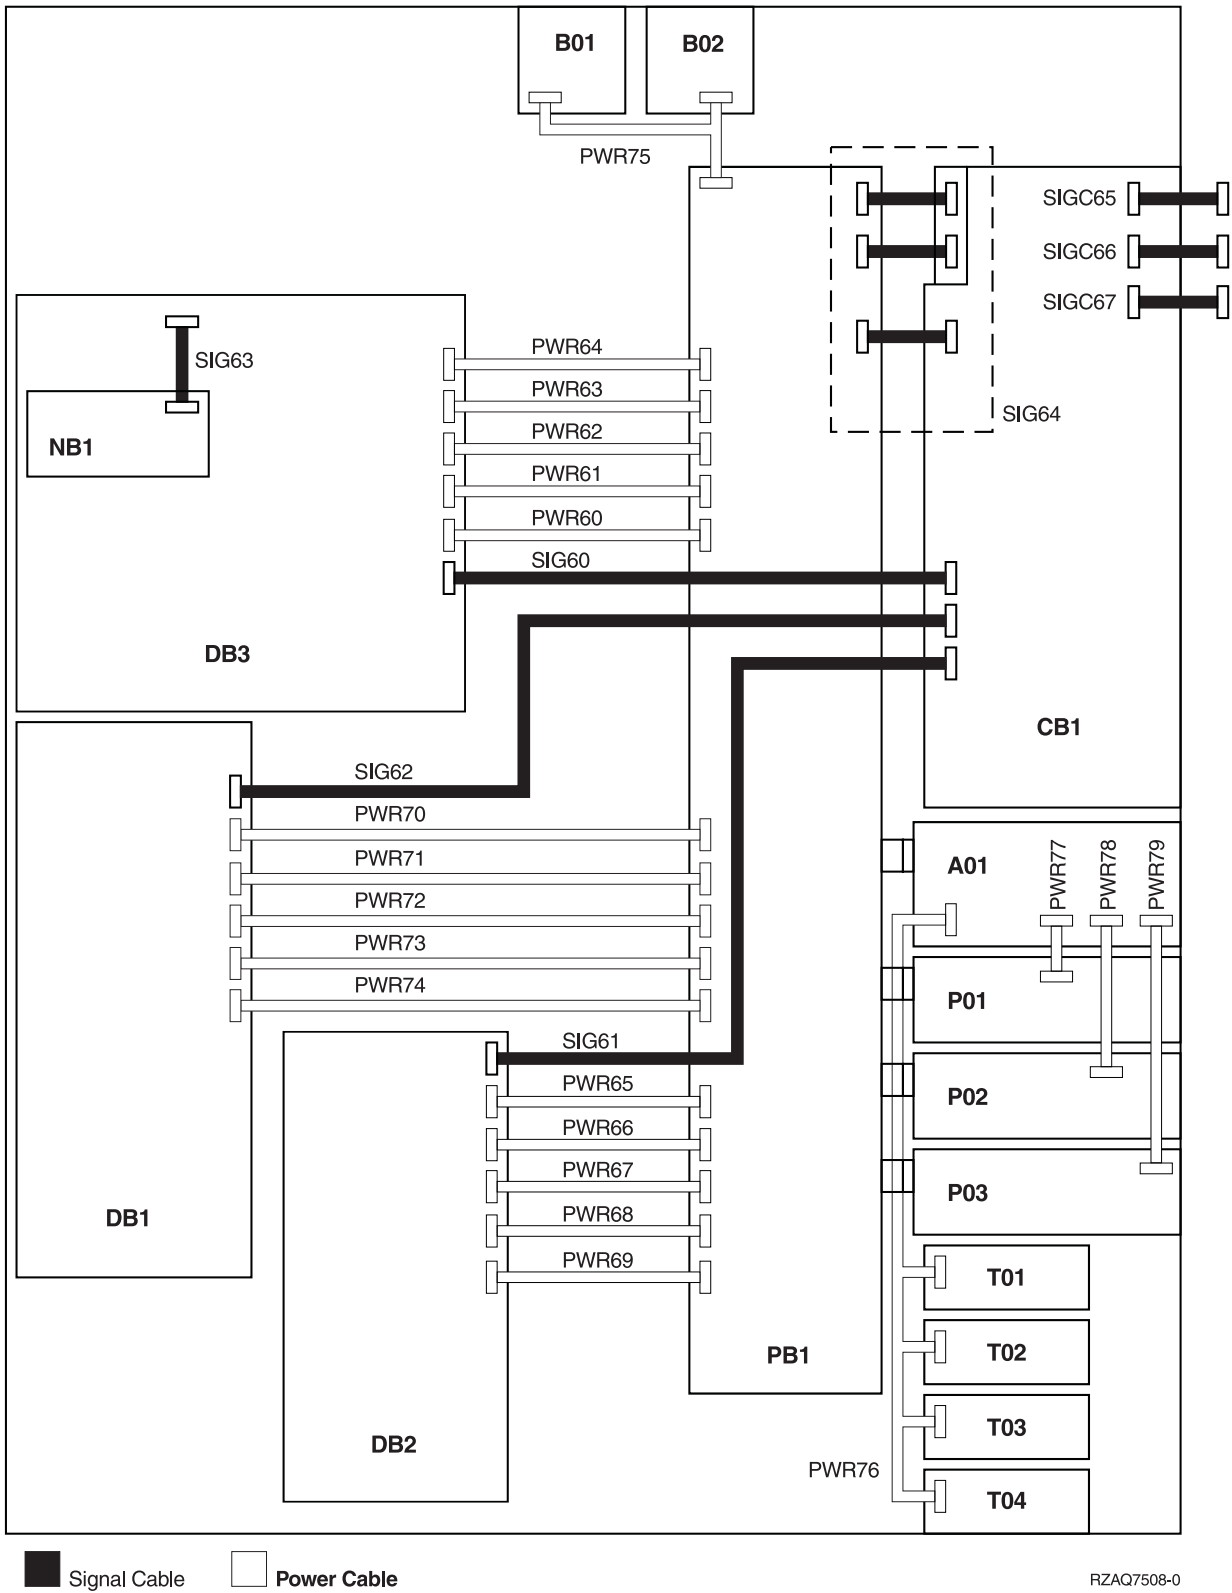
Figure 56. Model 840 and Model SB3 (FC 9079) Base I/O Tower – Single Line Cord Power and Signal Cables

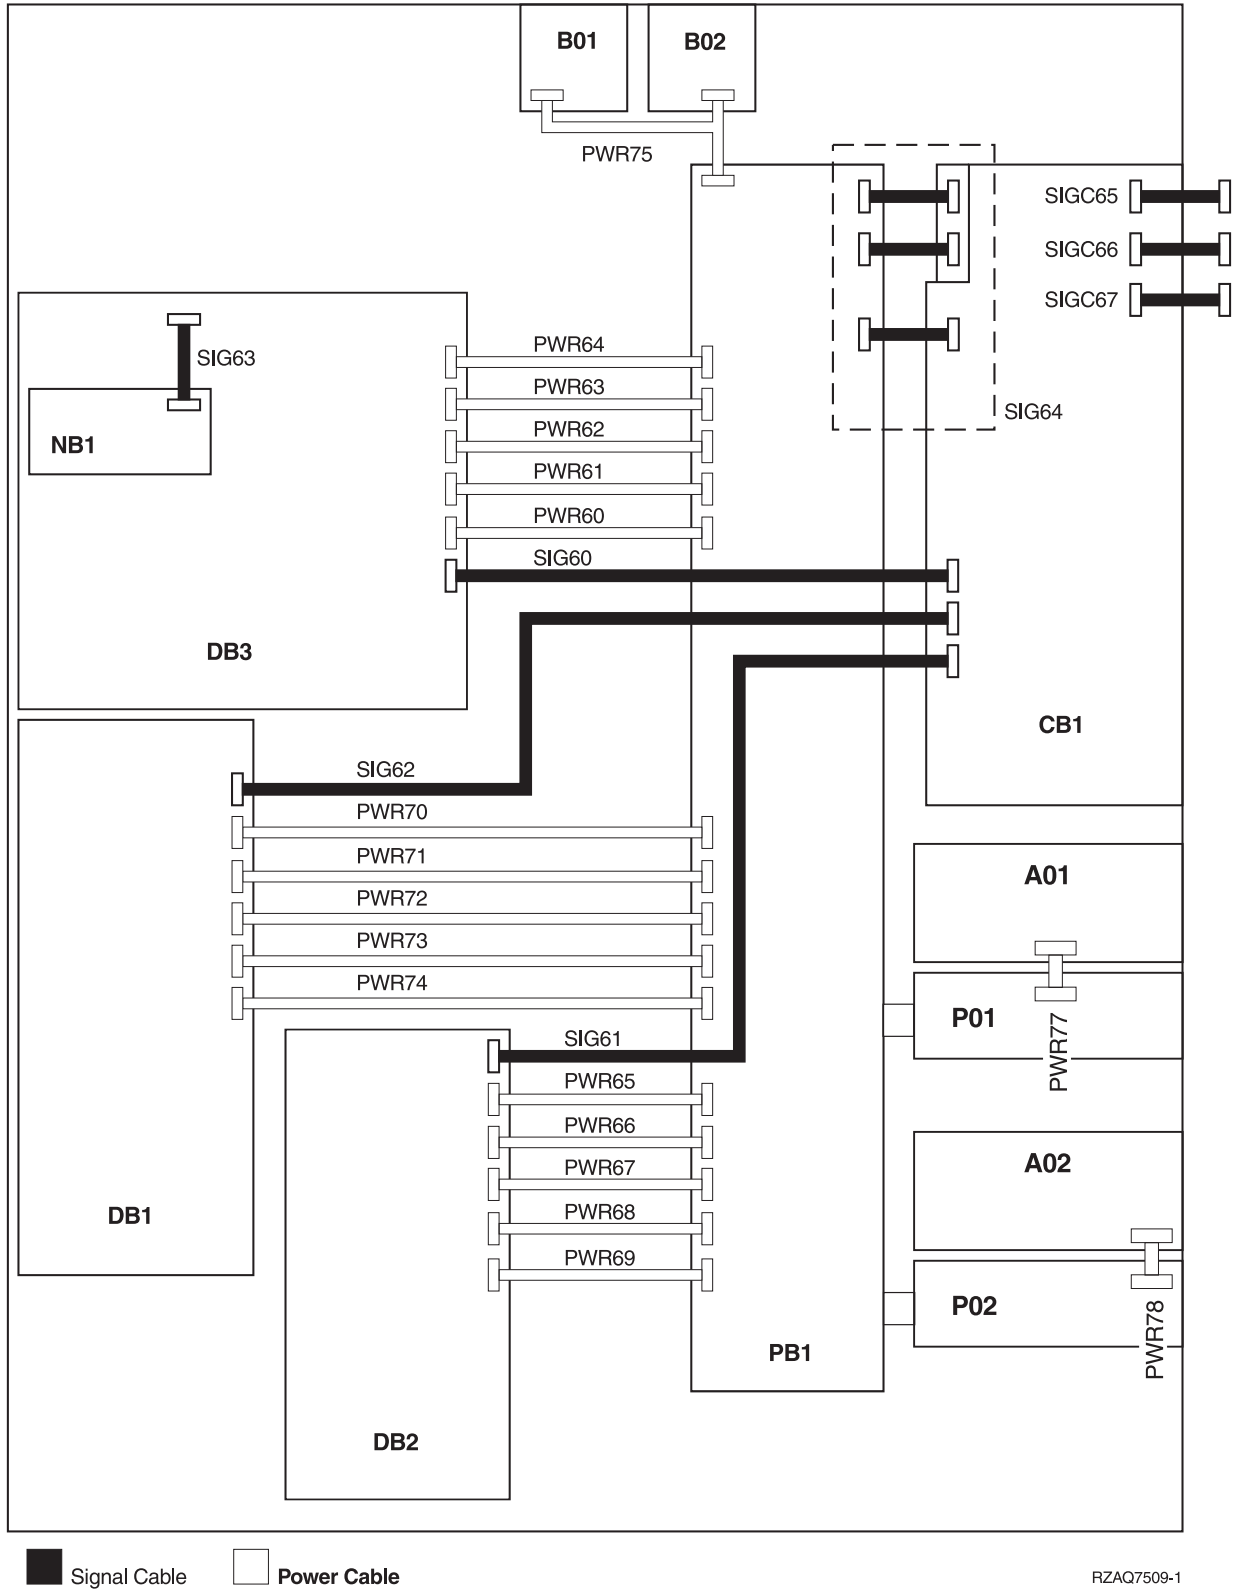
Figure 57. Model 840 and Model SB3 (FC 9079) Base I/O Tower – Dual Line Cord Power and Signal Cables
